MARINE OCCURRENCE REPORT

03-206

tanker *Capella Voyager*, grounding, Whangarei

16 April 2003

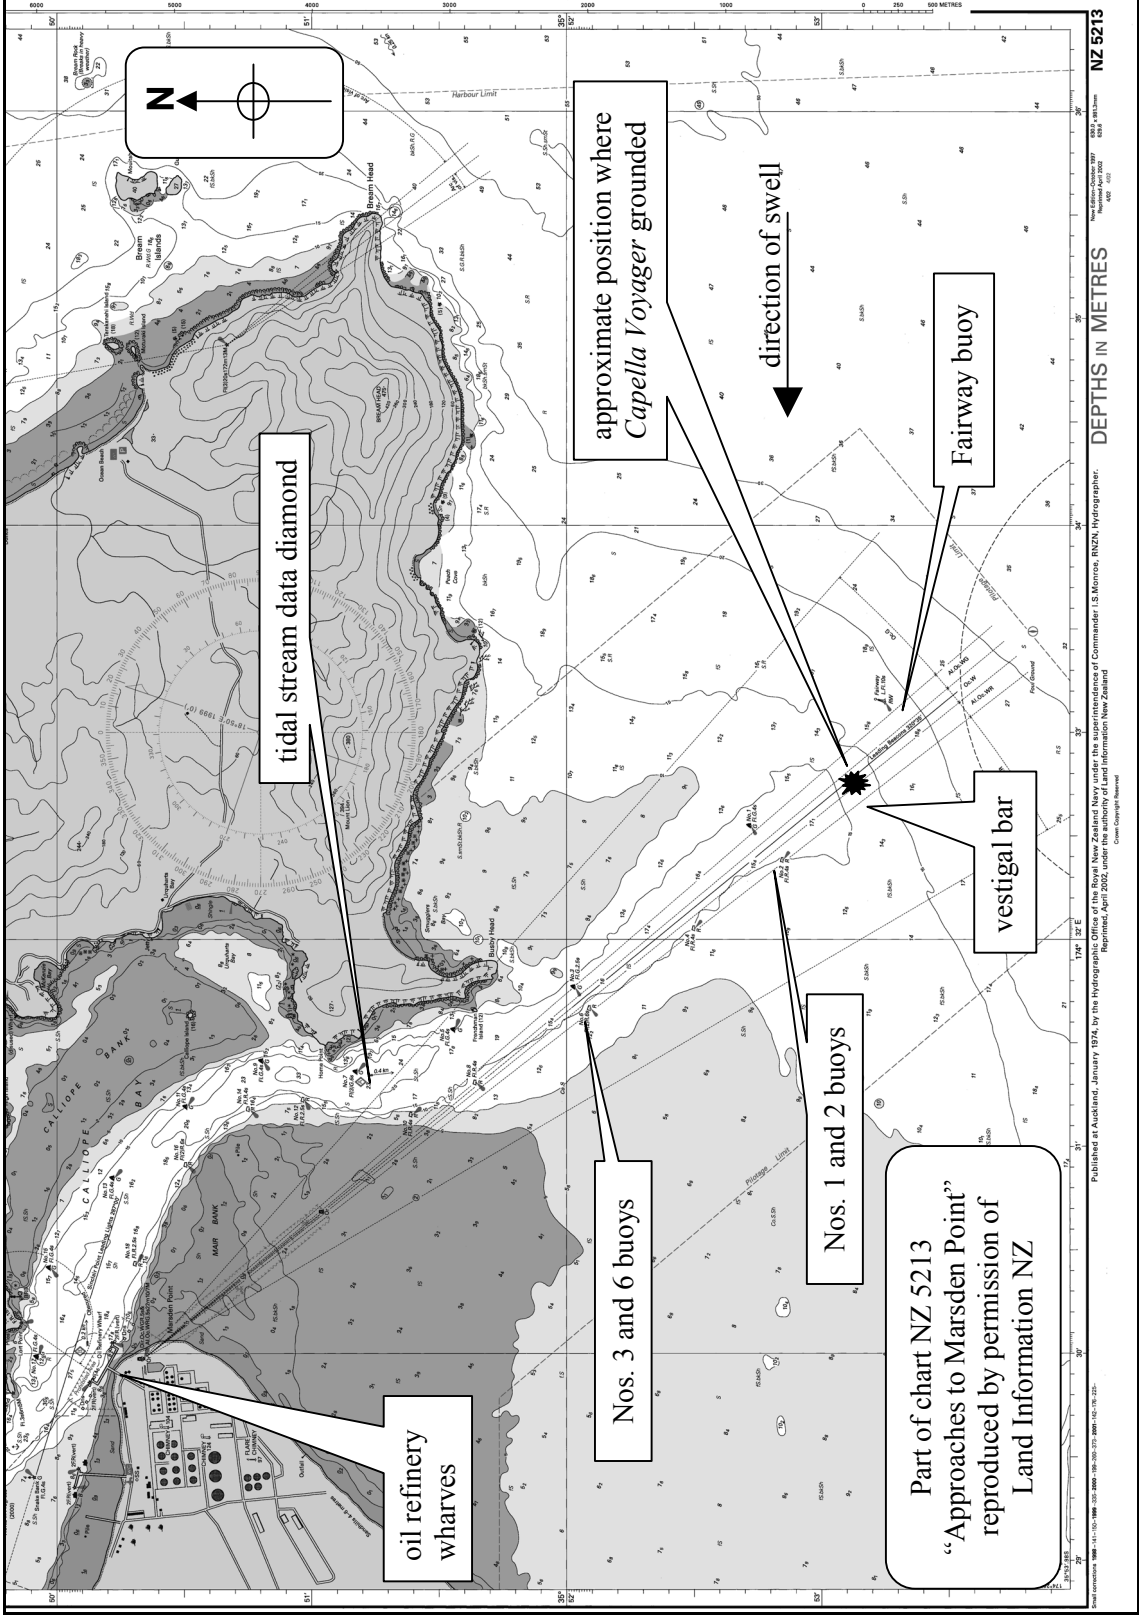
Figure 2
Whangarei approach channel

- 1.6.3 Between the Fairway buoy and Nos. 1 and 2 buoys, the first set of buoys in the marked channel, the channel passed over a vestigial bar (see Figure 2), composed of fine sand and broken shell, with a minimum depth of 14.8 m. This depth was obtained from the latest close grid hydrographic survey, which was undertaken in July 2002. There was anecdotal evidence that the least sounding over the vestigial bar had never been known to be less than 14.8 m. The New Zealand Pilot (Admiralty Sailing Directions NP51) reported that the outer channel had a least reported depth of 14.6 m at the seaward end. The pilots used the promulgated channel depth of 14.6 m for the calculation of under keel clearance (UKC).

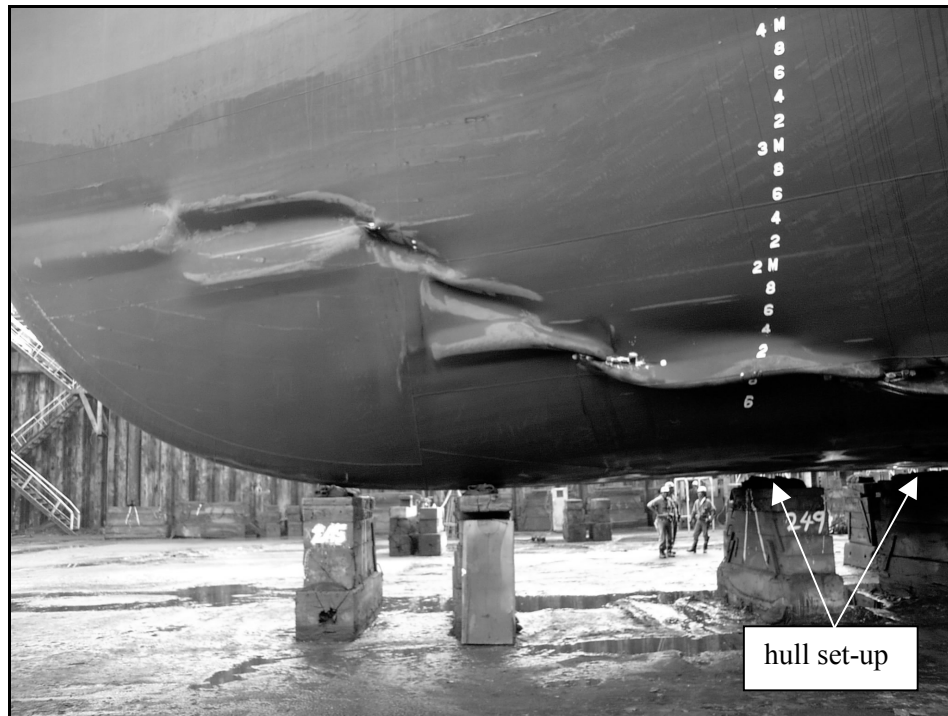
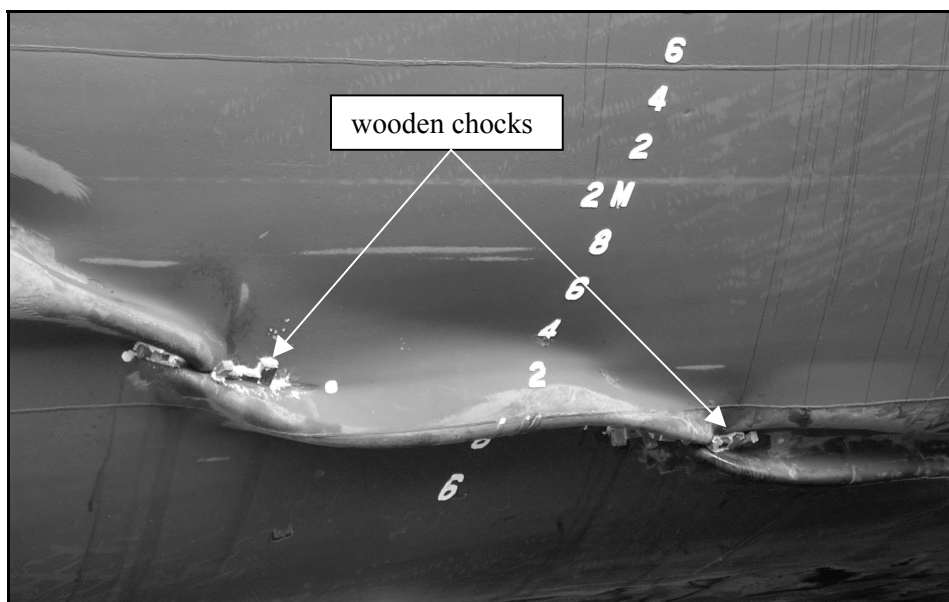
- 1.4.1 While the ship was at Marsden Point divers discovered damage to the hull of the *Capella Voyager*. The damage was confined mainly to the area forward of the collision bulkhead which was located at frame 85.
- 1.4.2 The hull was set up with the plate deformity beginning about 600 mm astern of the first lateral weld behind the bulbous bow. The damage increased in width and amplitude as it progressed aft, about 14 m, until it reached frame 85, where the deformity reached 250 mm and extended the full width of the hull. About 0.5 m forward of frame 85 a penetration was evident.

- 1.4.3 At about the 1 m draught mark significant creasing of the port side hull plating was found starting at the bulbous bow and extending about 21 m aft. The creasing appeared as folds in the hull plating with radii of about 50 mm and extending out about 250 mm from the profile of the hull. There was a series of ruptures to the hull plating associated with the troughs of the folds (see Figure 3).
- 1.4.4 Temporary repairs were made to the hull at Marsden Point by divers. The ruptures in the hull plating were filled with wooden chocks hammered into epoxy mastic (see Figure 3).

Figure 3
Buckled plating damage on the bow of the *Capella Voyager*, note wooden chocks in hull ruptures

- 3.1 The motor tanker *Capella Voyager* grounded in the entrance channel to Whangarei when the bow of the tanker fell into troughs behind a series of larger than expected swell waves.
- 3.2 All aspects of bridge resource management were used in the navigation and passage planning of the *Capella Voyager*.
- 3.3 The pilot calculated the static under keel clearance but did not make any allowance for dynamic conditions other than squat and roll.
- 3.4 The estimation of the pitching of the ship by watching the foremast's movement was prone to inaccuracies and should not have been relied upon in the prevailing marginal transit conditions.
- 3.5 There was no way of accurately determining the direction and height of swell waves in the entrance channel at the time of the grounding.

- 1.1.16 Temporary repairs were made at Marsden Point before the ship was allowed to sail for Singapore to make permanent repairs.
