## MARINE OCCURRENCE REPORT

03-209

container vessel *Bunga Teratai 4* and fishing vessel *Mako*,  
collision, Tasman Bay

4 July 2003

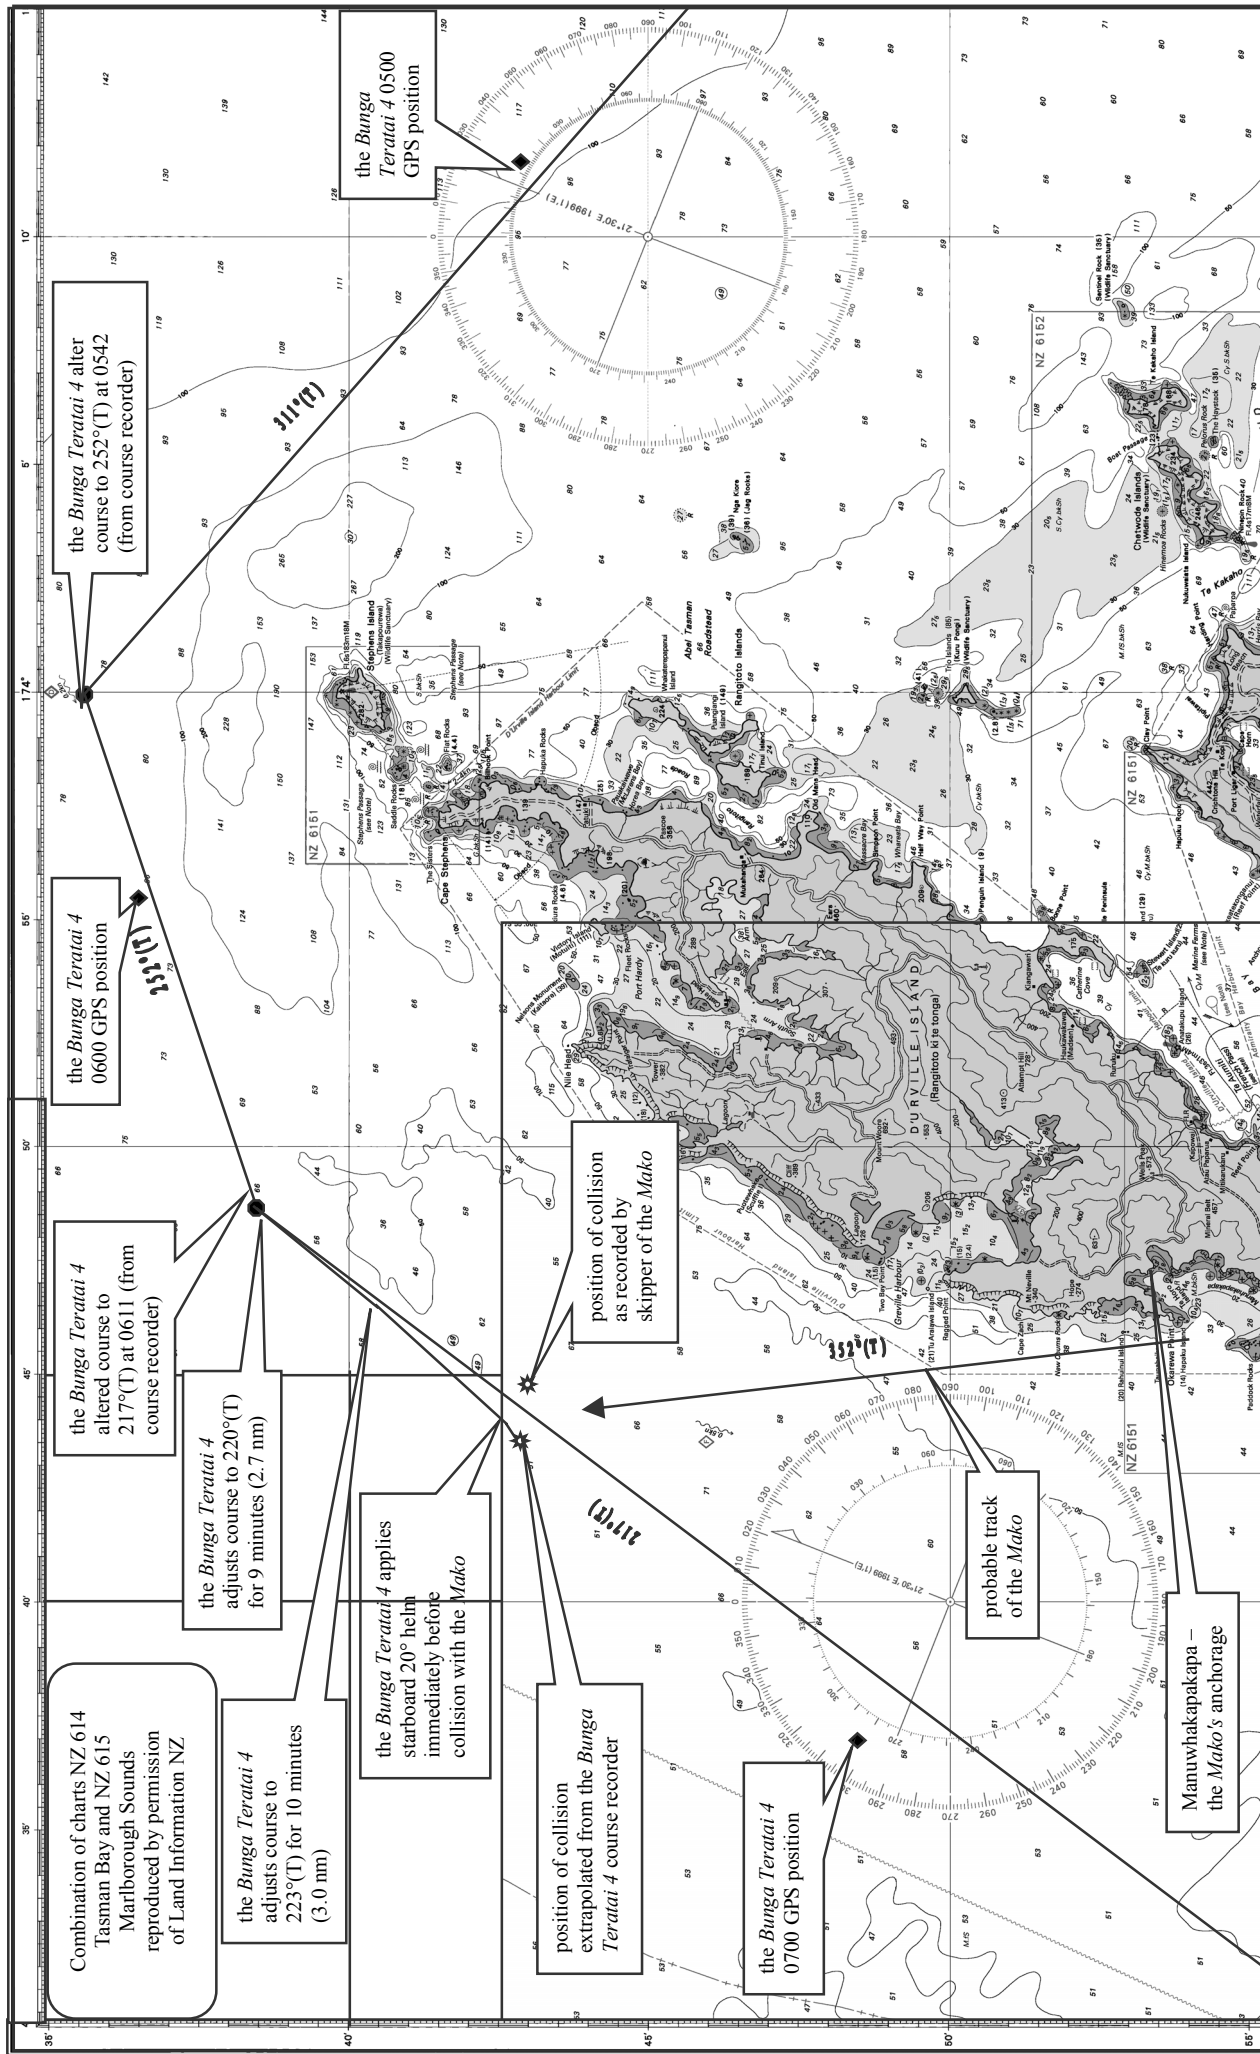
Figure 1

Combination of charts NZ 614 and 615 showing the respective tracks of the *Bunga Teratai 4* and the *Mako*

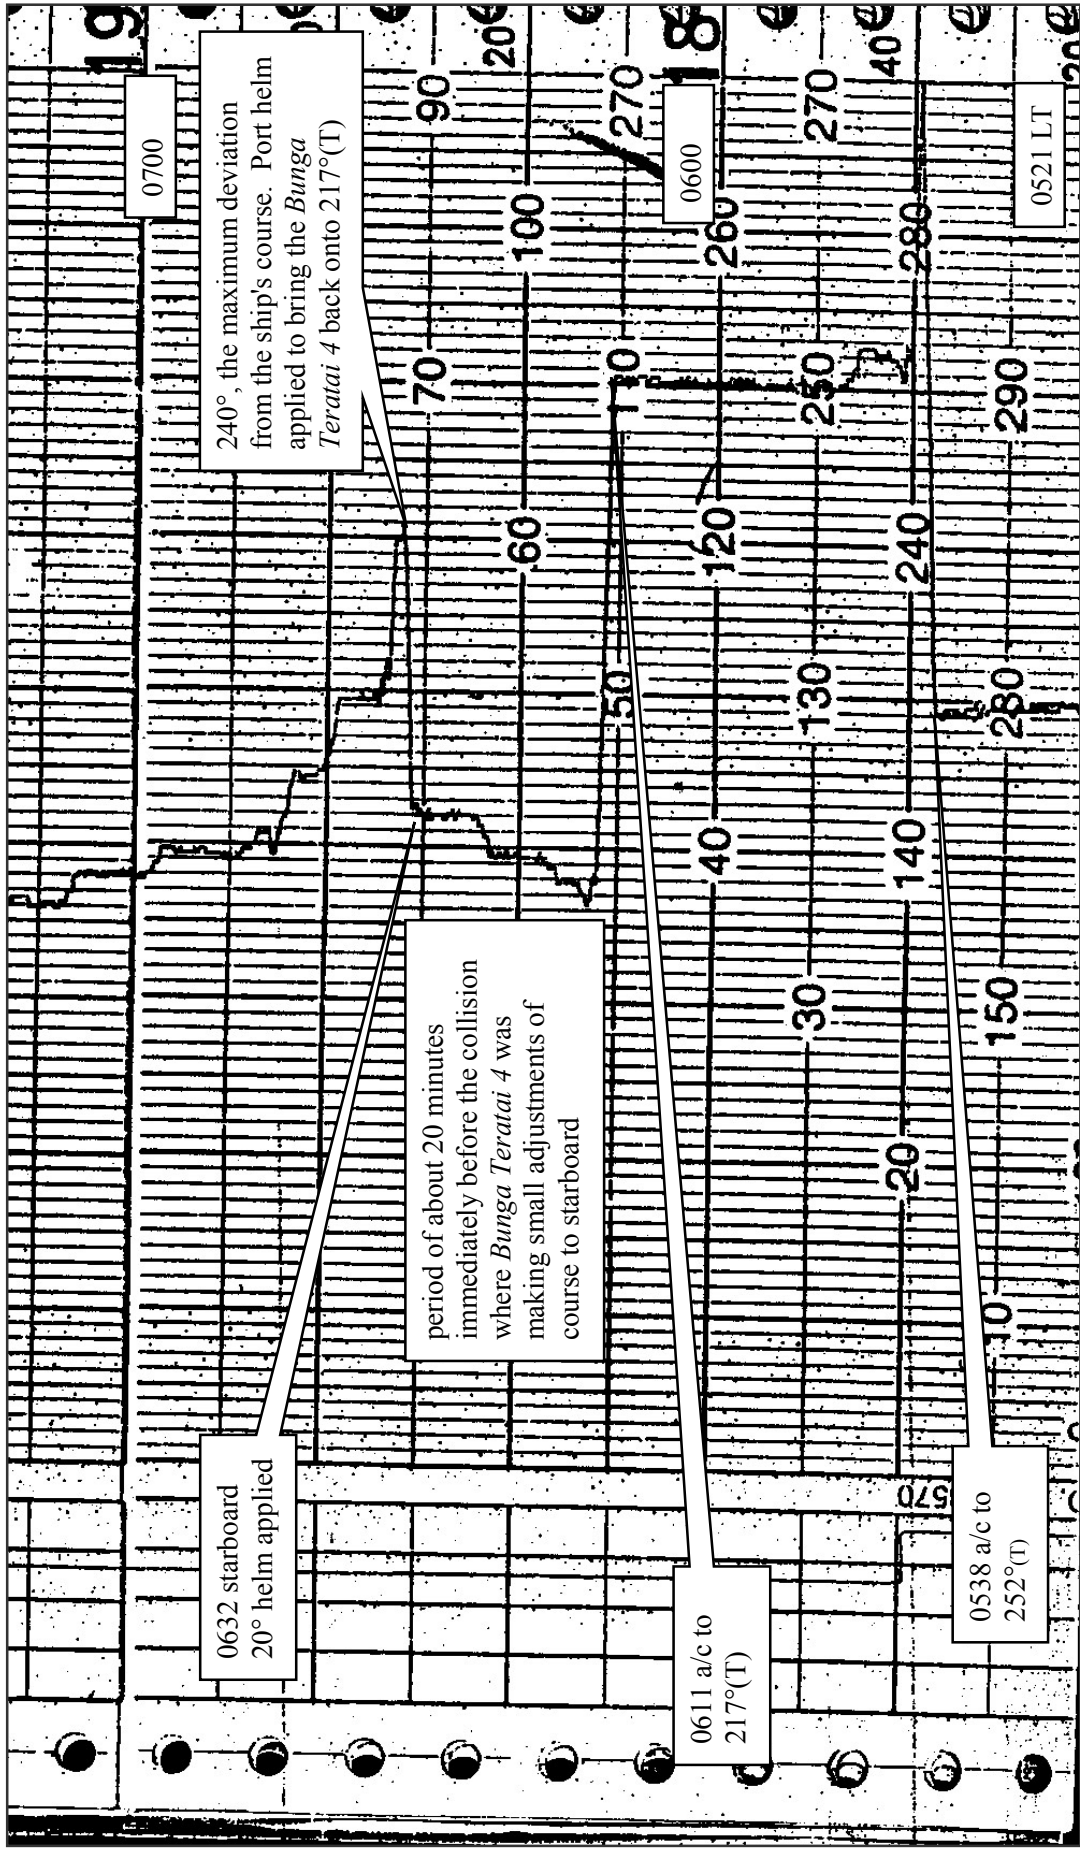
1.4.1 The courses steered by the *Bunga Teratai 4* were recorded on a course recorder. The courses in the hours leading up to the collision, as shown on the recorder, were very similar to those recalled by the crew.

Figure 2  
Section of the course recorder from the *Bunga Teratai 4*

- 1.4.8 Over the 19 minutes immediately preceding the collision, the two 3° alterations of course made by the chief officer of the *Bunga Teratai 4* resulted in the ship being approximately 0.274 nm [507 m] to the west of its original course at the time of the collision.

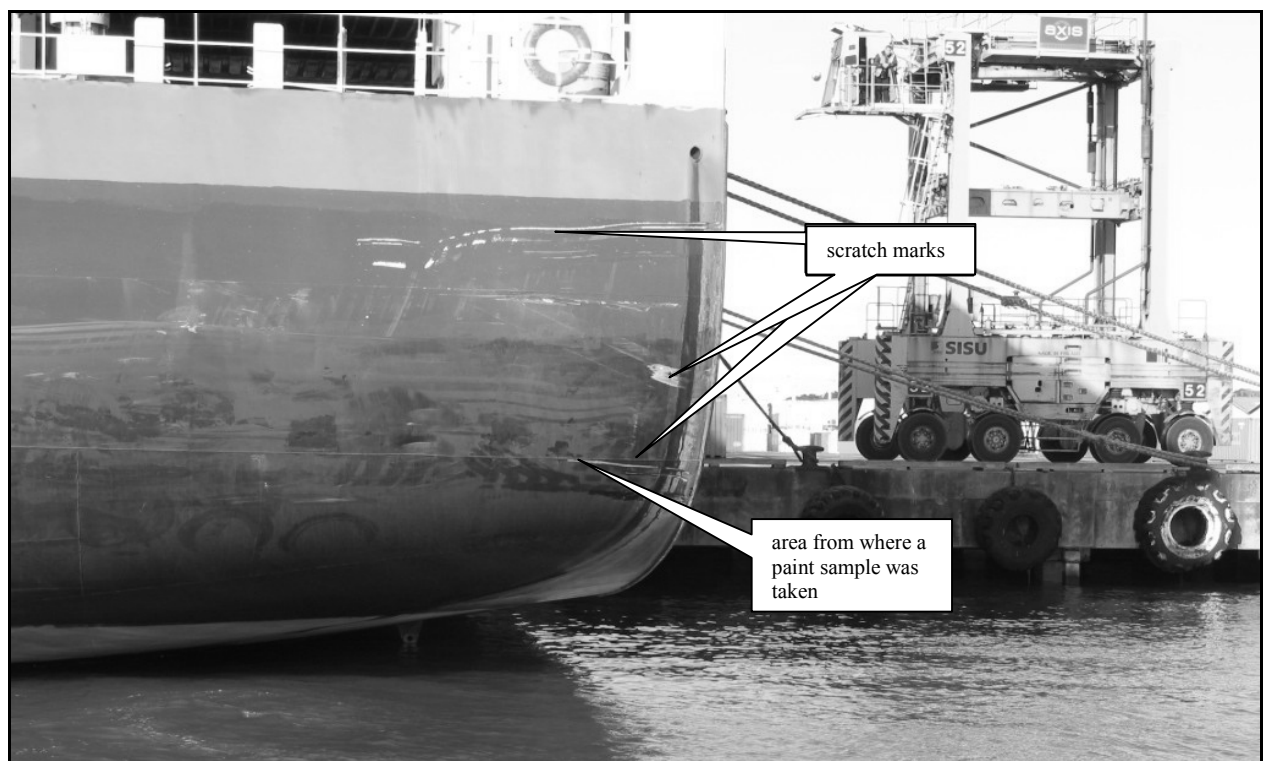
- 1.5.1 The crew of the *Bunga Teratai 4* said they were sure that the fishing vessel had passed their stern, albeit very closely. None of the bridge team said that they felt any collision, but the helmsman indicated that there was a sound similar to a large sea hitting the side of the ship.
- 1.5.2 The port quarter of the ship, close to the transom, had distinct score marks at 3 vertical levels, commensurate with 3 points of contact; the anchor, the paravane arm and the top of the wheelhouse.

**Figure 3**  
**Photograph of the after port quarter of the *Bunga Teratai 4* taken in Auckland,**  
**Tuesday 8 July 2003**

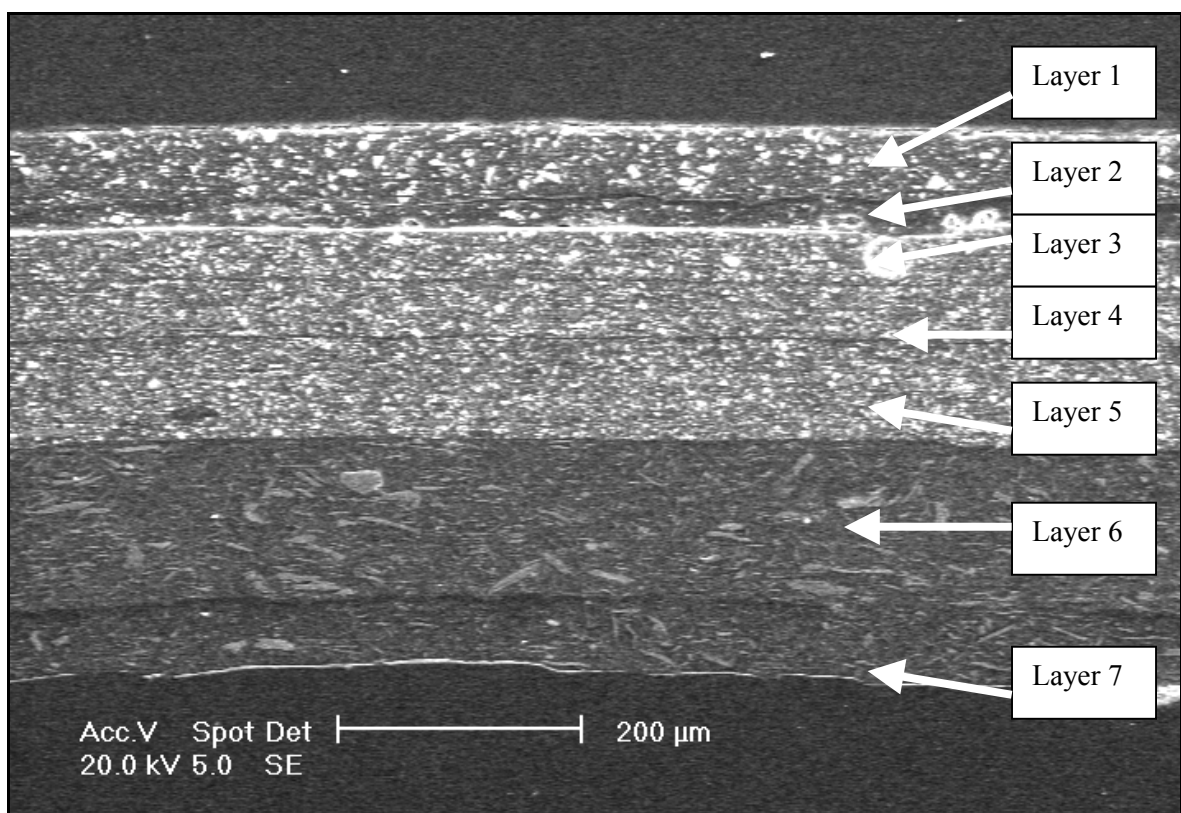
The paint from *Bunga Teratai 4* (item 1) consisted of seven layers of paint. These were five black layers on top of two gold layers. If I label these layers 1-7 then layers 1-5 are black and 6&7 are gold. The paint from F/V *Mako* (item 2) consisted of four layers. These were three black layers on a gold layer. The visual and colour correspondence is between these four layers and layers 3,4,5 &6 of the paint from *Bunga Teratai 4* (item 1). There is a good correspondence of chemical composition between the black paints and between the gold paints. In my opinion this evidence very strongly supports the suggestion that the two paint samples have the same source.

Photographs at Figures 4 and 5 show the paint samples as seen through a scanning electron microscope with areas of concurrence between the 2 samples identified.

**Figure 4**  
**Paint sample from the *Bunga Teratai 4* under an electron scanning microscope**

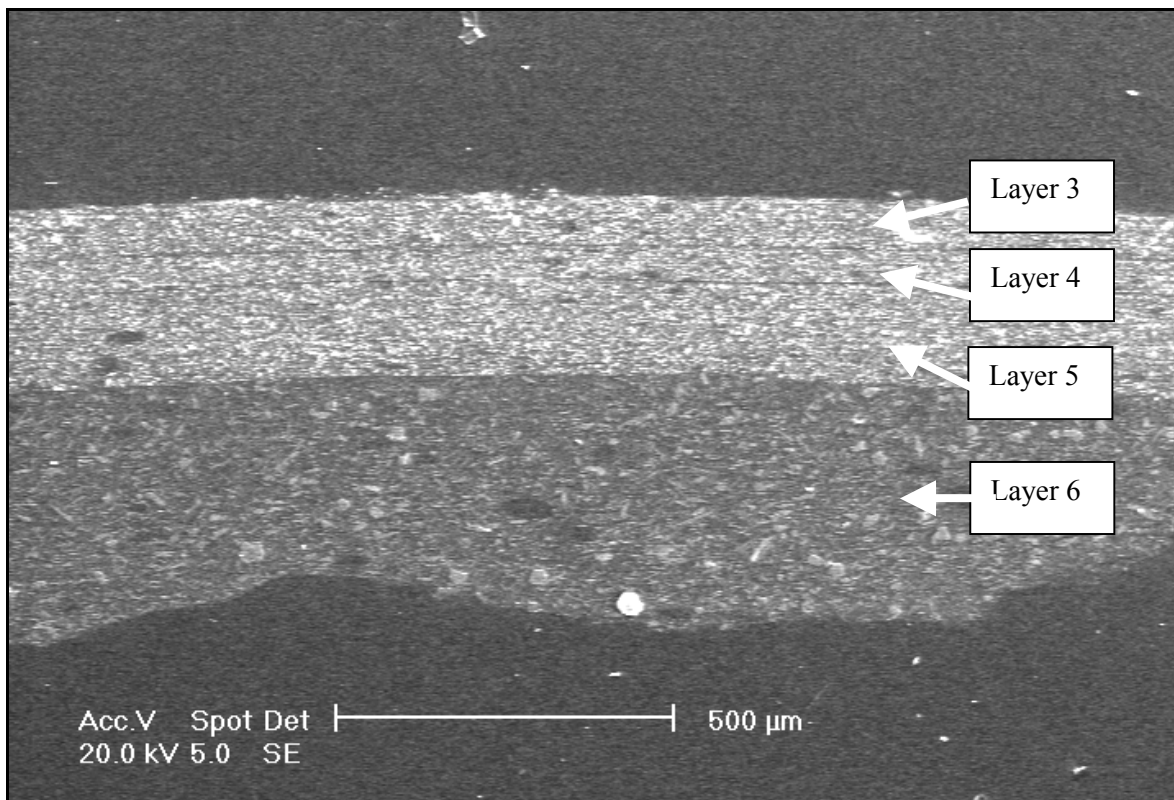
1.5.3 In order to confirm that a collision did occur, paint samples found embedded in the *Mako's* anchor were compared with paint from the lower scratches on the hull of the ship. The Institute of Environmental Science and Research Limited (ESR) carried out the comparison and produced a report which stated in part:

**Figure 5**  
**Paint sample from the anchor of the *Mako* under an electron scanning microscope**

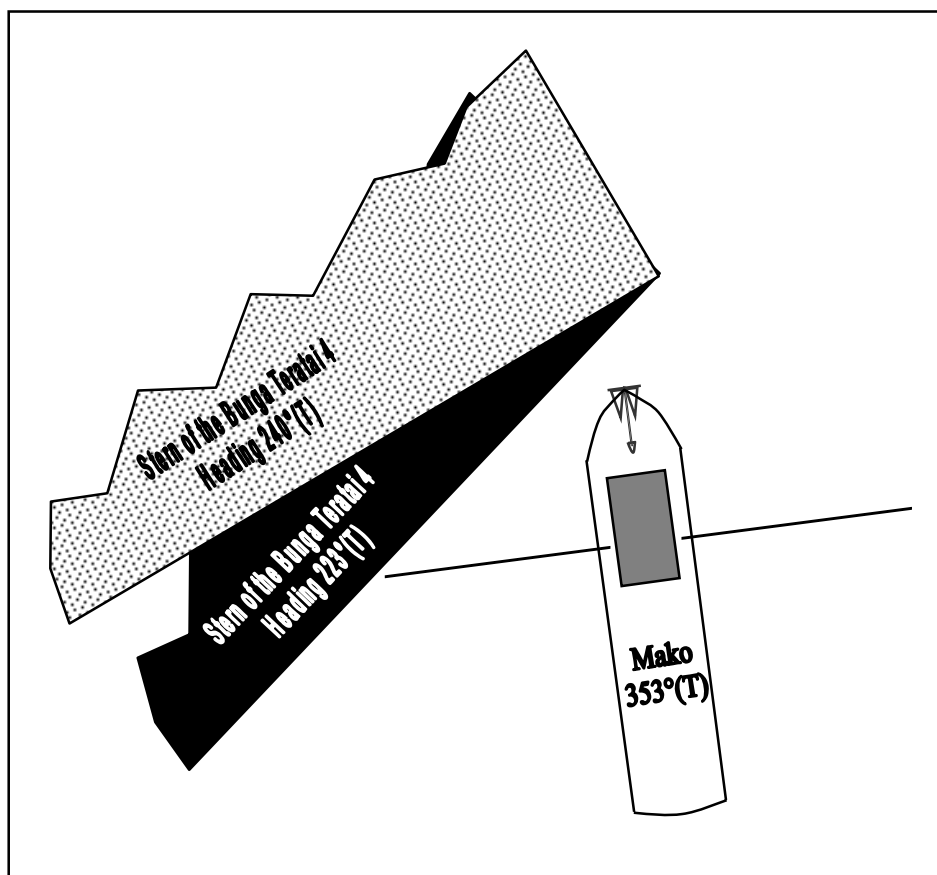
- 1.7.1 The *Mako* had been retrospectively fitted with stabilising arms, which extended about 12 m at right angles to the fore and aft line, about one third of the vessel's length from forward. From the outboard end of each of these arms a paravane was dangled into the sea to help reduce the rolling of the vessel in a seaway.
- 1.7.2 The skipper thought that the port arm had been the first point of contact with the ship's hull. The vessels' courses were plotted, showing that it was probable the arm and the bow would have made contact almost simultaneously (see Figure 6). Which occurred first would depend on the ship's actual heading at the time of the collision.

**Figure 6**  
Diagram to show the possible points of contact between the 2 vessels

- 2.20 The angle of contact between the two vessels was between 50° and 67° dependant on how much the *Bunga Teratai 4* had altered course at the actual time of collision. The angle of impact was sufficiently broad to cause damage to the bow and the paravane arm of the fishing vessel, but was acute enough to allow the *Mako* to glance off and pass around the ship's stern.
