MARINE OCCURRENCE REPORT

03-210

passenger freight ferry *Aratere*, collision with moored fishing vessel *San Domenico*, Wellington Harbour

5 July 2003

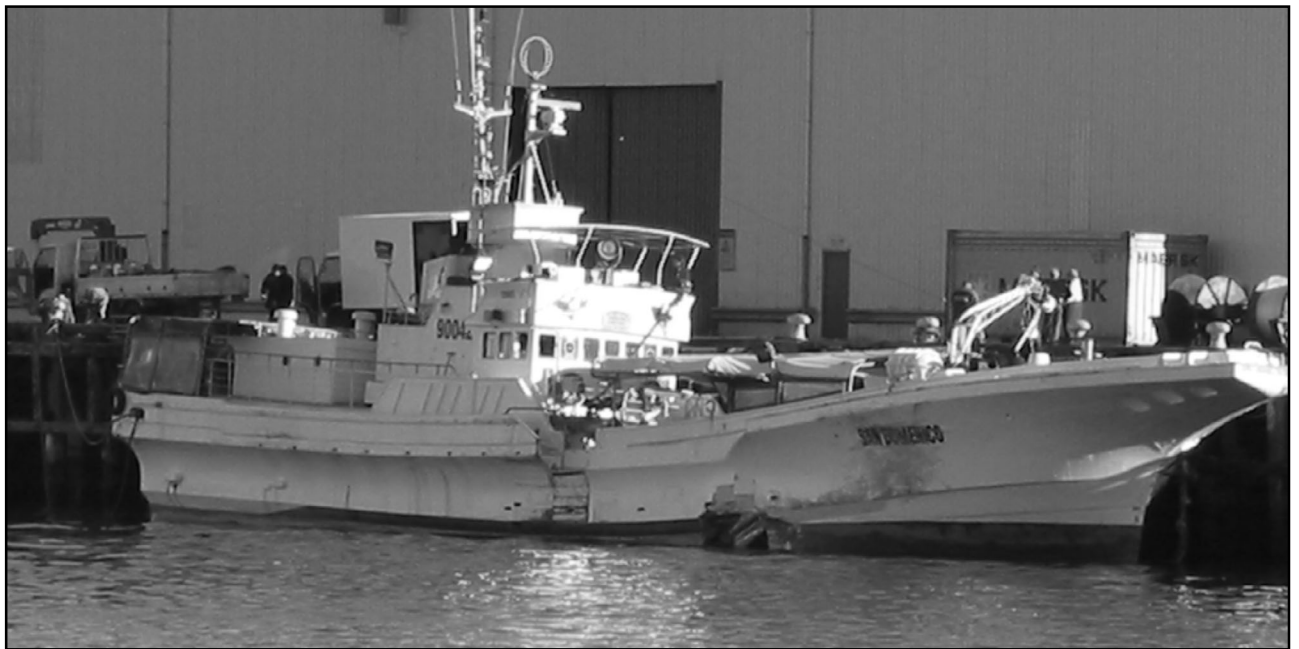
The *San Domenico* alongside Aotea Quay after the collision, damage visible on starboard side

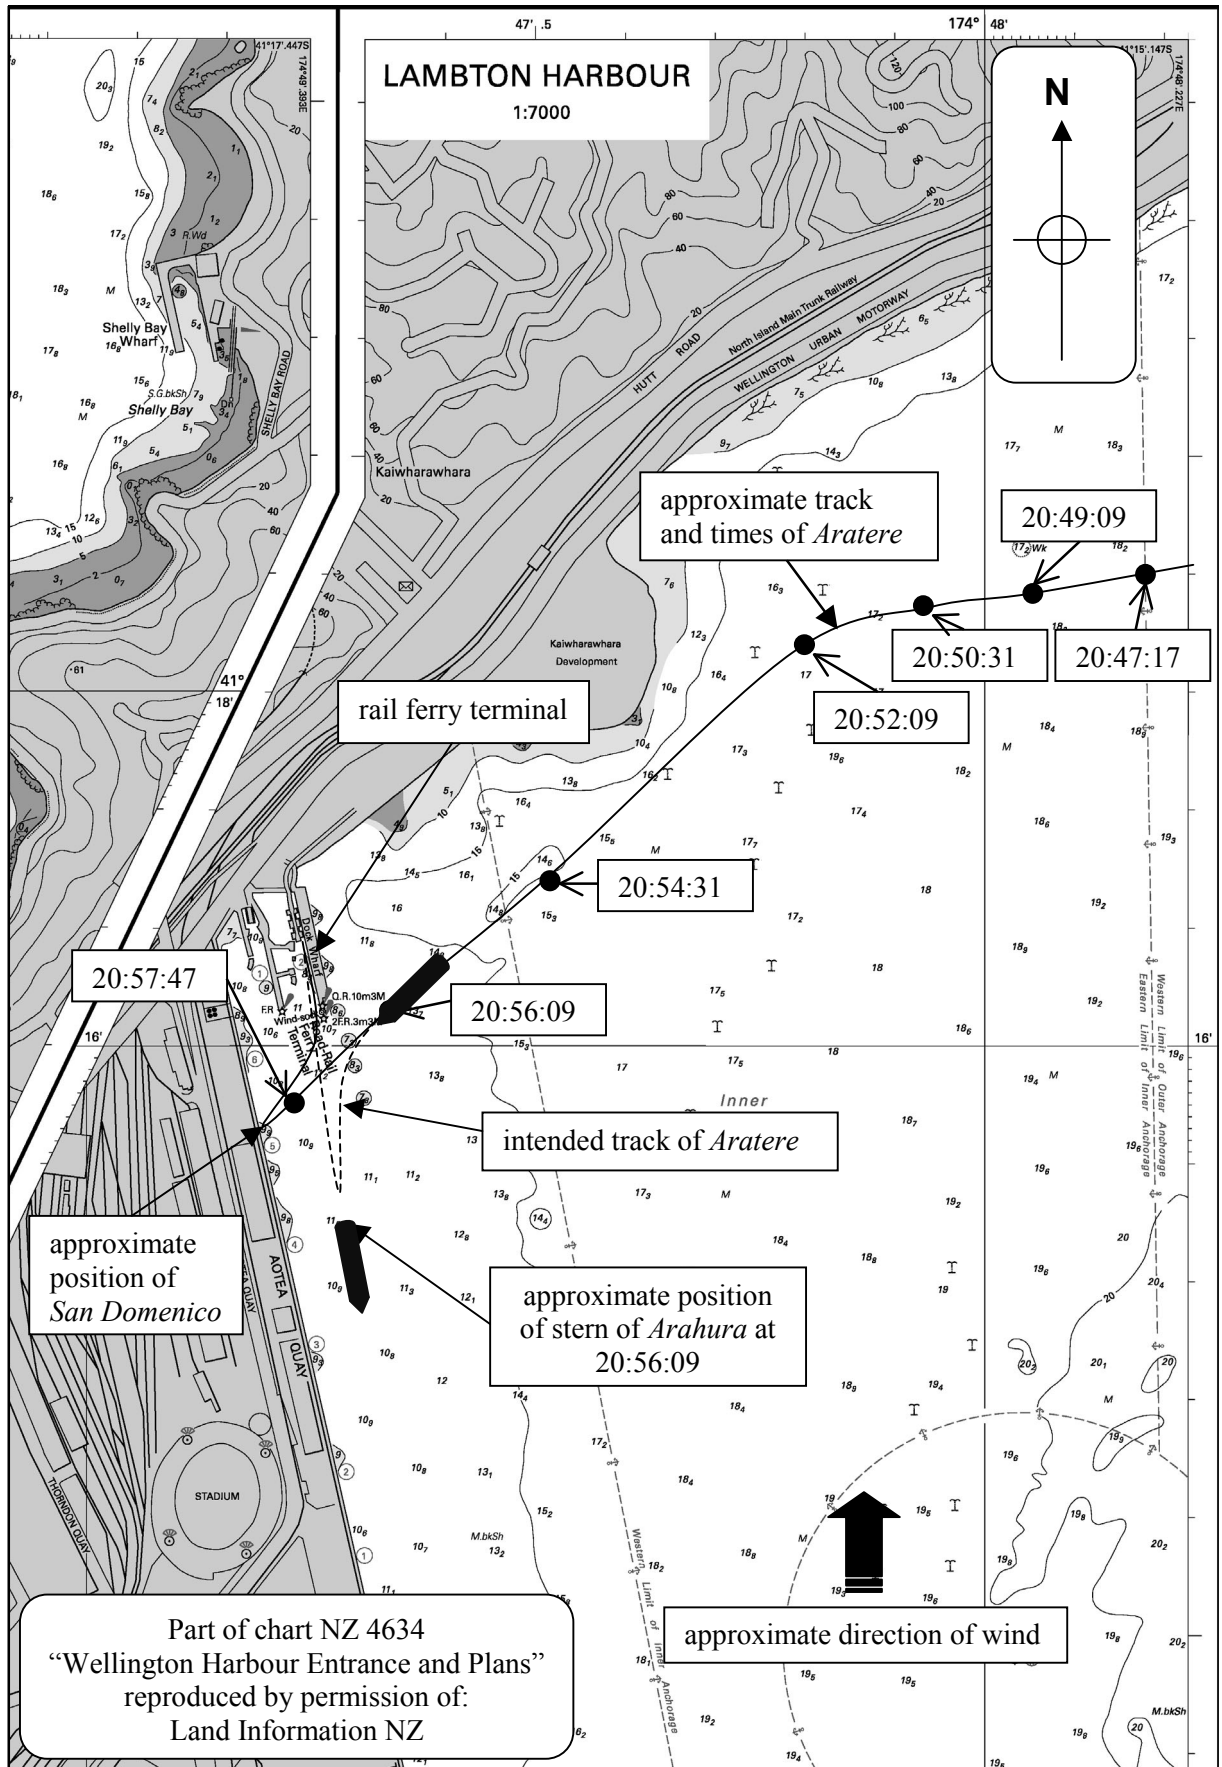
Figure 1
Approximate track of *Aratere* prior to collision

- 1.2.13 The voyage data recorder on the *Aratere* showed that when the ship was approaching RFT2, the clearance between it and the *Arahura* was about 0.19 nm [352 m] and holding steady (see Figure 1).

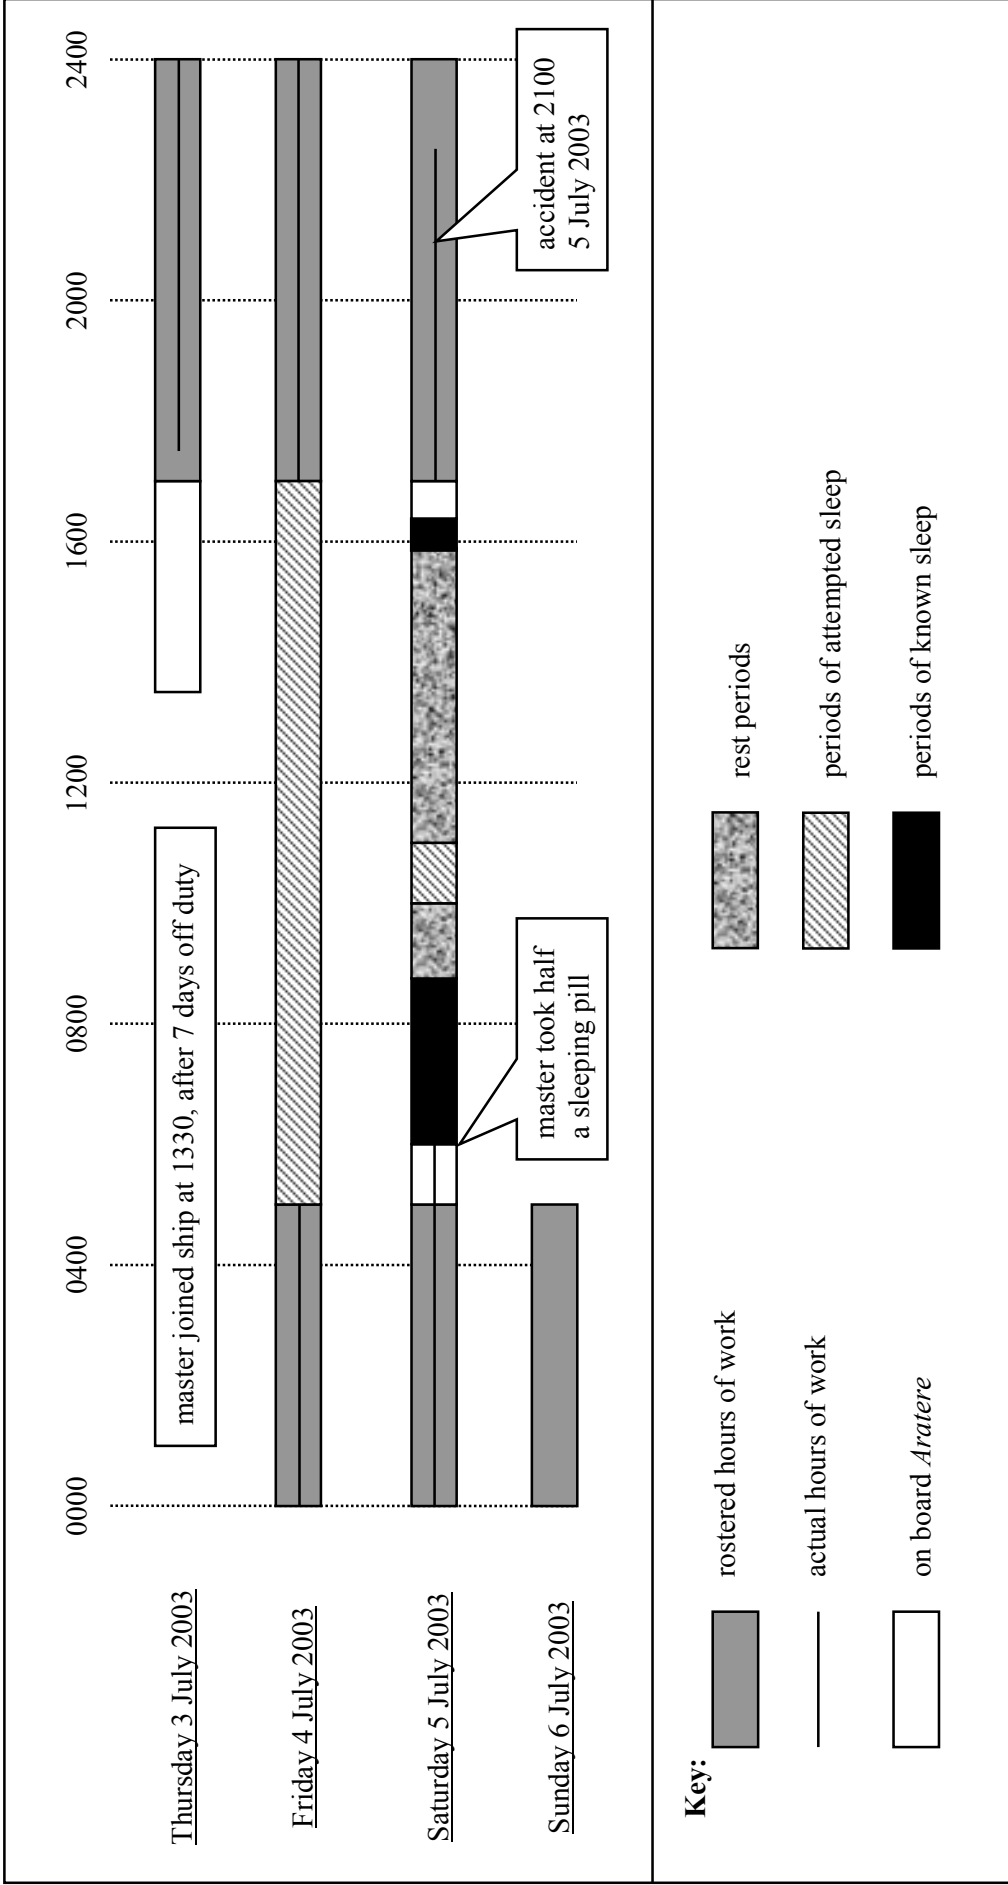
Figure 4
Master's sleep wake information

1.4.4 The master's sleep and duty history immediately prior to the accident is summarised in Figure 4. It should be noted that he was working a 12 hour on duty followed by a 12 hour off duty shift system: The accuracy of the sleep information is inherently limited by the fact that subjective reports of sleep duration and timing are not necessarily reliable, and by the fact that the accident had intervened between the sleep episodes and when they were being recalled.

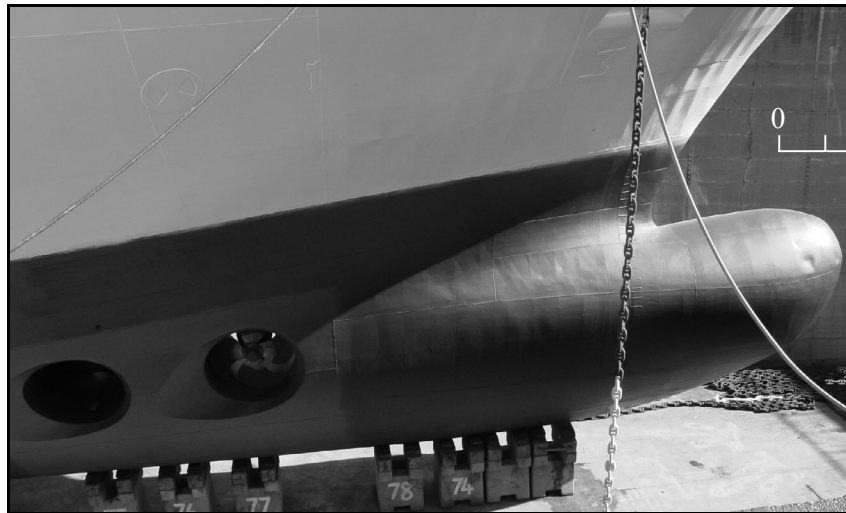
Figure 5

- 1.1.9 The bulbous bow of *Aratere* struck the *San Domenico* below the waterline, causing the port side of the *San Domenico* to rise up on the wharf piles before rolling back upright as the bulbous bow continued through the vessel. The force of the movement caused one of the crewmembers to lose his footing and fall to the lower deck, but all 3 managed to scramble ashore.

Aratere's forefoot showing the bulbous bow and 2 bow thruster tunnels

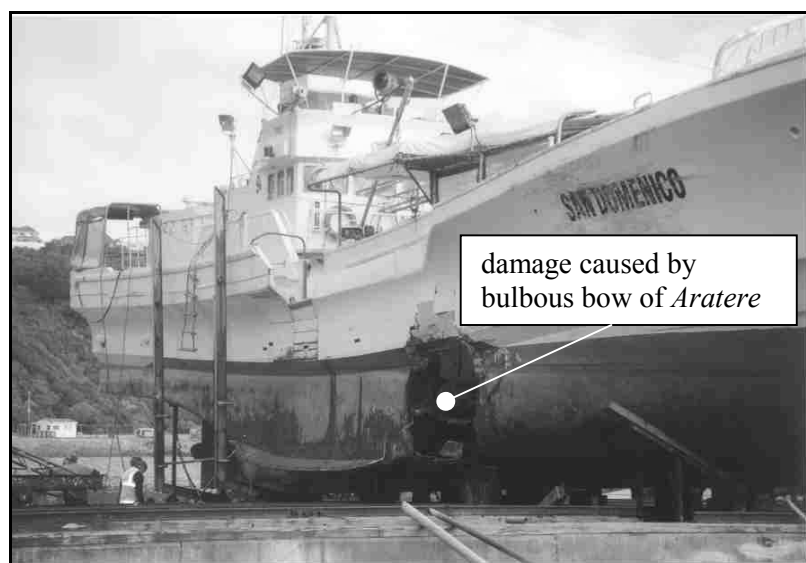
Figure 6

1.5.1 The *San Domenico* suffered extensive damage. Damage to the hull consisted mainly of a 3 m diameter hole in the starboard side extending from just above the waterline to keel level, and an 8 m long split to the bilge hard chine on the port side with other splits spreading out from it. A section of wooden wharf pile was embedded into the port side of the hull aft of the split and sections of the bilge keel had been ripped off. Additionally the foremast was severely bent towards the port side. The damage was such that the *San Domenico* was declared a constructive total loss and broken up.

The *San Domenico* showing damage to the starboard side of the hull
