MARINE OCCURRENCE REPORT

03-211

oil tanker, *Eastern Honor*, grounding, Whangarei Harbour

27 July 2003

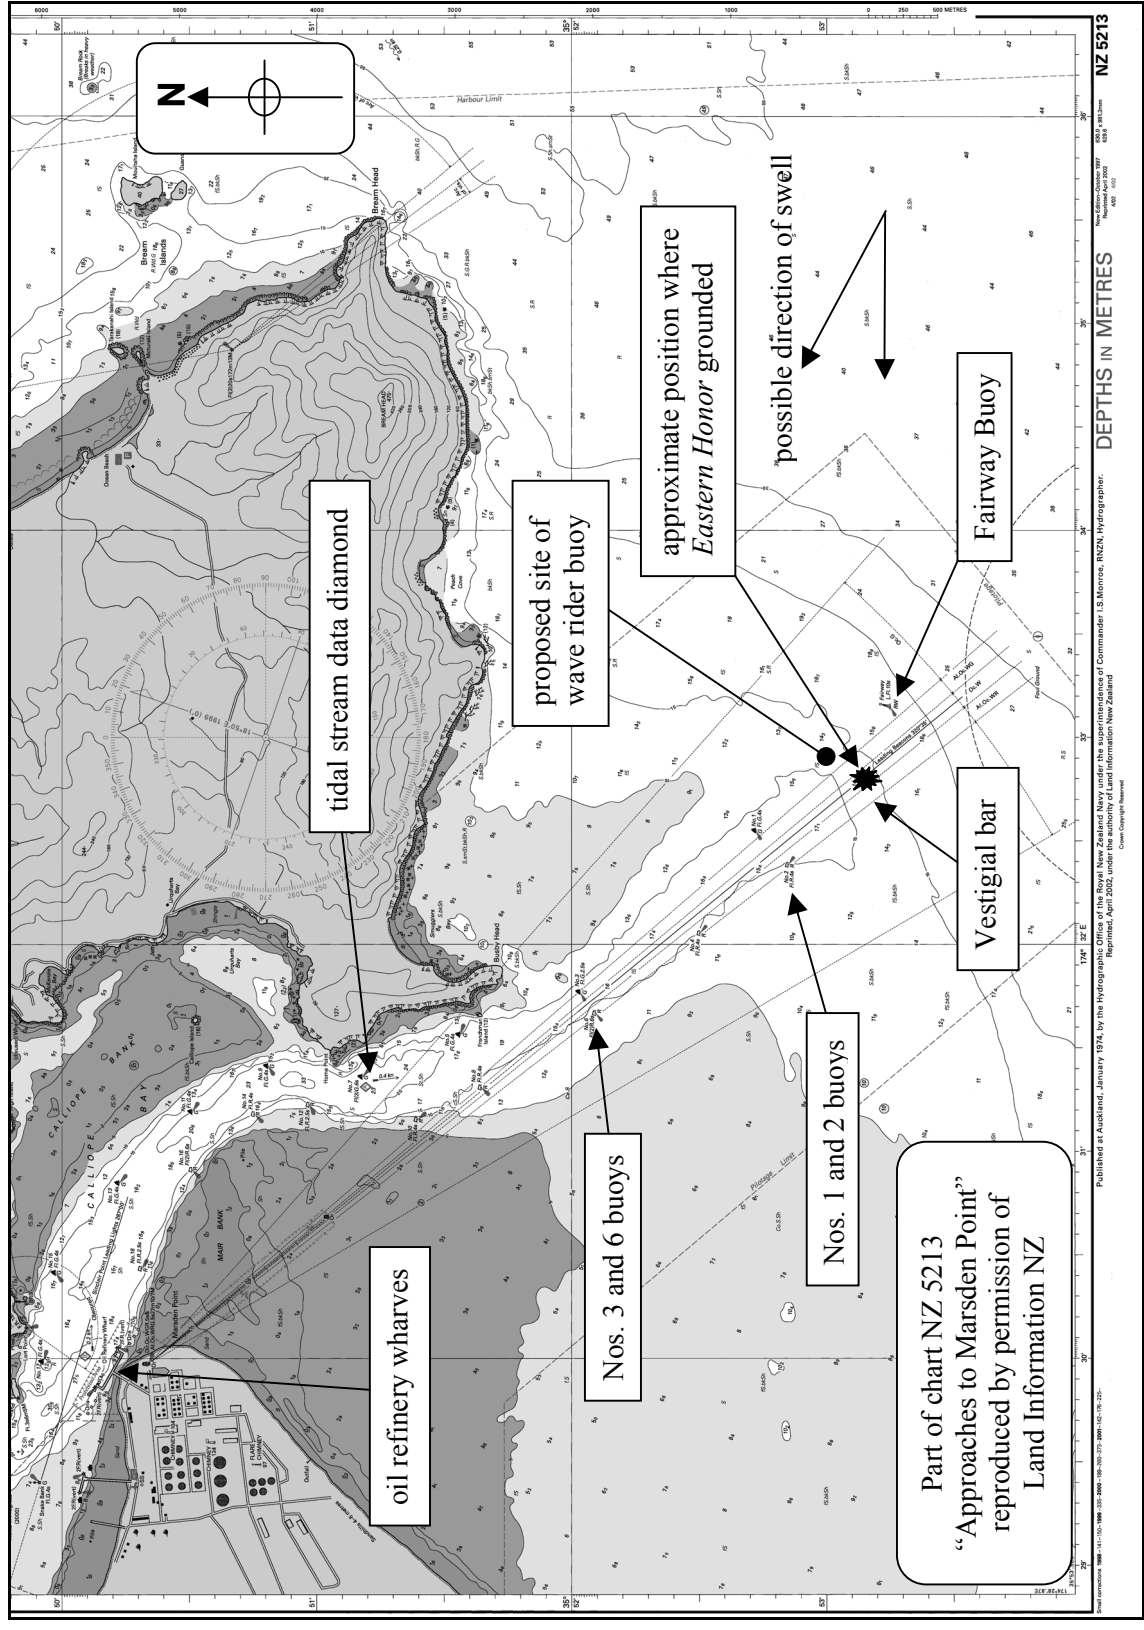
Figure 2
Whangarei approach channel

1.5.15 Tidal current information contained on chart NZ 5213 for 0441, one hour before high water Auckland, indicated a current flow of about 1.1 kts in a direction of about 005° (T) at a position 35°51'.3 S 174°31'.3 E south-west of buoy No.7 and Home Point (see Figure 2).

- 1.6.3 Between the Fairway Buoy and Nos. 1 and 2 buoys, the first set of buoys in the marked channel, the channel passed over a vestigial bar (see Figure 2), composed of fine sand and broken shell, with a minimum depth of 14.7 m. This depth was obtained from a hydrographic survey that was carried out after the incident. There was anecdotal evidence that the least sounding over the vestigial bar had never been known to be less than 14.8 m. The New Zealand Pilot (Admiralty Sailing Directions NP51) reported that the outer channel had a least reported depth of 14.6 m at the seaward end. The pilots used the promulgated channel depth of 14.6 m for the calculation of under keel clearance (UKC).

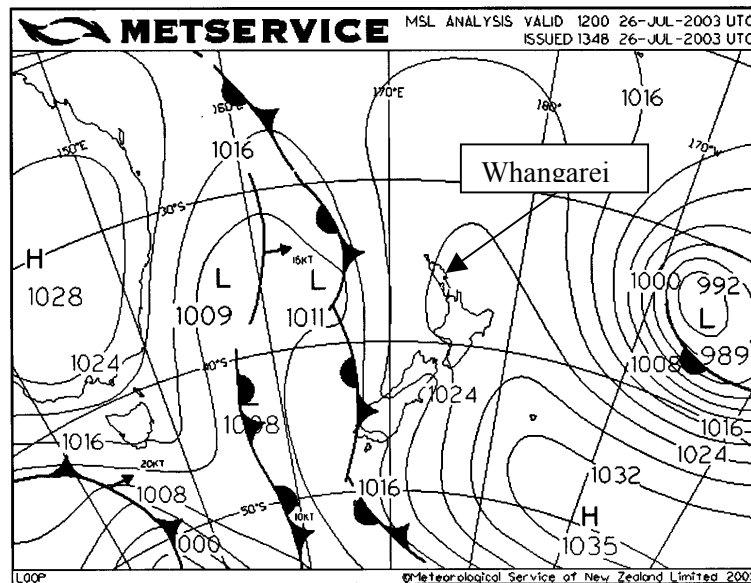
Figure 3
Mean sea level analysis synoptic chart for 0000 27 July 2003

1.5.1 During the 48 hours prior to the grounding, a low pressure system had moved across to the north of New Zealand and was slowly moving south-east and deepening. The effect of the low

was to produce swell waves, which arrived at Whangarei from an easterly to south-easterly direction (see Figure 3).

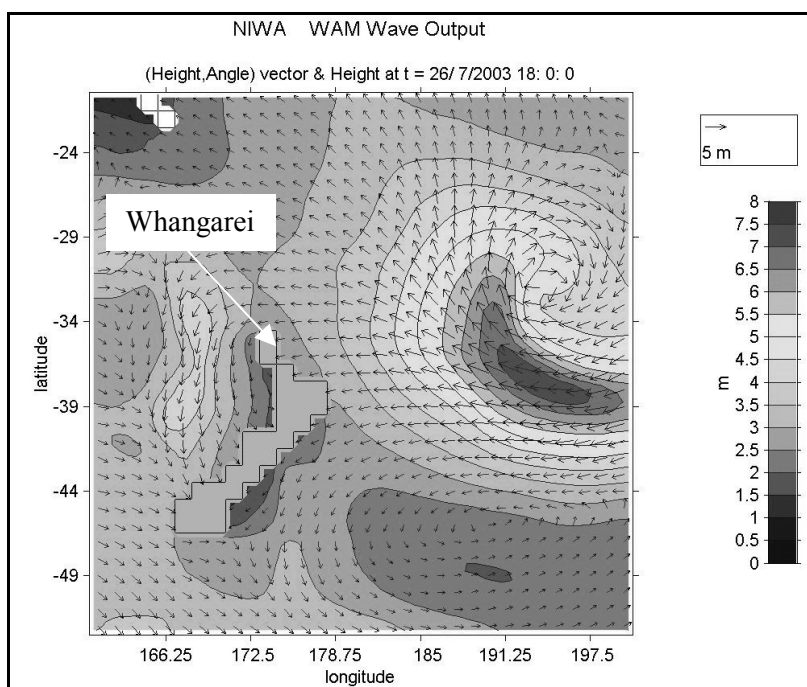
Figure 4
NIWA wave model for 0600 27 July 2003

- 1.5.8 After the incident the Commission contacted the National Institute of Water and Atmospheric Research (NIWA) who produced a computer generated wave output model for 0600 27 July

2003, which showed an expected wave height of 2.5 to 3.0 m from an easterly direction for the Whangarei area (see Figure 4).

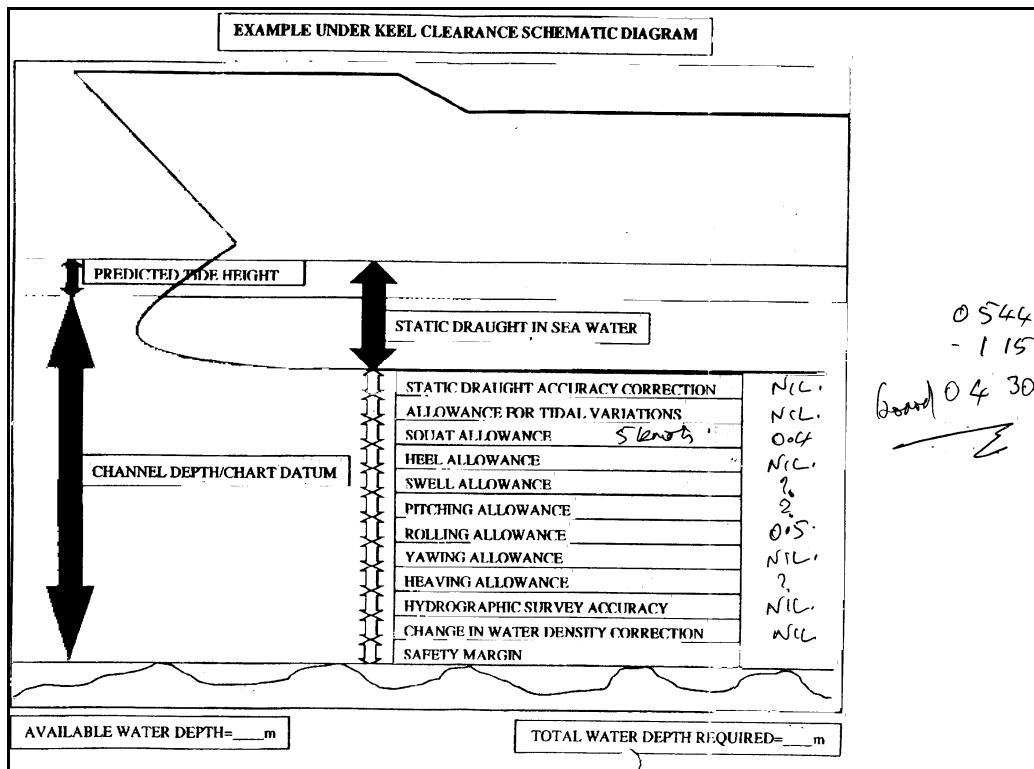
Figure 5
Passage plan additional sheet (not full size)

- 1.7.8 Since the grounding of the *Capella Voyager*, North Tugz in conjunction with the MSA had amended the standard passage plan to include a sheet for more accurately determining the under keel clearance for a ship in dynamic conditions (see Figures 5 and 6). The MSA indicated that its supplied pro forma was to be amended to suit North Tugz operational needs, However, North Tugz included the pro forma in its entirety.

- 3.2 The pilot had calculated the static under keel clearance and made a blanket allowance of 0.5 m for dynamic conditions other than squat. Inclusion of the required figures in the amended pilotage plan may have shown that the proposed pilotage was in doubt.

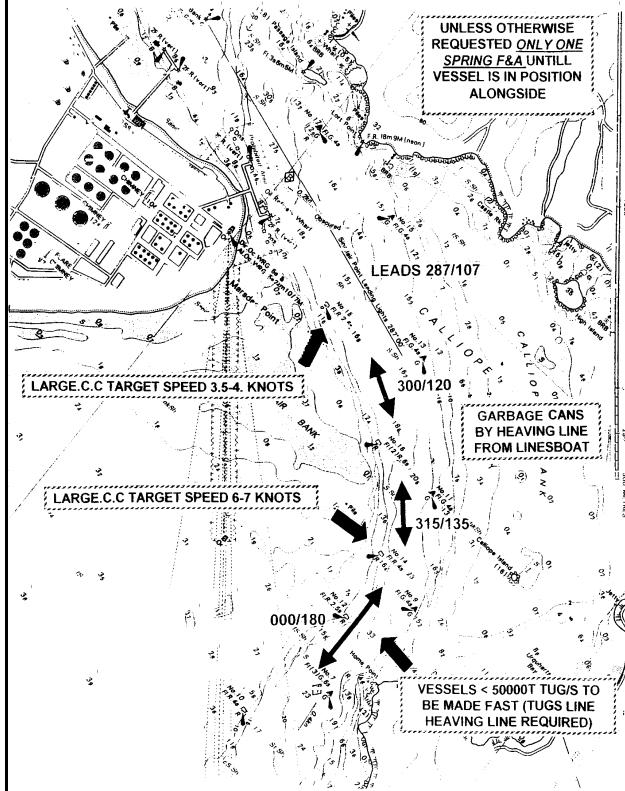
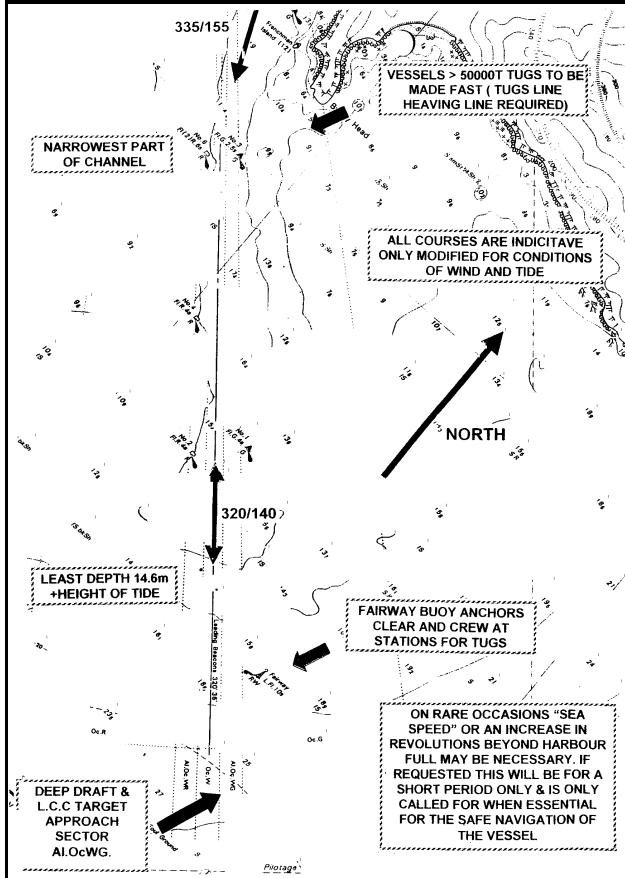
NORTH TUGZ REFINERY PILOTS PASSAGE AND BERTHING GUIDE

+ Estimated height of tide	2.2
Available depth	16.8
Ships maximum draft	15.24
Underkeel minimum clearance	1.56
10% ships draft manoeuvring clearance Y/N	Y
Agreed berthing plan	<input type="checkbox"/>
