AVIATION OCCURRENCE REPORT

04-001

Piper PA23-250E Aztec, ZK-DGS, landing gear collapse during taxi, Paraparaumu Aerodrome

9 January 2004

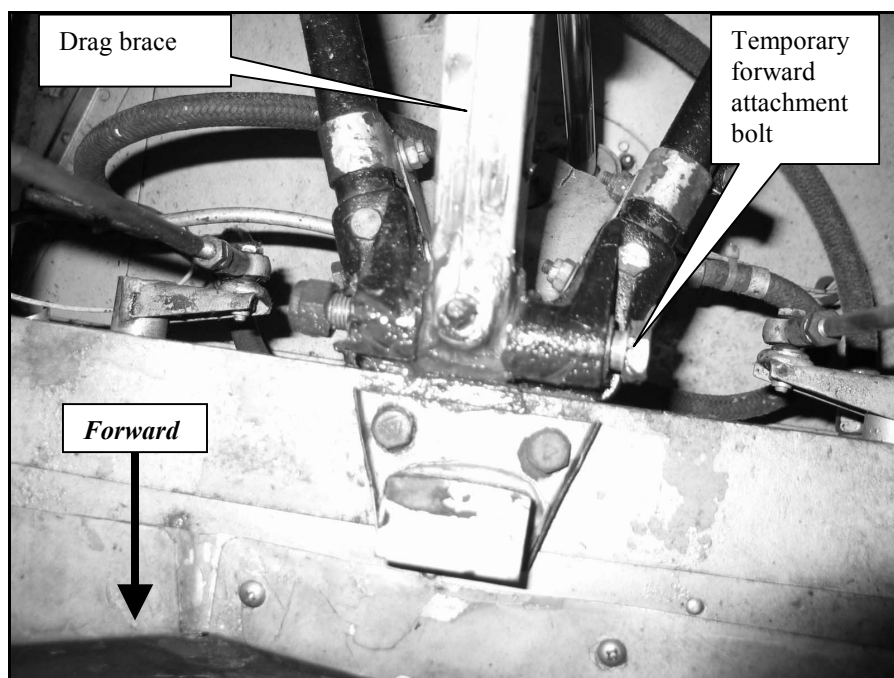
Figure 1
Drag brace forward attachment

- 1.2.1 An independent maintenance engineer at the aerodrome inspected the aircraft and found the right main landing gear drag brace forward attachment bolt had failed (see Figure 1). The aircraft was moved to a hangar on the aerodrome where the Commission inspected it on 12 January 2004.

- 1.5.1 A metallurgist examined the failed bolt and drag brace. Examination of the fracture surface of the bolt revealed that it was a typical reverse bending multi-origin fatigue failure. Fatigue arcs had grown from both sides towards the centre of the bolt, and were separated by a small brittle fracture section, indicating the bolt had not been subjected to excessive force at the time of failure. The bolt was a 7/16-inch, high tensile close tolerance bolt, which met the correct specification.

- 1.5.2 The failure occurred at mid-length in the bolt, where 2 bushings met inside the drag brace. The outside surface of the bolt was polished in the area that was inside the bushings, indicating that the bolt had been in service for some time and that normal movement had occurred between the bolt and the bushings.

- 1.5.3 The bushings were a split type so that grease could be applied down the split line between them. Examination of the ends of the bushings showed that they were slightly elongated. When the intact bolt from the left gear was inserted into the bushings it could be moved sideways slightly. This movement occurred in one direction only, parallel to the axis of the drag brace. In other directions, the bolt was a tight fit.

- 2.1 The right landing gear collapsed rearwards because its supporting drag brace forward attachment bolt broke.
- 2.2 Examination of the forward attachment bolt indicated that it failed because of reverse bending fatigue. The fatigue had built up probably during many cycles over a number of years. The bending fatigue was consistent with the fact that the failure occurred near the middle of the bolt.

- 2.3 The forward attachment bolt was fitted through attachment points either side of the drag brace (see Figure 1). Whenever the aircraft was landed or taxied the drag brace would transfer a load onto the bolt. If the bolt was loose in the drag brace bushings the 3-point bending could eventually result in premature failure of the bolt.

- 2.5 The cause of the drag brace bushings being slightly elongated could either have been due to normal wear or from being subject to a heavy loading. From the information available regarding the repair of ZK-DGS after its forced landing in 1995, the drag brace and its attachment bolt were possibly re-used. These components might have been subject to excessive stress during the forced landing which could have initiated the fatigue process in the bolt.

- 3.1 The pilots were appropriately licensed to conduct the flight.
- 3.2 The conduct of the flight did not contribute to the accident.
- 3.3 The aircraft records indicated ZK-DGS was correctly maintained.
- 3.4 The drag brace forward attachment bolt failed because of reverse bending fatigue. The elongation of the drag brace bushings might have allowed the reverse bending to occur.

- 2.6 The Piper Aztec Service Manual stated that the drag link bolts were to be inspected every 1000 hours and replaced if required. An inspection of the drag link bushings was not specified, nor did the service manual specify any service tolerance limits for these bushings. The bushings may not have been visible during the bolt inspection unless the drag brace was moved out of position relative to the attachment points on either side. Due to the small amount that the bushings were elongated, this damage may not have been easy to detect unless the bolt was tested for movement inside the bushings while the brace was clear of the attachment points.

- 2.7 The operator said he planned to carry out non-destructive testing on the drag brace attachment bolts in conjunction with the required visual checks.

- 4.1.1 publish guidelines for operators and maintenance facilities for the appropriate re-use and inspection of parts from accident-damaged aircraft. (028/04)
