AVIATION OCCURRENCE REPORT

04-003

Bell/Garlick UH1B Iroquois helicopter, ZK-HSF, in-flight
break-up, near Mokoreta, Southland

23 April 2004

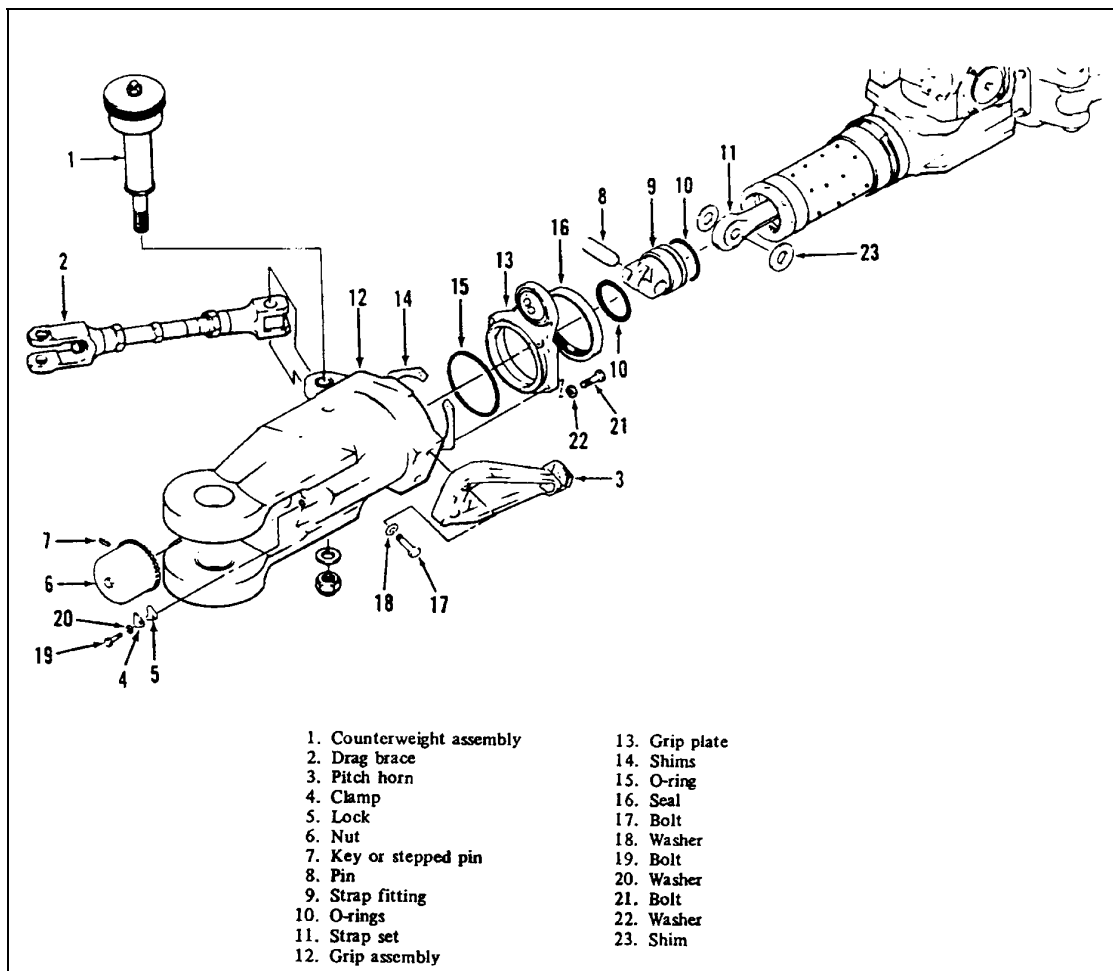
Figure 3
UH-1B grip assembly, showing TT strap

- 1.6.15 The function of the TT straps was to retain the main rotor blades in place in the rotor hub against the large centrifugal forces developed at normal rotor RPM, while allowing the blades to pivot on their feathering axes as required by the control inputs from the swashplate. The TT straps were contained within the arms of the yoke part of the hub assembly, with each outboard end attached to a main rotor blade grip. The blade grips were supported on bearings on the outside of the yoke arms. The yoke arms were filled with oil.

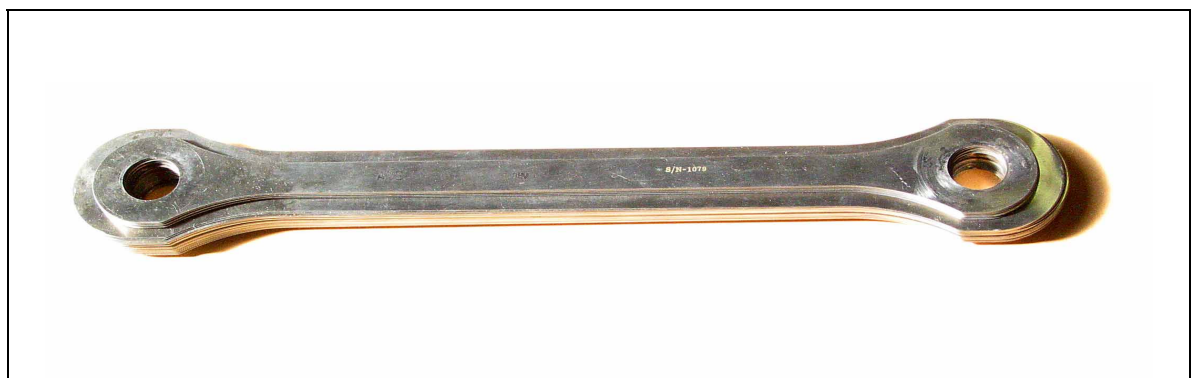
Figure 4
Time-expired TT strap

- 1.16.7 The laminates from the other comparison (time-expired) TT strap were examined. All laminates were flat, with no evidence of buckling or other distortion. No laminates were cracked. Some discoloration on adjacent surfaces due to slight relative movement was apparent in the anchor pin areas.

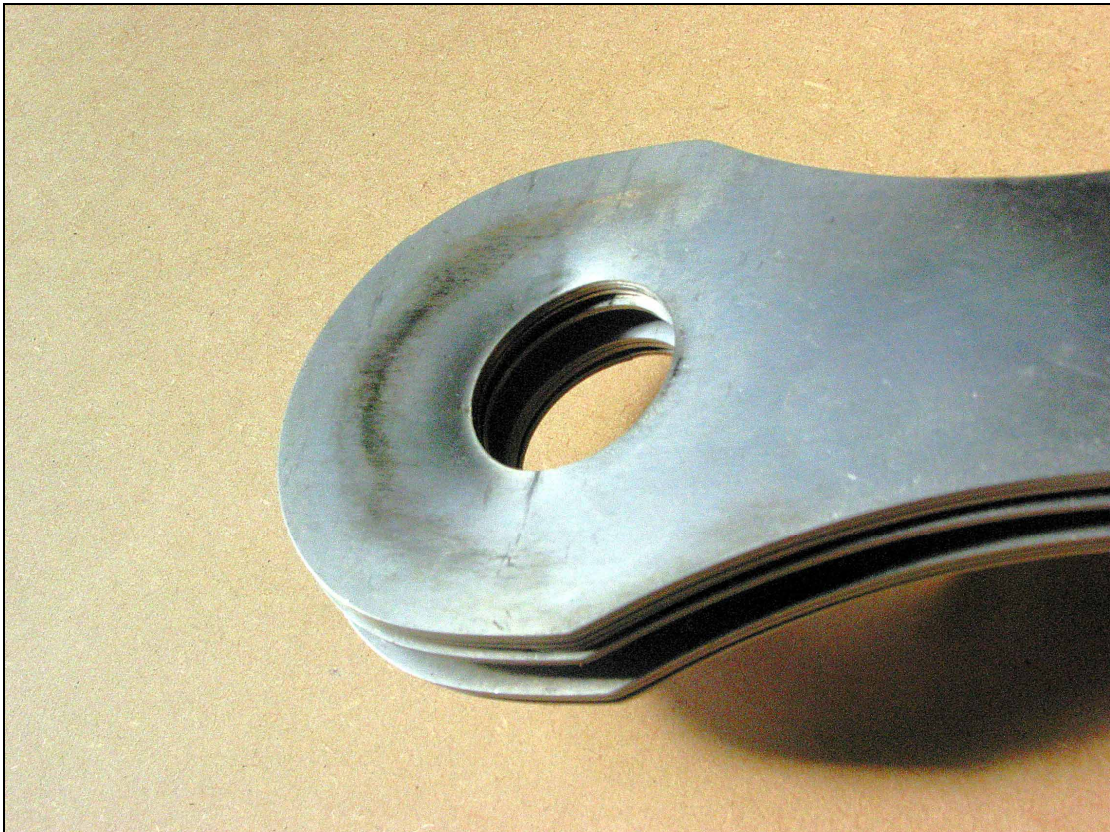
Figure 5
Red TT strap detail, showing buckling and crack

- 1.16.5 The red (unfailed) TT strap had 2 laminates which had failed, and several which had visible cracks. The fracture surfaces showed low-cycle high-load fatigue similar to the white strap. All the laminates showed buckling due to overload at the anchor pin holes. While this was less than the most buckled laminates from the white TT strap, it was uniform between laminates.

- 1.16.8 The consultant metallurgist concluded:
- There was no evidence of metallurgical defects in either of the TT straps from ZK-HSF.
 - Both TT straps had been exposed to very high fluctuating, predominantly tensile loads resulting in low-cycle fatigue cracking of laminates and ultimately the failure of the white assembly.

- Similar damage (low-cycle fatigue cracking) had occurred to the red strap although the prior failure of the other strap prevented further damage.

- 2.5 The overstress on the TT straps which resulted from this overspeed was clearly beyond the fatigue limit for the material, because of the visible buckling it produced, and probably resulted in the fatigue initiation sites at the anchor pin holes of each laminate. Once the fatigue process had been started by such abnormal loads, cracks would continue to propagate under normal load conditions, probably at each flight cycle when the rotor was brought up to speed before take-off.
