AVIATION OCCURRENCE REPORT

04-006

Boeing 777, HL 7497, landed short of displaced threshold,
Auckland International Airport

16 November 2004

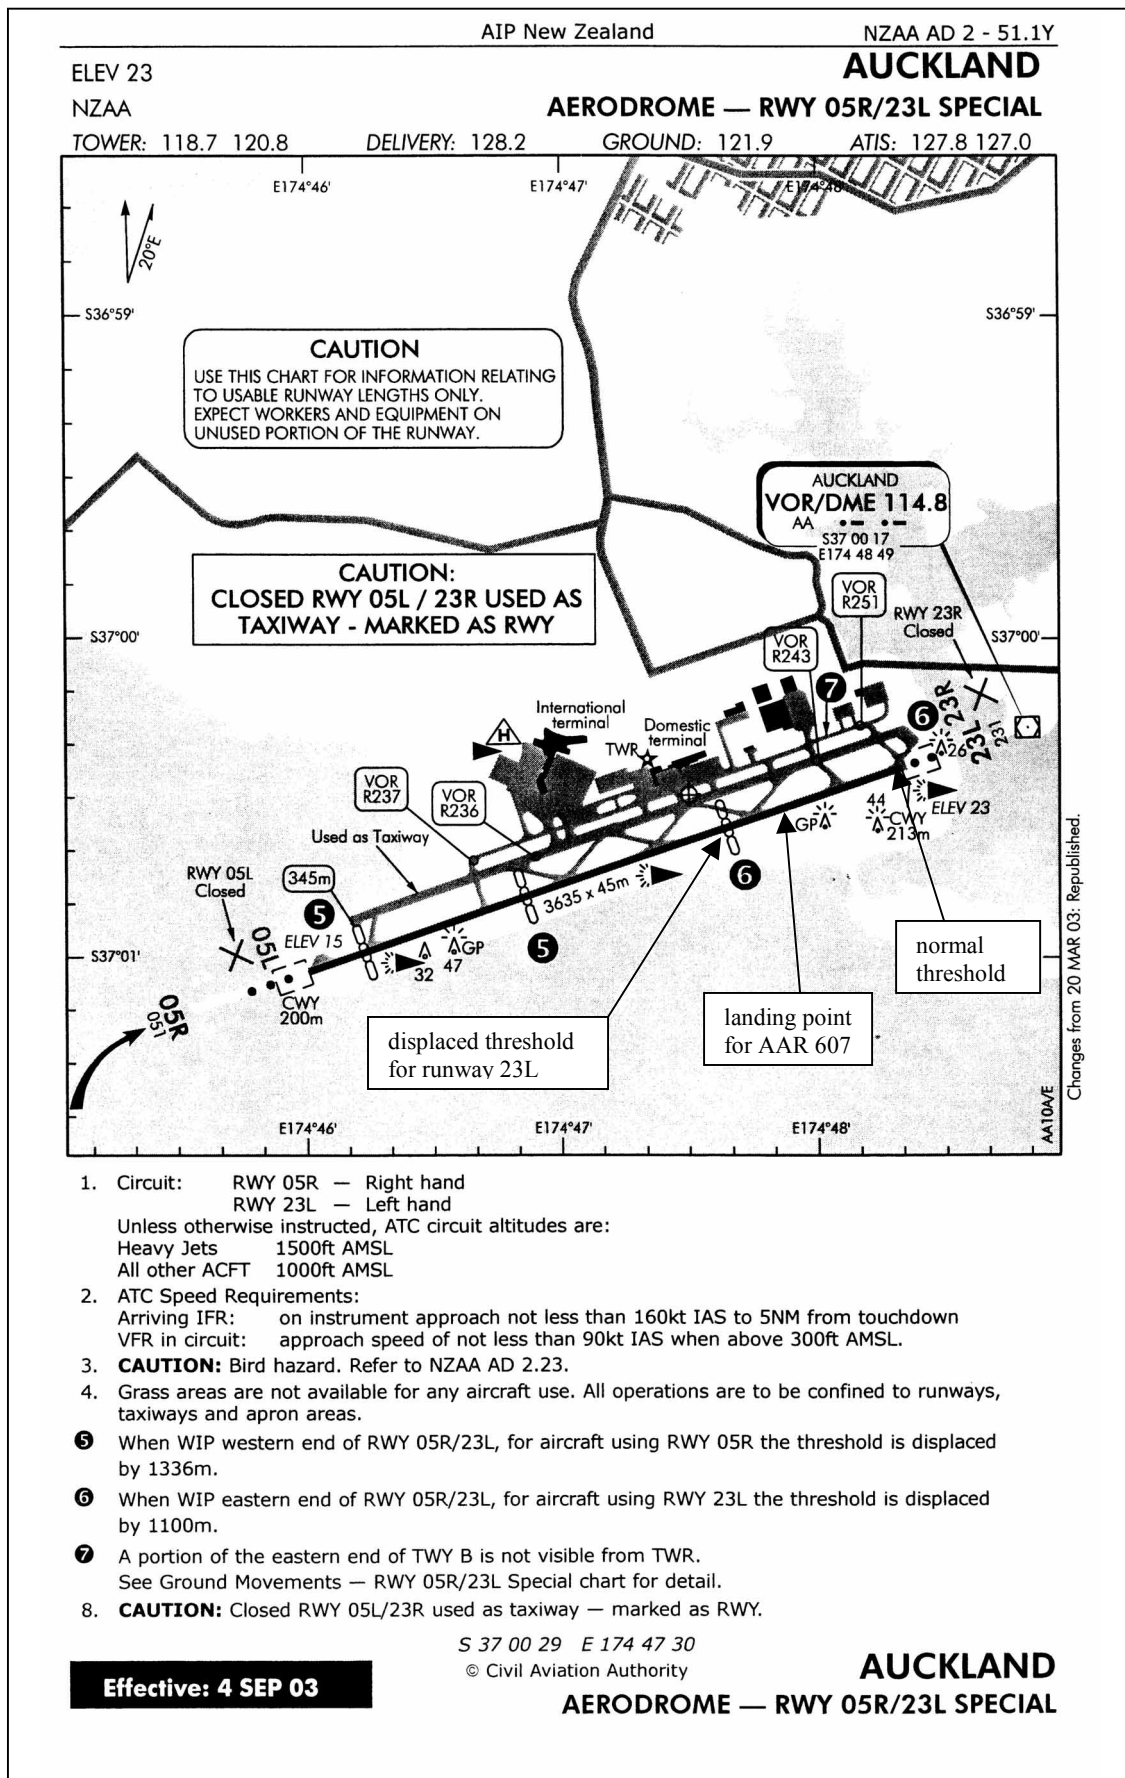
Figure 1
Auckland Aerodrome Chart, Runway 05R/23L Special
 (courtesy of Airways New Zealand)

- 1.1.14 At 1058 AAR 607 was observed to land abeam taxiway Bravo 3, about the normal landing position for full runway length operations (see Figure 1). The landing point was about 720 m past the full-length threshold, or about 380 m short of the displaced threshold, and about 750 m short of what was regarded as the landing point for displaced threshold operations. The crew of AAR 607 and the operator were not aware that there had been an incident until advised by TAIC some 10 days later.

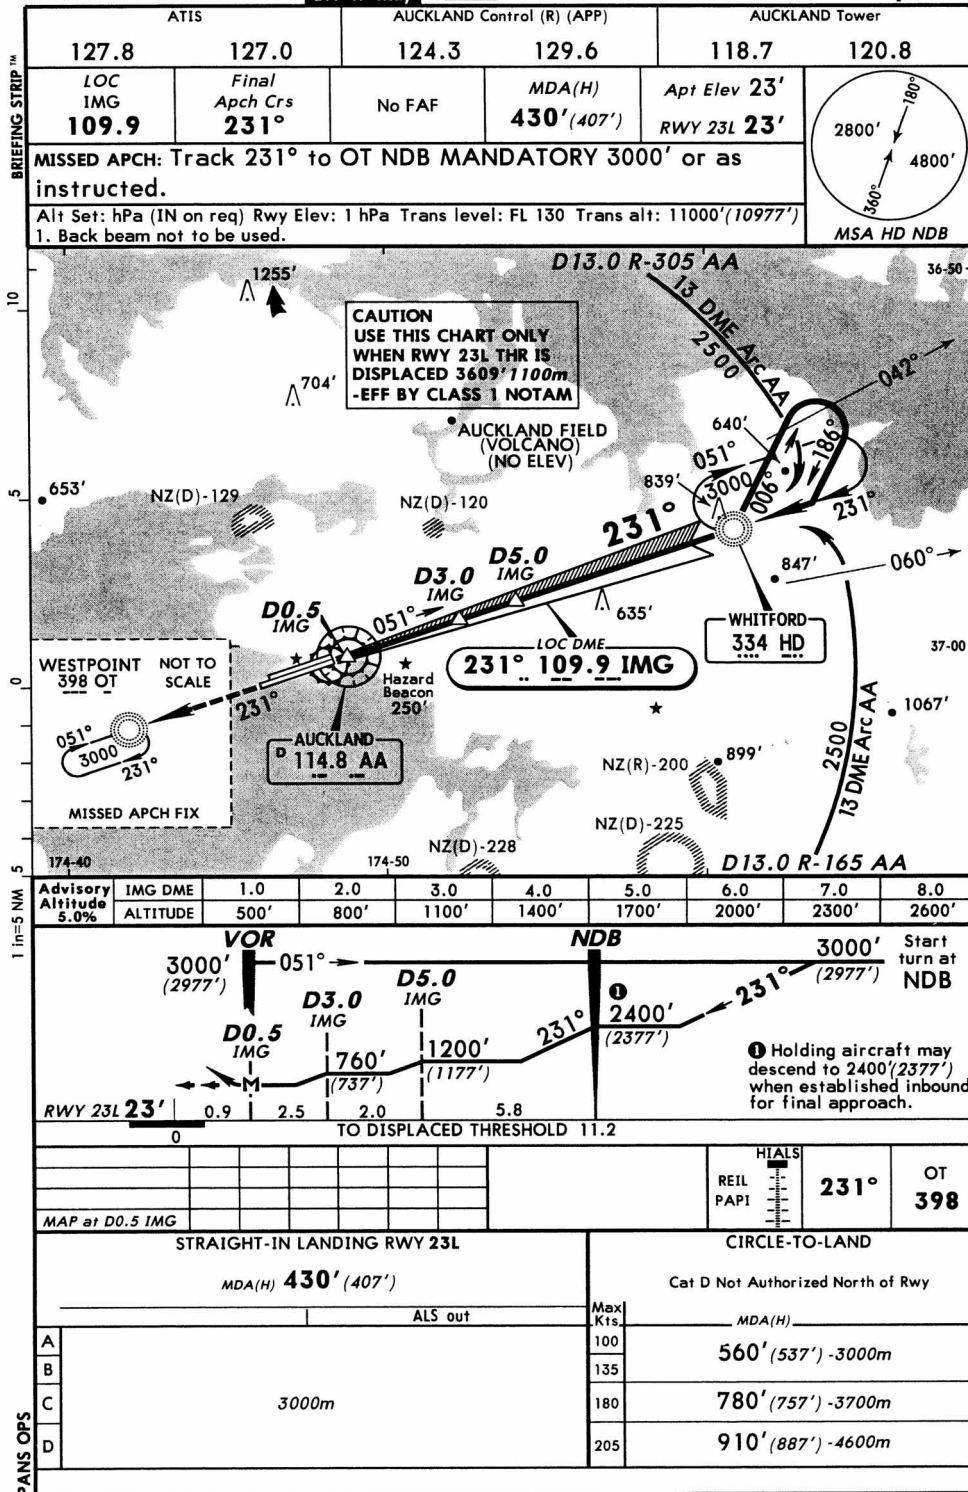
Figure 2
Jeppesen Auckland Approach Chart, ZULU 23L LOC DME Runway 23L
(Reproduced with permission of Jeppesen Sanderson, Inc)
NOT FOR NAVIGATIONAL USE
© Jeppesen Sanderson, Inc. All rights reserved.

- 1.10.3 For en route navigation, instrument approaches and aerodrome information, the operator used maps and charts produced by Jeppesen but based on locally manufactured charts produced by a country's aeronautical authority. For Auckland, Jeppesen produced a series of charts, also colour-coded white, yellow and green, based on the AIP charts produced for the Civil Aviation Authority of New Zealand (CAA). The chart used by the crew of AAR 607 for approach to runway 23L was a Jeppesen chart titled "ZULU 23L LOC DME Rwy 23L", effective from 17 May 2001 and was current on the day of the incident (see Figure 2).

- 1.10.4 While the AIP and Jeppesen charts for the 23L ZULU approach contained the same factual information, they did differ in presentation. One obvious difference was that the descent profile for the AIP chart was depicted as a constant angle. DME altitude limits during the approach were written along the constant angle profile.¹³ The Jeppesen chart approach profile was drawn in steps, with a descent after each DME altitude limit, followed by a level portion before the next DME limit was reached.

- 1.17 The Jeppesen instrument approach chart used for the approach clearly stated in a caution box on the chart that it was only to be used when the runway threshold was displaced by 1100 m. The chart was colour-coded yellow to reinforce the special conditions that applied, namely work on the runway and a displaced threshold.

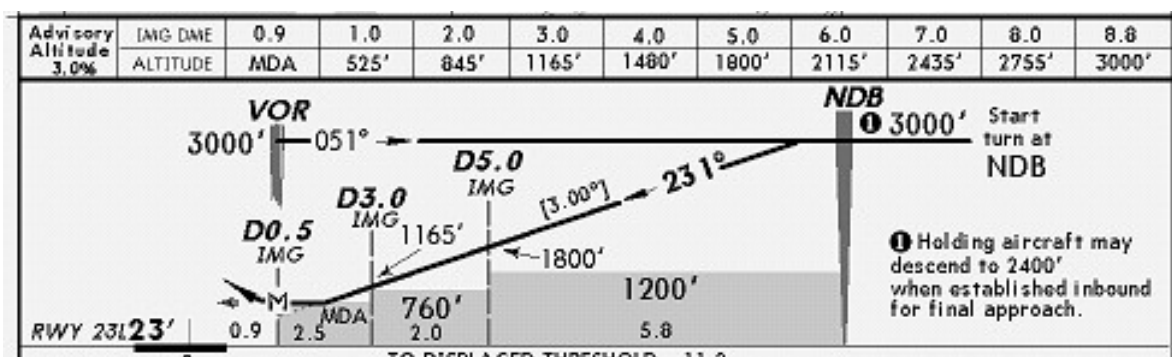
Figure 3
Proposed Jeppesen profile diagram for Localiser DME approach 23L
 (Reproduced with permission of Jeppesen Sanderson, Inc)
 NOT FOR NAVIGATIONAL USE
 (c) Jeppesen Sanderson, Inc All rights reserved.

A diagram of the proposed profile for 23L at Auckland is at Figure 3.
