AVIATION OCCURRENCE REPORT

04-007

PA34-200T Seneca 11, ZK-JAN, controlled flight into terrain
Mount Taranaki/Egmont

30 November 2004

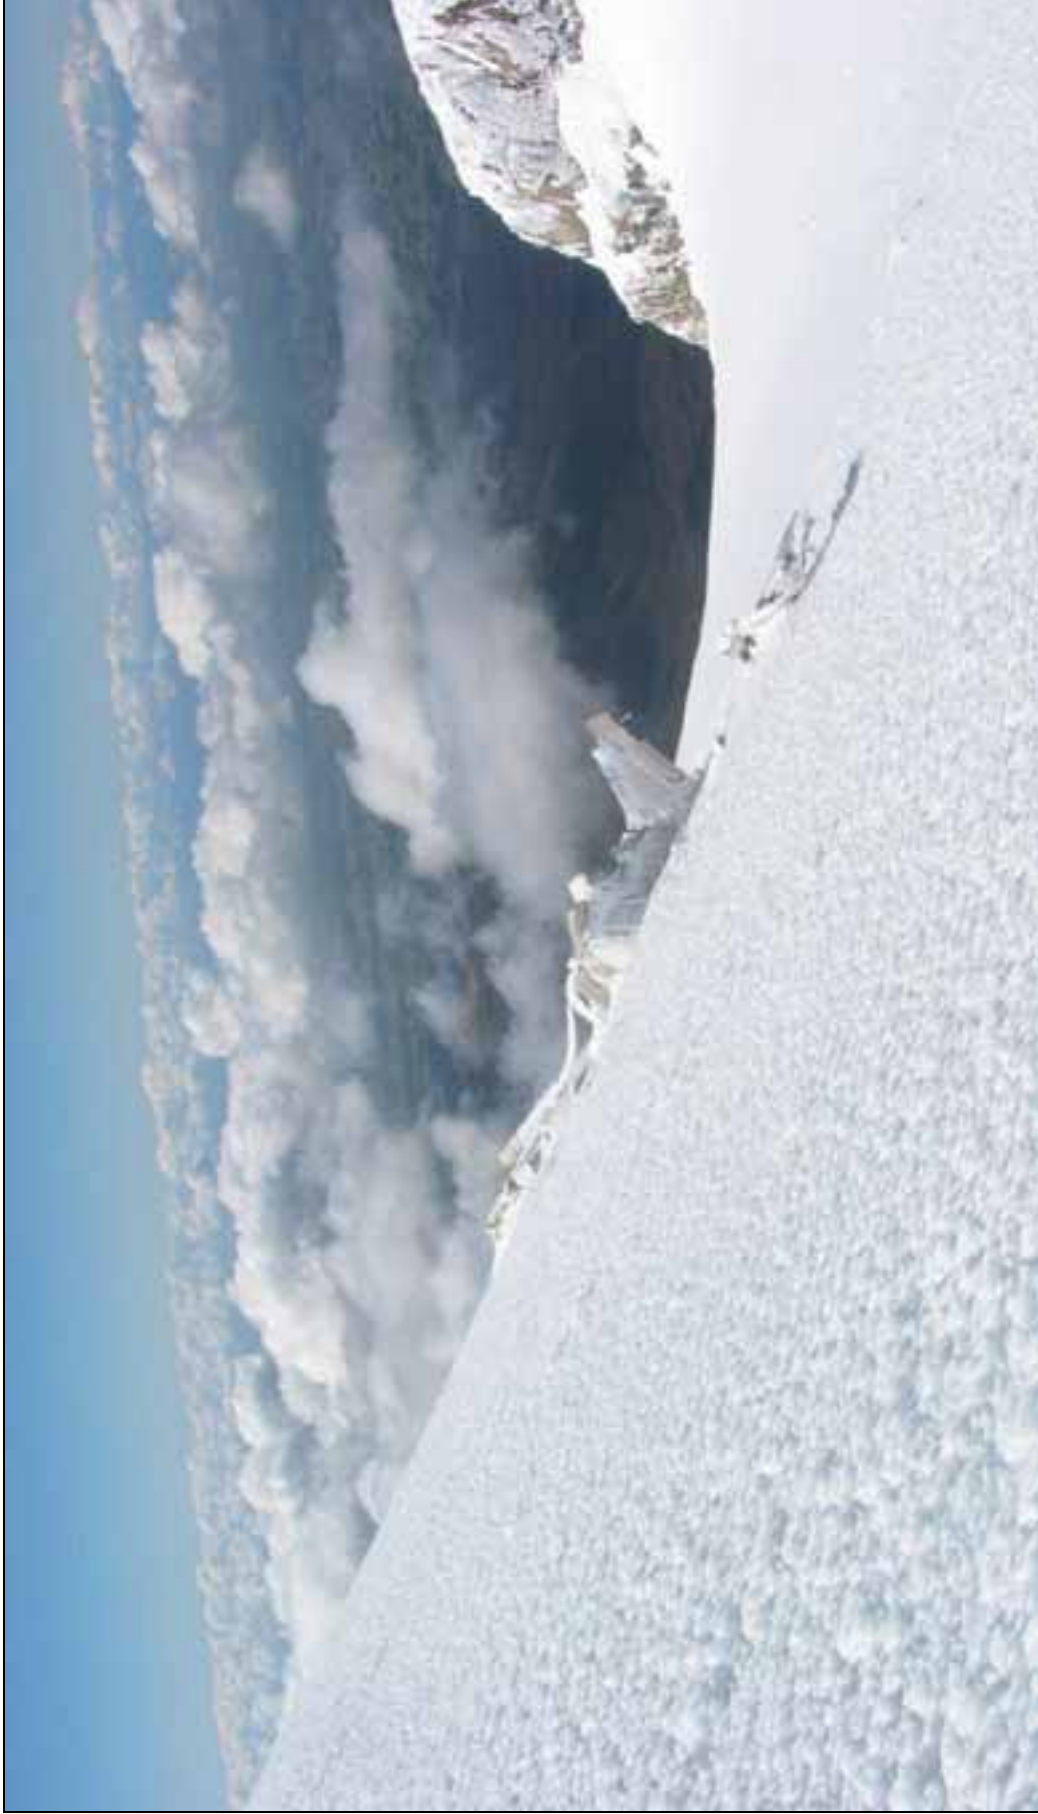
**Wreckage of ZK-JAN
Mount Taranaki / Egmont
(looking north)**

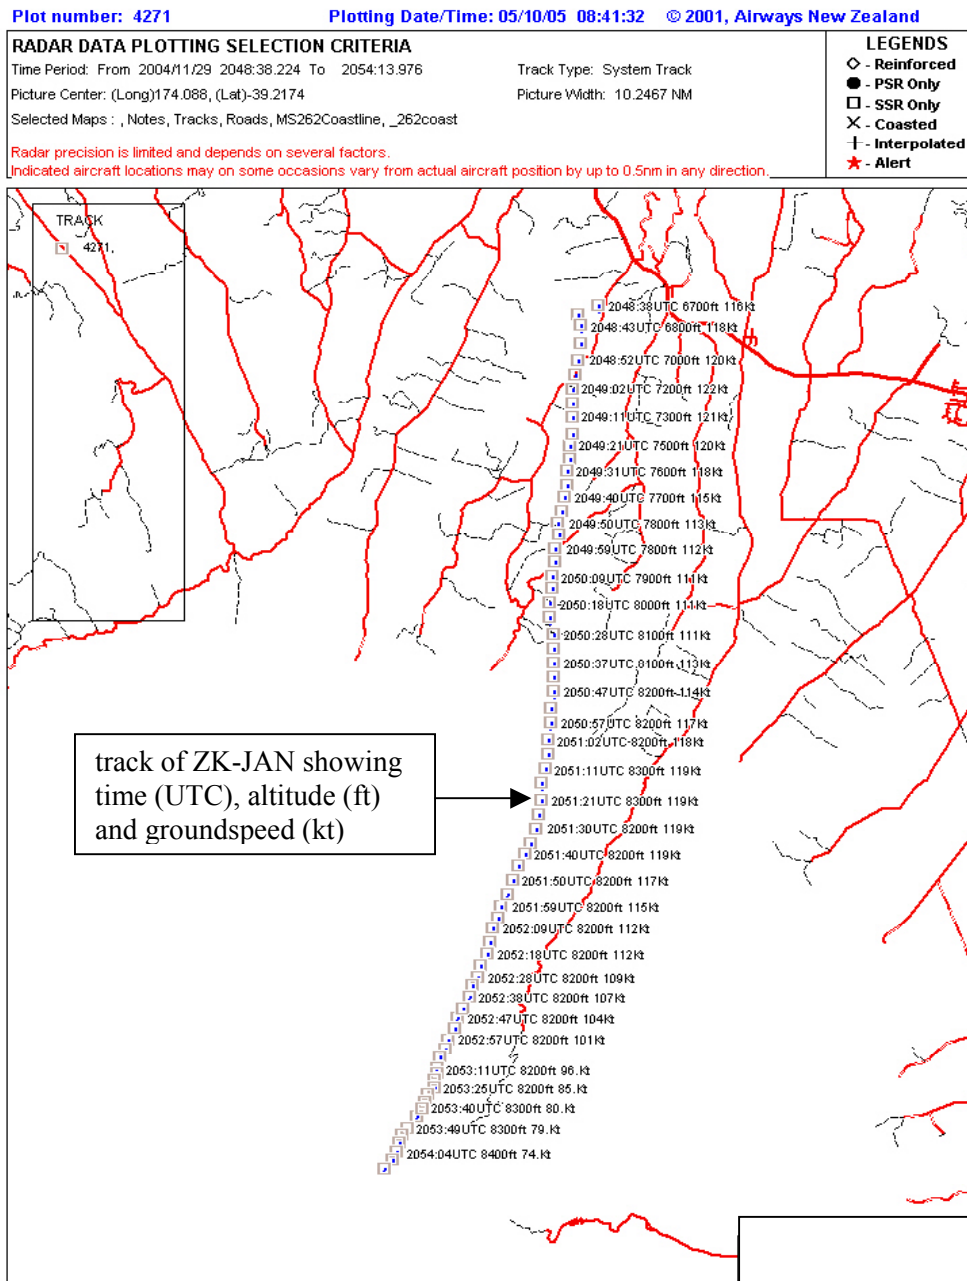
- 1.8.4 The last radar recording was at 0954:13 as ZK-JAN was near the summit of Mount Taranaki. The recorded altitude was 8400 ft and the groundspeed was 77 kt.

Figure 1
Radar track plot for ZK-JAN
(Courtesy of Airways Corporation of New Zealand)

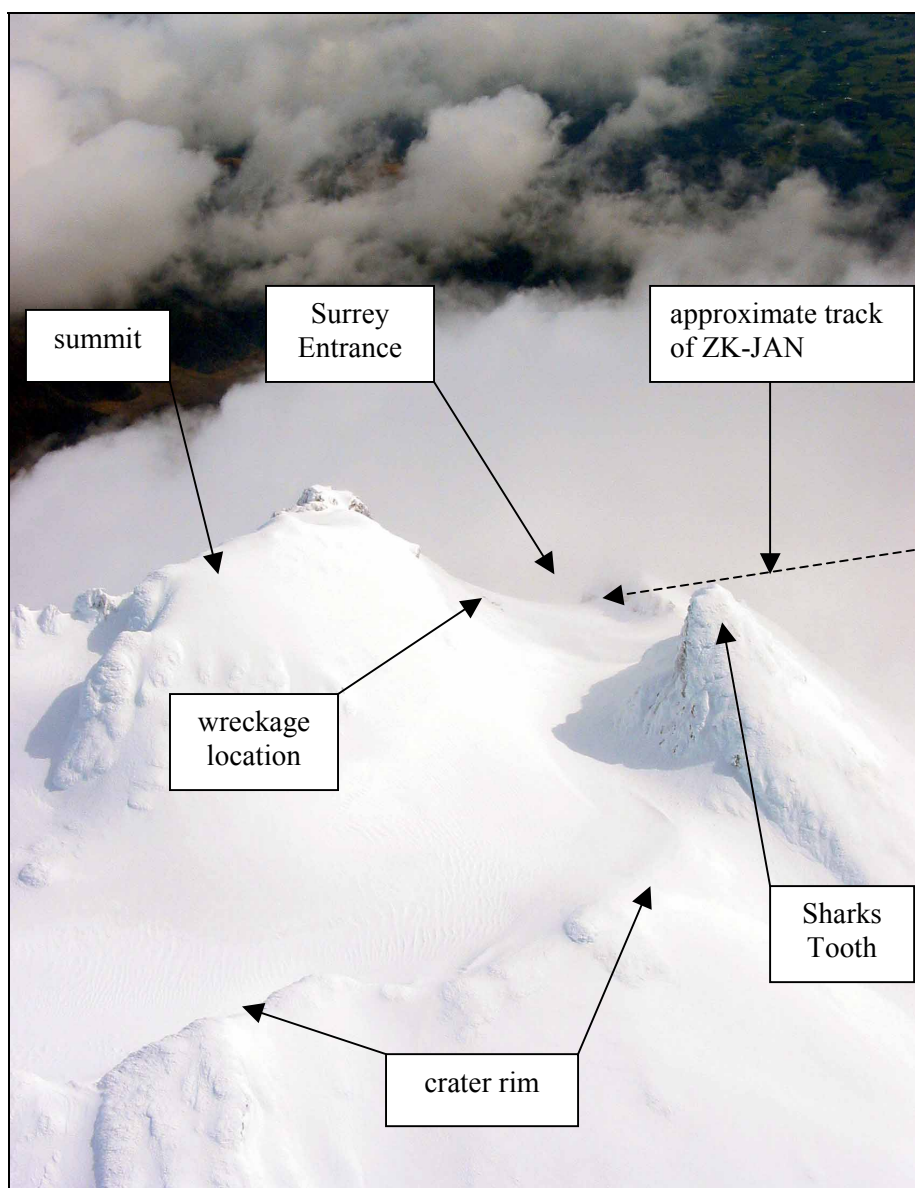
1.12.1 The accident site was on the summit of Mount Taranaki, on the eastern slope of the cone within the crater rim. The site was at an elevation of about 8100 ft (2470 m), or about 150 ft (50 m) below the summit. The summit was 18 nm (33 km) south of New Plymouth Aerodrome

1.12.2 ZK-JAN had impacted on the 35° ice-and-snow covered slope in an erect and almost wings level attitude. The aircraft lay on a south-south-westerly heading. The aircraft had penetrated about one metre into the snow and ice, leaving most of the fuselage and wings exposed. Because of poor weather the recovery team was unable to reach the aircraft until Monday 6 December 2004, 6 days after the accident, by which time the aircraft was partly covered by recent snow and ice (see Figure 2).

Figure 2
Accident site
(summit of Mount Taranaki)

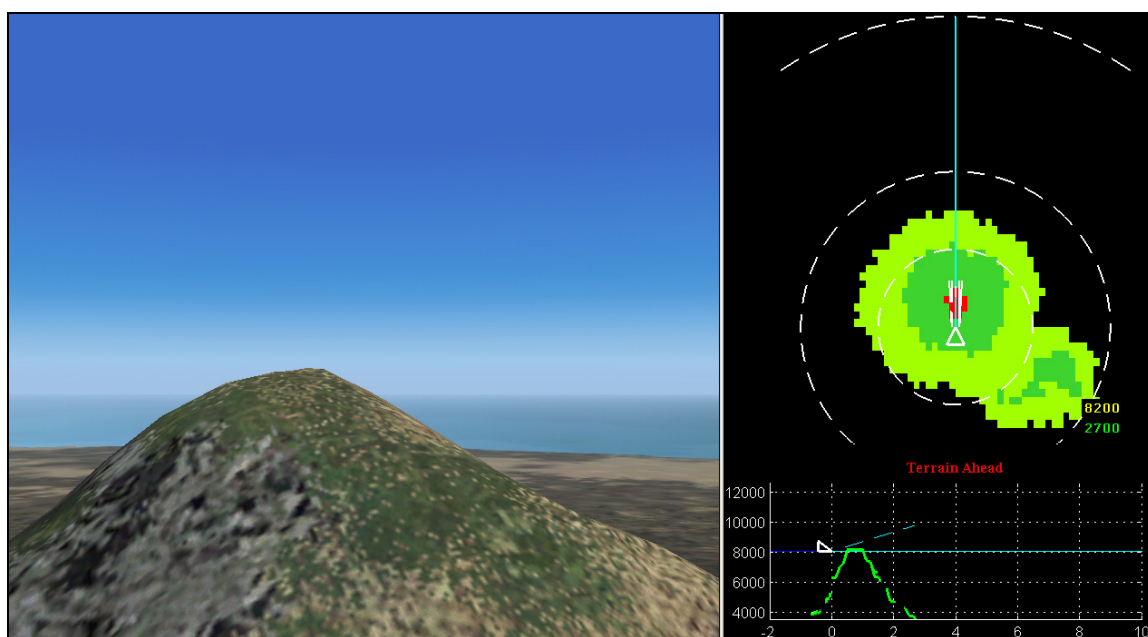
- 1.16.7 With the assistance of a commercial manufacturer of TAWS equipment, a profile of the flightpath of ZK-JAN was calculated using ATS radar information. This was overlaid onto the local area terrain database to determine what information a pilot should receive in similar circumstances. It was calculated that a pilot should receive 2 audio alerts; the first advising "Caution Terrain" at 41 seconds before calculated impact and, a second advising "Terrain Terrain Pull Up" at 30 seconds before impact. Where an aircraft was also fitted with a visual display, a pilot should be shown a depiction of the mountain ahead (see Figure 3).

Figure 3
Depiction of TAWS imagery 30 seconds before impact

4.2.1 The Director will accept this recommendation. He has already committed to a time frame for preparing a draft Final Rule for the Ministry of Transport. This will require the fitting of TAWS equipment to aircraft first entering the New Zealand Register at the earliest opportunity
