## AVIATION OCCURRENCE REPORT

## **Report 04-009**

**Hughes 369D**

**tail rotor strike with sling load and emergency landing**

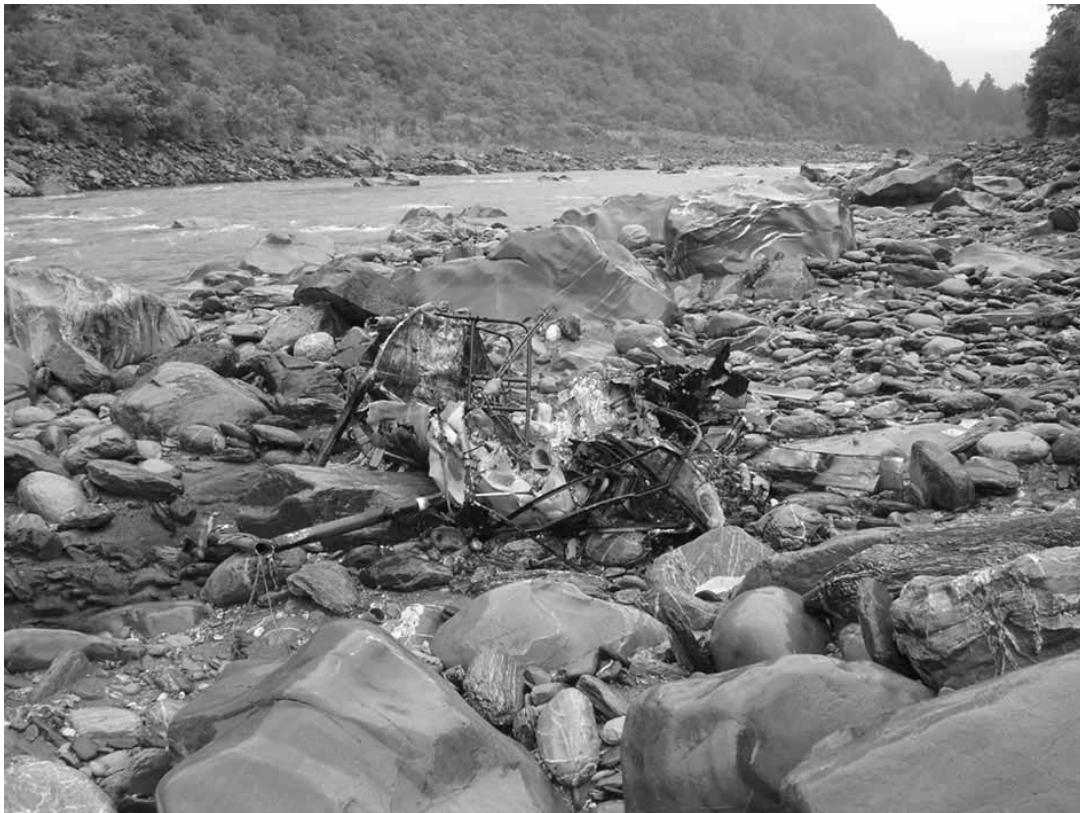
- 1.2.1 ZK-HHT was destroyed by the heavy landing and fire.

The accident occurred in a gorge area of Wanganui River, about 4 km upstream of the roadbridge and pick-up point. ZK-HHT had landed on a rocky riverbed on the southern side of the river. The fuselage, destroyed by the post-impact fire, lay on its side about 5 m from the river's edge. The tail boom separated from the fuselage and was in 2 pieces. The tail rotor assembly was severed from the boom about 0.5 m forward of the vertical fin and lay about 20 m from the main wreckage. The remainder of the boom was closer to the wreckage. Three of the 5 main rotor blades broke from the rotor head and were found between 10 and 25 m from the main wreckage (see Figure 1).

**Figure 1**  
**Wreckage of ZK-HHT looking east**  
**(photograph courtesy of the pilot of ZK-HHT)**

Marks on the tail boom were consistent with several of the main rotor blades striking and severing the tail boom. The blades had then struck the rocky riverbed causing them to either separate or fold back at the hub.

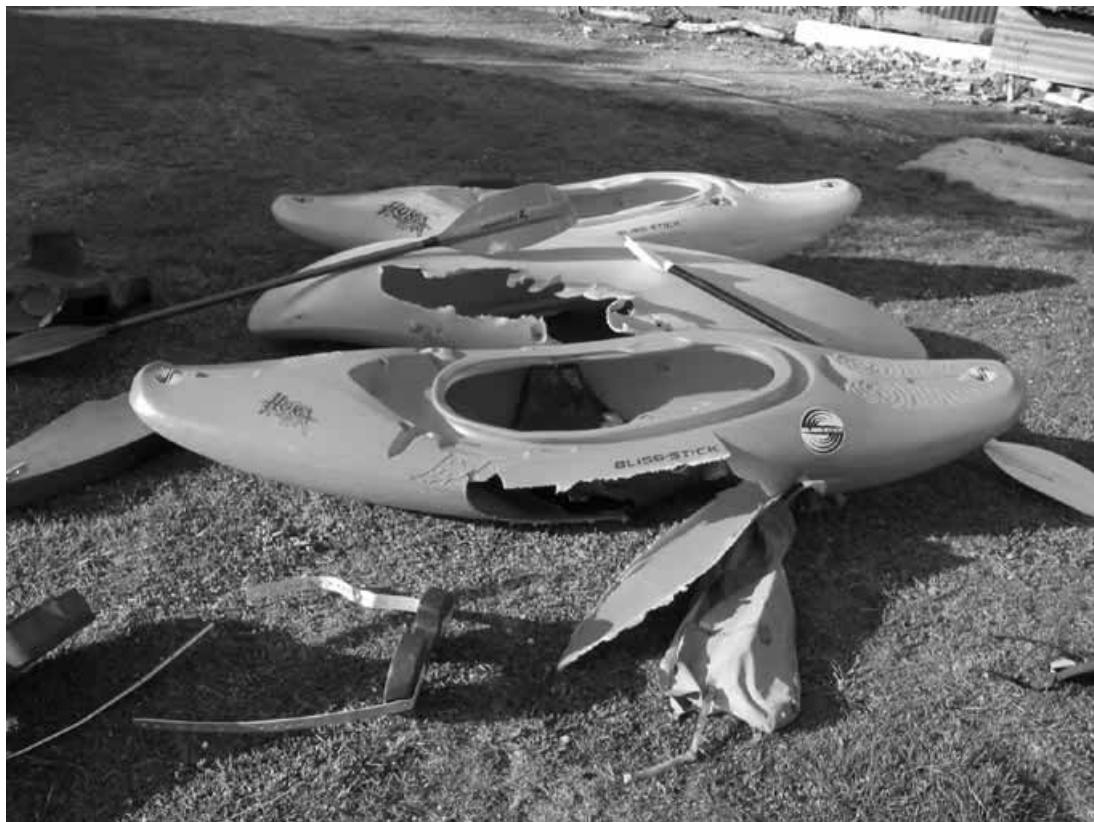
A partially burnt and torn cargo net lay beside the wreckage. The 3 kayaks and paddles were found between 150 and 200 m downstream on the opposite side of the river.

The 4-bladed tail rotor assembly was badly damaged. All the blades were bent and one blade displayed evidence of having struck the tail boom. This blade and its coupled partner blade had separated from their retaining hinge and were flapping loose. Several of the tail rotor blades had blue coloured transfer marks and held small pieces of material that matched the construction of the cargo net. Damage to the kayaks was consistent with them being struck by the tail rotor, with numerous saw-tooth type strikes (see Figure 2).

**Figure 2**  
**Damaged kayaks from cargo net**

- 2.3 As ZK-HHT lifted off, the net would have started to stream back underneath the helicopter as it climbed and accelerated. The 3 kayaks and paddles weighed about 55 kg, so there was little weight to hold the net down as the helicopter approached 70 kt. The size and shape of the kayaks also meant that they were easily affected by the airflow. The higher speed, combined with the turbulence ZK-HHT encountered as it rounded the bend in the river, was probably enough to start the load oscillating underneath the helicopter. With a 2 m strop, the net was able to swing back and strike the tail rotor.

- 2.6 The accident could have been prevented by a number of means. The pilot could have flown at a lower speed, thus reducing the amount the net streamed backwards. Extra weight could have been added to the sling load to hold it down. The spare fuel containers were readily available for this option. The strop could have also been shortened so the net would have been unable to reach the tail rotor.
