MARINE OCCURRENCE REPORT

04-202

Restricted limit passenger vessel *Queenstown Princess*,
grounding, Lake Wakatipu

13 February 2004

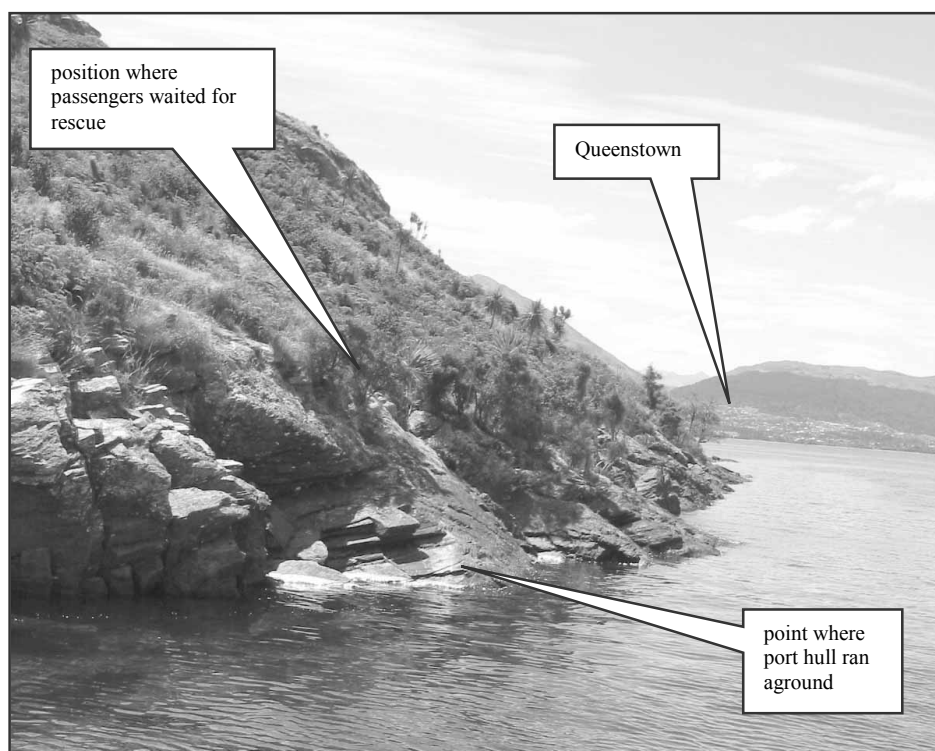
- 1.1.4 At about 2215, the *Queenstown Princess* grounded, its port hull riding up on the rocky shore and slewing the boat round to port. It came to rest with the forward port hull elevated on a rock shelf (see Figures 2 and 3) and the starboard quarter deeper in the water. At the time of the grounding, 2 passengers on the afterdeck were propelled forward, lost their footing and crashed into the barbeque and ship's structure. Another passenger near the steering position was thrown forward into the console.

Figure 2
Grounding position with Queenstown in the background

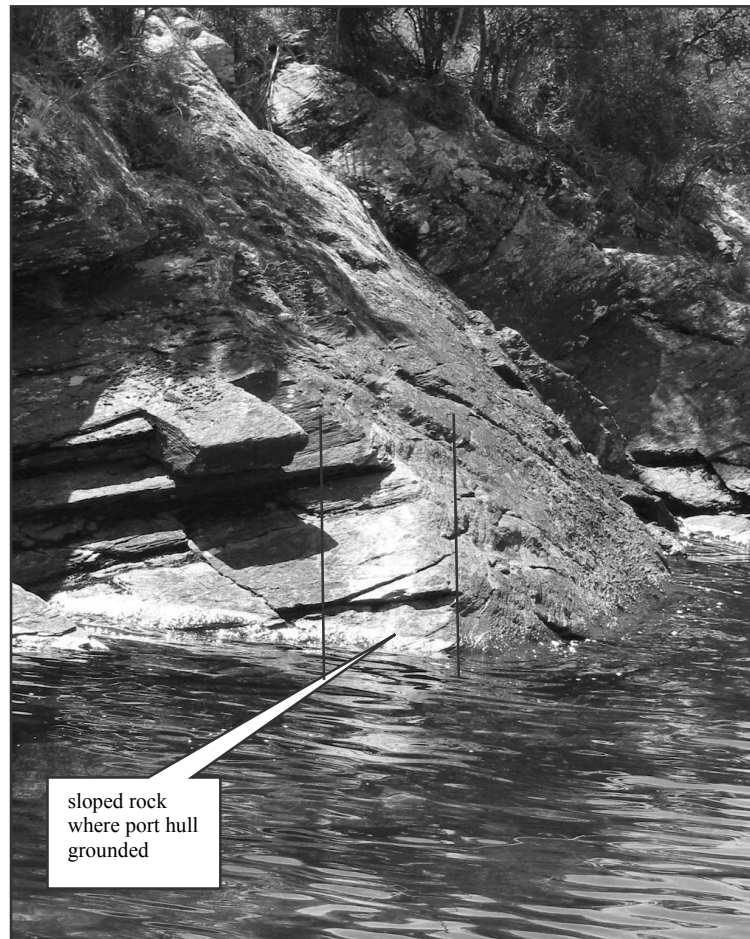
Figure 3

Close-up of grounding position showing jagged rock that was narrowly missed

- 1.2.1 The boat grounded on a sloping rock shelf (see Figures 2 and 3) and its port hull was holed forward of and across the collision bulkhead (see Figures 4 and 5). The angle the boat assumed resulted in the starboard transom being submerged and water entering the starboard engine space through a hole that had been cut in the transom for the outboard motor control cables. An automatic submersible pump was unable to keep up with the ingress and the compartment was flooded. The flooding disabled the starboard engine and with it the main bilge pump, which was driven by that engine.
- 1.2.2 A boat builder in Dunedin repaired the port hull. The starboard engine was dismantled, dried and inspected; no corrosion was found in its internals.

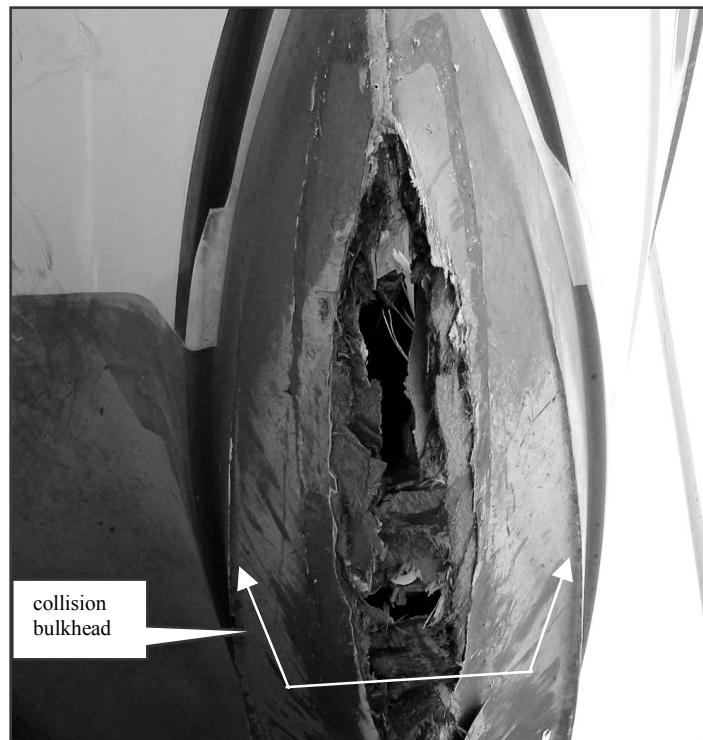
Figure 4
Damage to port hull

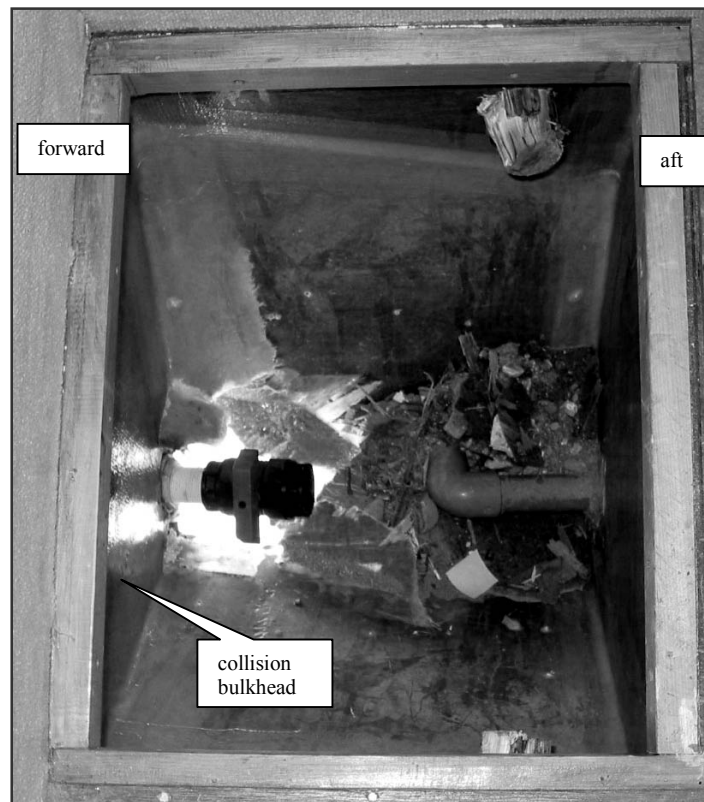
Figure 5
Damage from the compartment abaft the collision bulkhead in port hull,

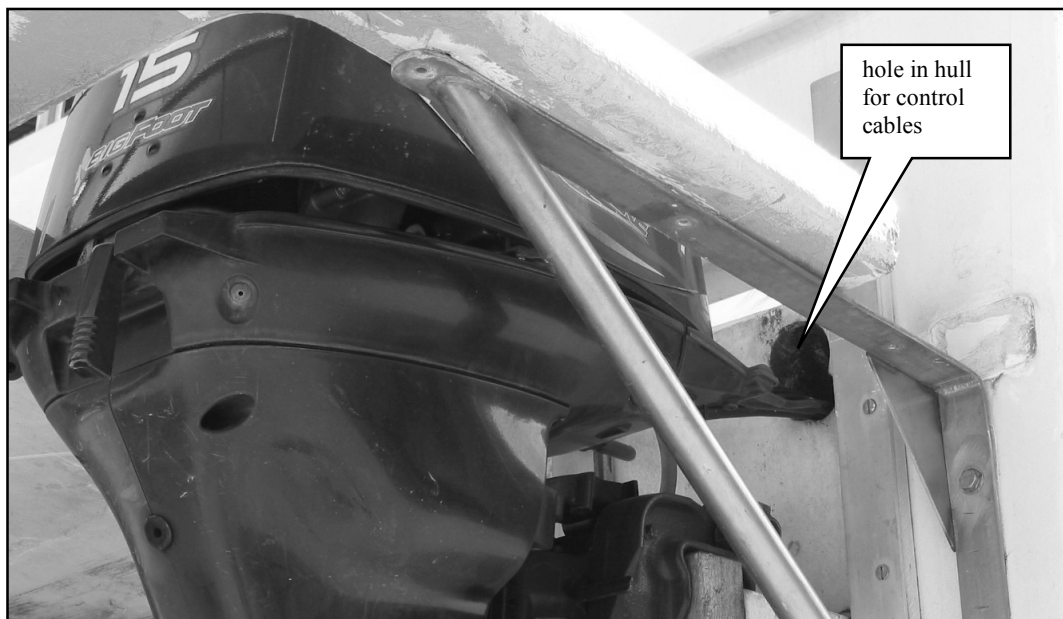
- 1.5.3 The new engines and propulsion system gave the boat a minimum speed of between 6 and 7 knots, too fast to troll for trout, one of the principal uses of the boat. To operate at between 1 and 2 knots, the owner decided to install 2 Mercury 15 hp outboard motors that could be lifted clear of the water when not in use. Sliding brackets to house the motors were fitted at the time of the stern modification. On the boat's return to Queenstown the outboard motors were fitted and the remote control cables were run through the transom into the engine compartment and to the steering position. No watertight glands were fitted where the control cables passed through the boat's hull (see Figures 6 and 7).

Figure 6
Control cables passing through a hole in the transom

- 2.9 SGS M&I supervised the major alterations to the boat in 1998 but was unaware of the holes in the transom for the outboard motor control cables, which were drilled after the boat was returned to Queenstown. Subsequent inspections by MSA and SGS M&I should have identified the holes as liable to compromise the watertight integrity of the boat, but had not done so. Additionally, the then owner had a responsibility to inform SGS M&I of any major alterations carried out. The then owner complied with this in regard to the new engines and extension to the hull but neglected to advise SGS M&I that holes had been drilled in the transom.

- 3.8 The boat had been modified in 1998 and subsequently holes had been cut into its transom to run the outboard motor control cables. No attempt had been made to seal the holes, so when the starboard transom became submerged the hole on that side allowed the free ingress of water into the starboard engine space.

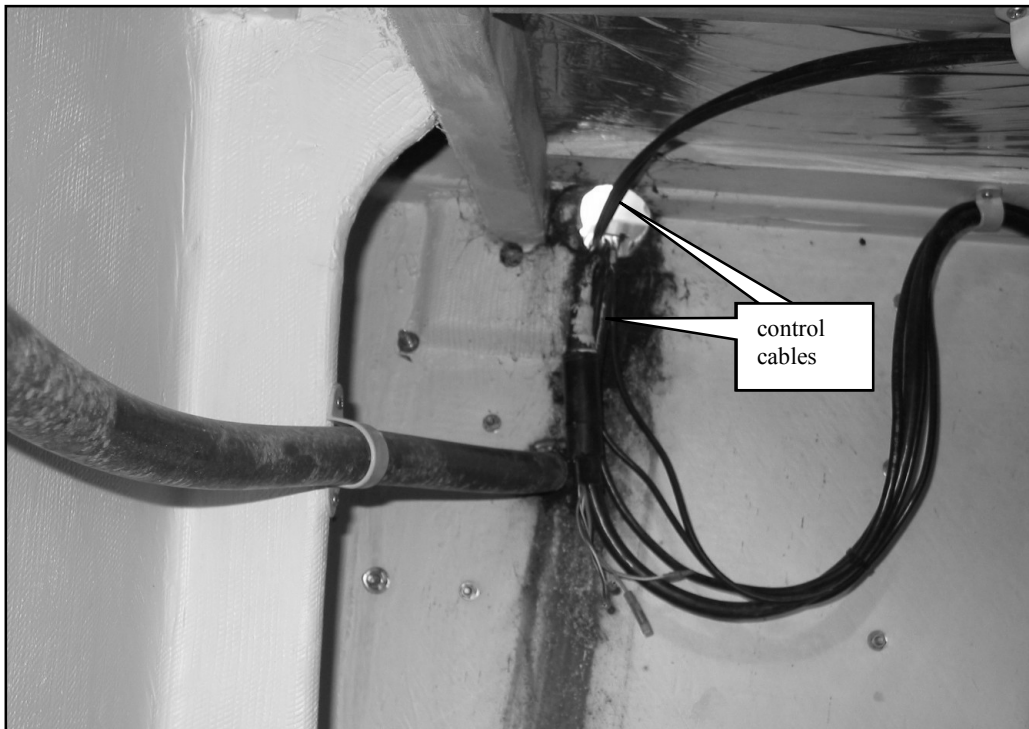
Figure 7
Hole through the transom, from the starboard engine space

- 3.9 The then owner had not informed his Safe Ship Management Company that holes had been cut into the transom and they had gone unnoticed during subsequent inspections.
