## M A R I N E   O C C U R R E N C E   R E P O R T

04-203

Coastal passenger and freight ferry *Arahura*, heavy weather incident, Cook Strait

15 February 2004

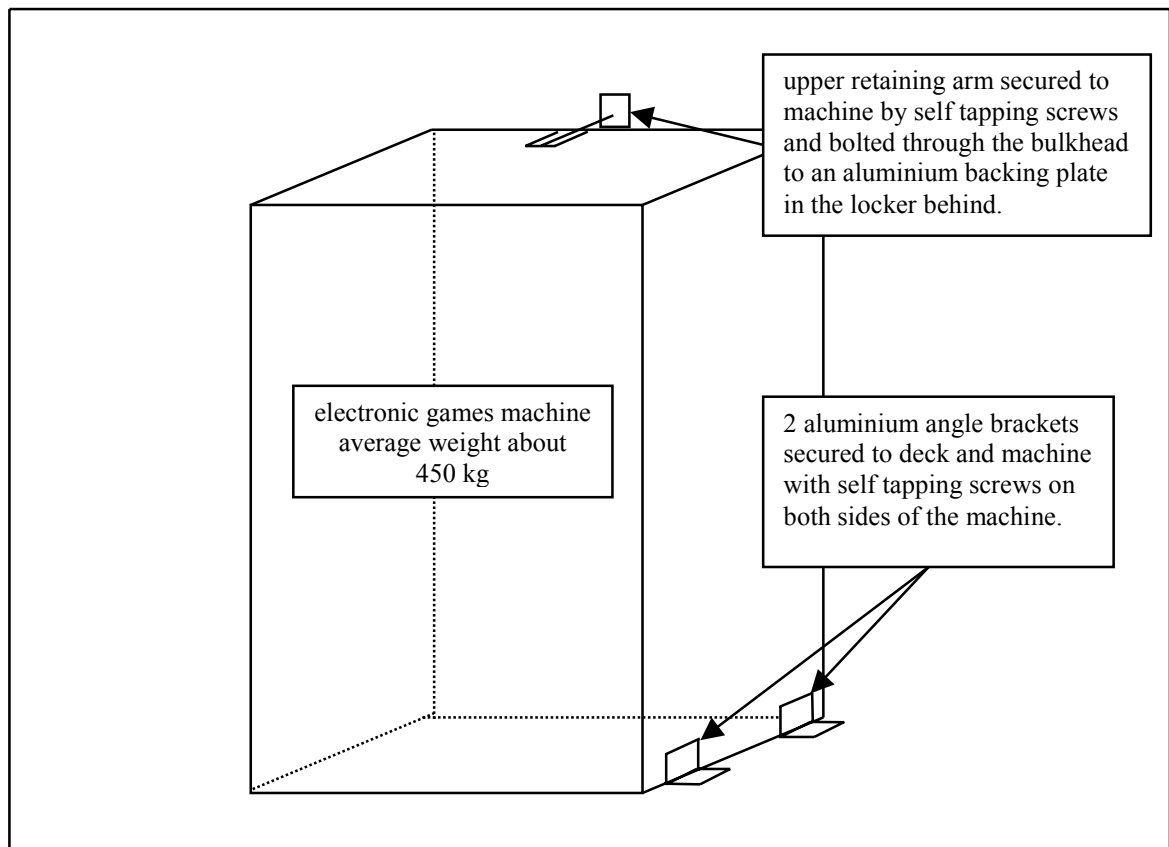
**Figure 2**  
**Diagram of securing arrangements for the games machines (not to scale).**

1.2.2 The 3 electronic games machines had been secured using aluminium angle bar between the deck and the side of the machine, and an upper retaining arm attached to the top of the machine bolted to the bulkhead (see Figure 2). Inspection found that:

- the self tapping screws that were used to secure the aluminium angle bar between the side of the games machine and the ship's deck were of insufficient length to penetrate the fitted floor coverings and gain a reasonable hold in the metal deck underneath.
- the upper retaining arm was bolted through the adjacent bulkhead and to a short length of aluminium angle bar in the locker behind. The adjacent bulkhead was constructed of a pair of thin-faced decorative panels separated by a fibrous mat and was not load supportive (see Figure 4).

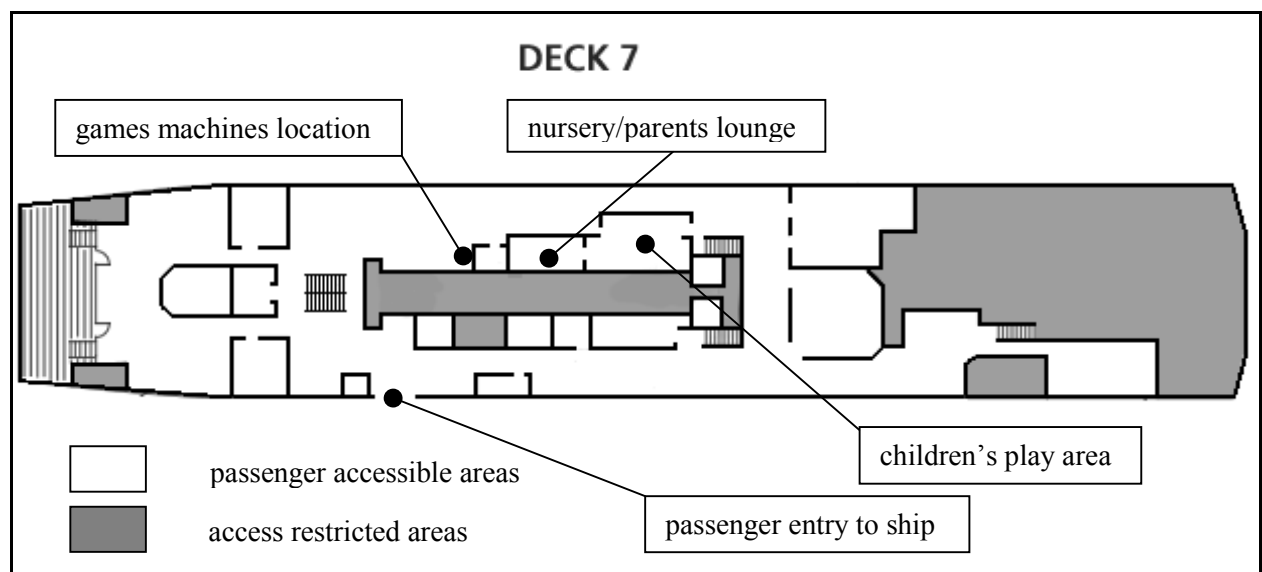
**Figure 3**  
**Layout of deck 7 showing the location of the electronic games machines**

1.2.1 The electronic games machines had been repositioned from deck 8 down to deck 7 during the vessels dry-docking in 2002. The suppliers of the machines secured them in place when they were relocated. The ship's safety officer conducted an inspection after the dry-docking and although the method of securing appeared adequately robust, without dismantling the attachments he was not able to inspect their strength.

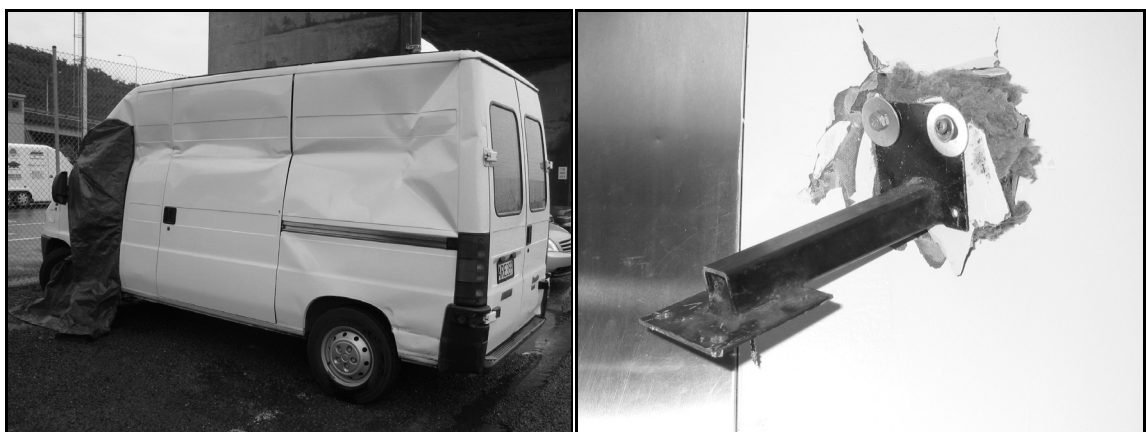
**Figure 4**  
Damage sustained to one cargo van and to the games machines upper retaining arm

1.5.1 Three electronic games machines were badly damaged, such that the owners replaced them.

1.5.2 Part of the bulkhead in the games machine area was damaged where the securing arrangements for the machines was pulled through the bulkhead. The self-tapping screws securing the games machines into the deck tore out.

1.5.3 Three small luggage vans had damage to their bodywork; none of the passengers' luggage inside the vans was damaged.
