MARINE OCCURRENCE REPORT

04-204

restricted limit passenger vessel *Freedom III*, grounding,
Lake Manapouri

24 February 2004

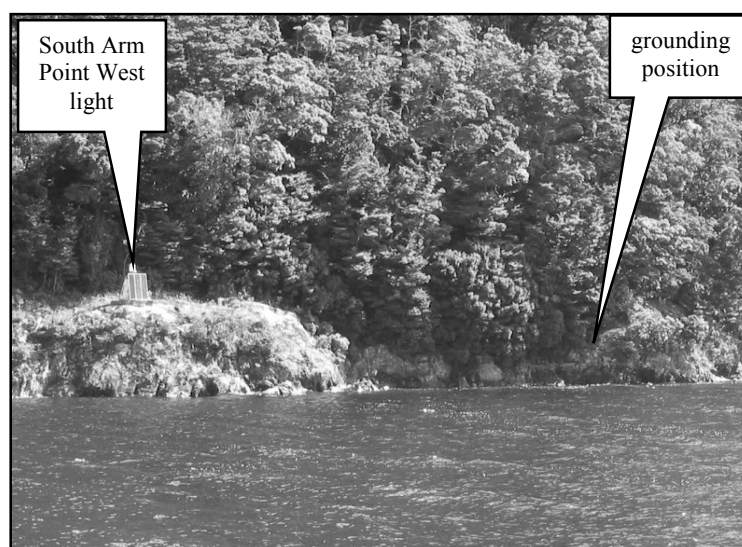
Figure 2
Grounding position in relation to the South Arm Point West light

Shortly before 0600 on Tuesday 24 February 2004, while on a trip from Manapouri to West Arm across Lake Manapouri, the restricted limit passenger/non-passenger vessel *Freedom III* grounded about 30 m past the South Arm Point West light.

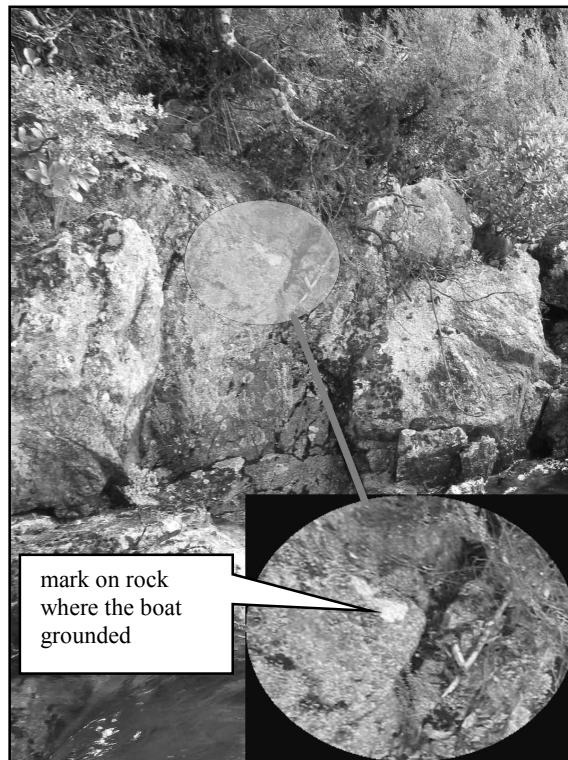
Figure 3
Grounding site, inset showing aluminium mark on rock

- 1.3.7 After the accident, the skipper initially said that he had grounded close to the West Arm light (Figure 1, light No. 9), about 2.5 nm further west than the actual grounding position. The passengers were convinced that they had grounded 30 m past the South Arm Point West light (Figure 1, light No. 7) because they could see the loom of the light while they were alongside the shore. The passengers' assertion was confirmed when broken branches and an aluminium mark were found about 30 m west of South Arm Point West light (see Figure 3). The skipper subsequently agreed that this was the grounding position.

- 1.6.2 When the boat grounded, the bow rose up the rock face. The stem was dented and holed, but only in the chain locker, a non-watertight compartment. The impact caused the engine to move forward, damaging its mountings.

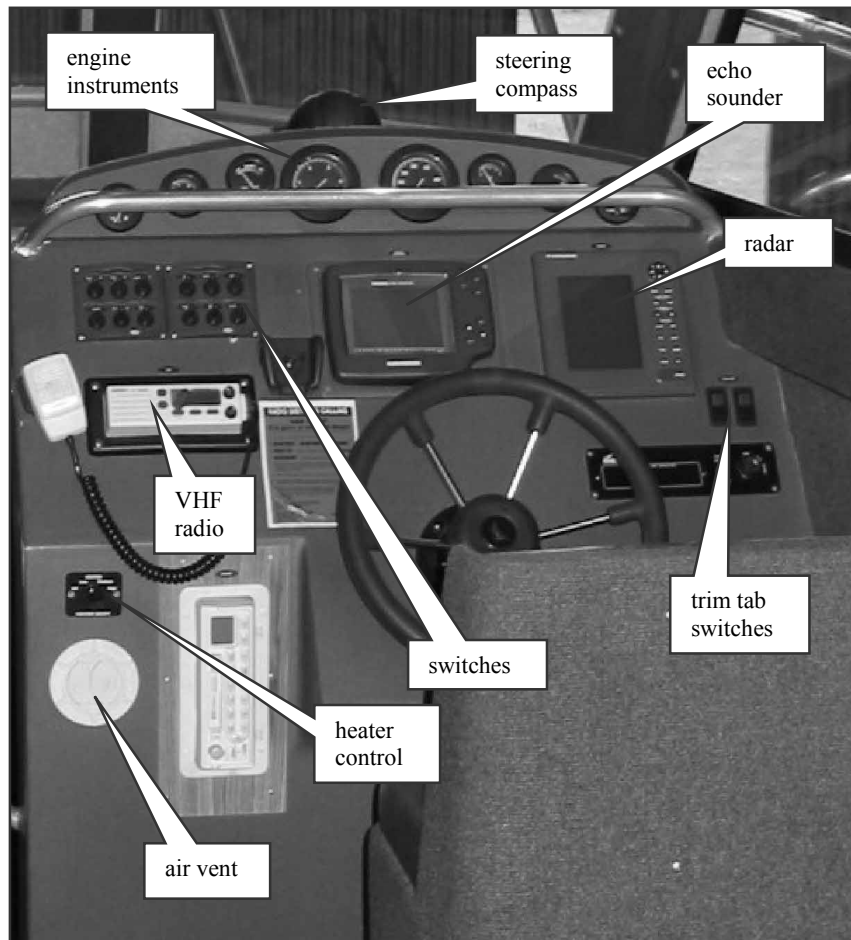
Figure 4
Steering console and instruments

- 1.2.4 The console immediately in front of the driver had a radar and echo sounder (see Figure 4). Engine instrument gauges were across the top of the console. Above and in front of the console was a magnetic steering compass. The radar had a dimmer switch to reduce the intensity of the screen, but the instrument lights could only be turned on or off and could not be dimmed. The skipper complained that the instruments caused a lot of backscatter of light which, combined with rain and spray on the windscreen, made visibility forward quite difficult. The passengers observed the skipper adjusting switches and looking out of the side window to get an uninterrupted view forward.

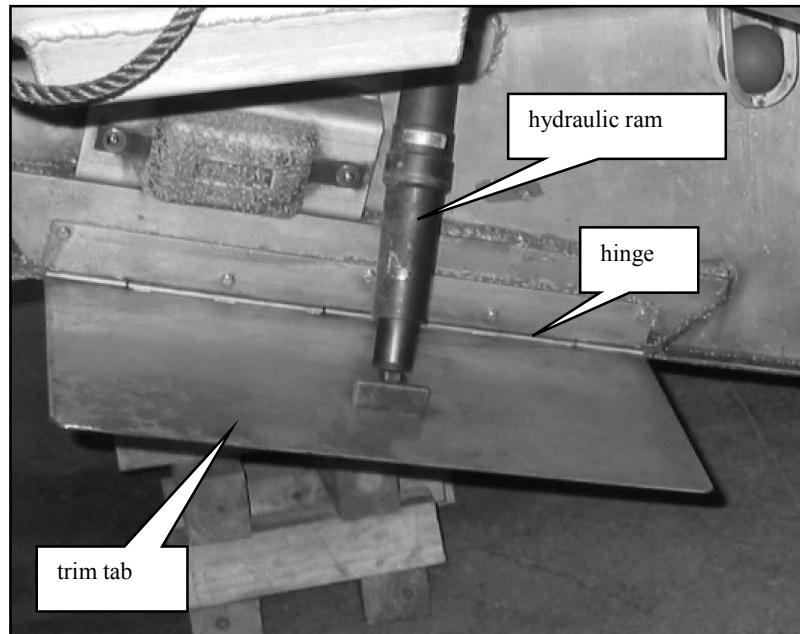
Figure 5
Port trim tab in the fully down position

- 1.2.6 The boat was fitted with electro-hydraulic trim tabs (see Figure 5). The trim tabs were used to assist the boat to attain the plane at a lower speed, and could also be used to maintain an even keel when there was unequal weight distribution. The trim tabs were plates fitted to and hinged at the transom in line with the bottom of the boat. They were each controlled by a hydraulic ram that lowered and raised the trailing edge. Two rocker switches on the steering console controlled the hydraulic rams (see Figure 6); down for trim tab down and up for trim tab up. To correct the longitudinal attitude of the boat, the trim tabs were used together to raise or lower the bow. However, they could be used independently to correct a list caused by an athwartship weight imbalance. There were no trim tab position indicators, so the operator could determine the position of the trim tabs only from the behaviour of the boat.

- 1.6.4 When the boat was inspected after it was taken from the water, the trim tab on the port side was found in the fully down position, as shown in Figure 5. The broken isolating switch prevented the trim tabs being moved.

- 2.3 The loss of control was probably caused by the position of the trim tabs, which were found after the accident with the port tab fully extended and the starboard one retracted. This was probably the position the trim tabs were in before the accident as they would not have been able to move after the isolating switch for the house batteries was damaged in the impact. In the short time between the skipper regaining control and the grounding he probably did not adjust the trim tabs.

- 2.4 The trim tabs provided lift at the stern of the boat, but they also induced drag, particularly as speed decreased. Having only the port tab extended would have caused that side to lift but also would have caused drag on that side and exerted a turning moment to port.

- 5.2.1 develop a comprehensive standard passenger safety briefing to include the position of life saving apparatus, actions in the case of an emergency and identifying hazardous areas on the boat. (056/04)
- 5.2.2 fit trim tab indicators. (057/04)
