MARINE OCCURRENCE REPORT

04-211 coastal cargo vessel *Southern Tiare*, loss of rudder, off
Mahia Peninsula

4 July 2004

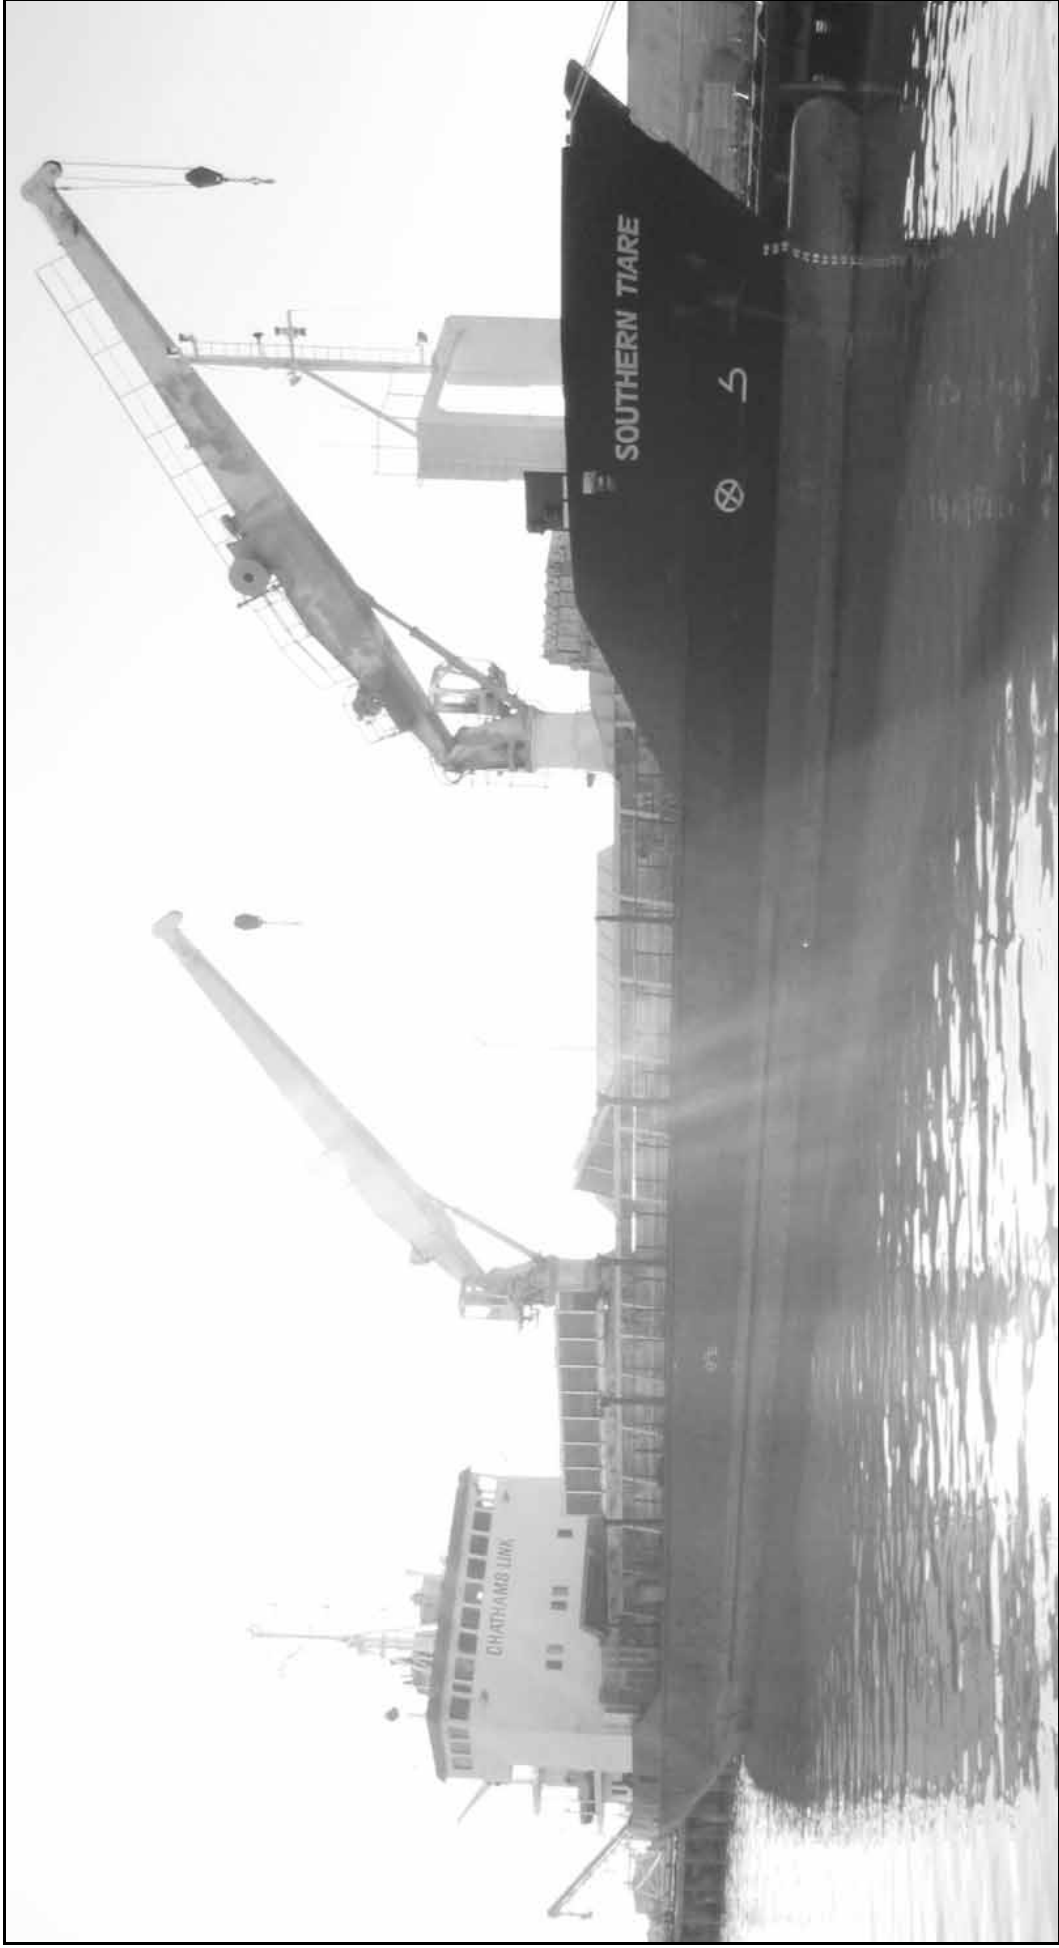
The *Southern Tiare* at Napier after the incident

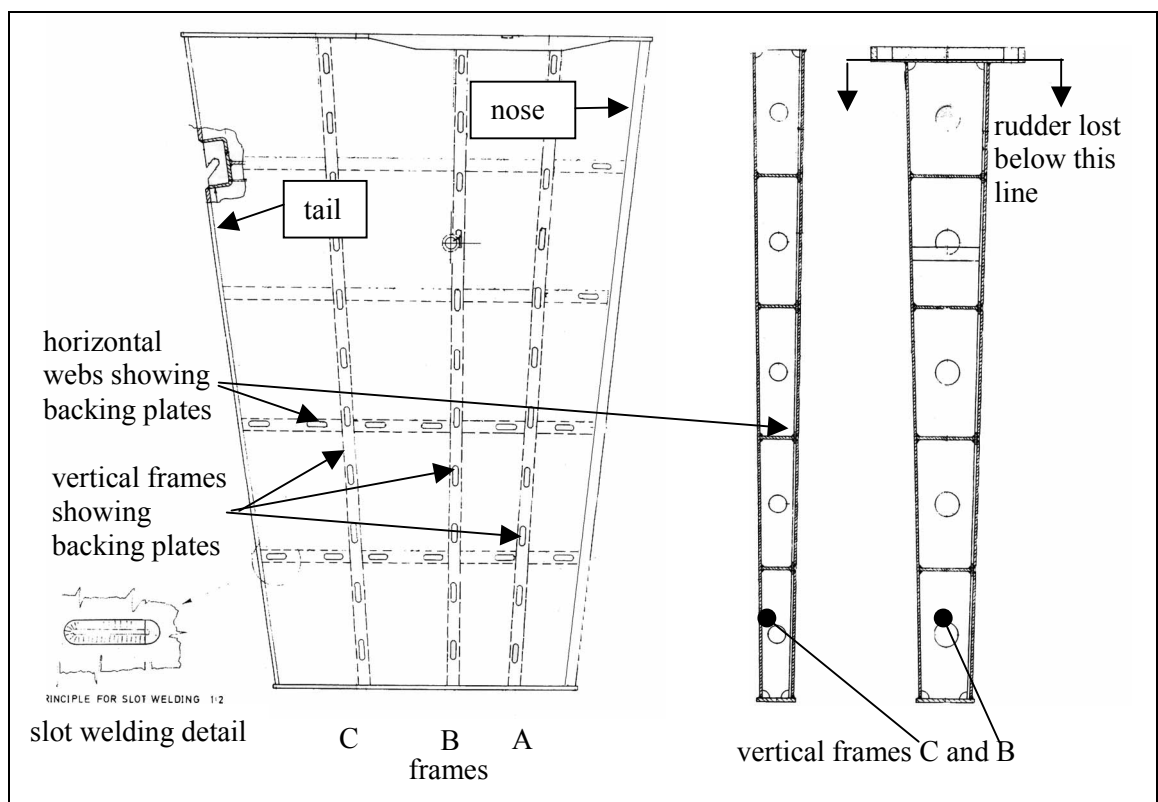
Figure 2
Diagram of rudder construction

- 1.2.4 The rudder was of welded construction, consisting of 3 vertical frames running between the top and bottom plates of the rudder, a hollow tube nose-piece and 4 horizontal transverse webs at equidistant intervals between the top and bottom plates. The skin on the port side of the rudder was welded directly to the top and bottom plates, the nose-piece, the vertical frames and horizontal webs. On the starboard side of the rudder, backing plates were fitted to the horizontal and vertical members before the starboard side skin was welded into place using slot welds on the horizontal and vertical members (see Figure 2). The rudderstock was of forged steel construction with the rudder palm welded onto the stock (see Figure 6).

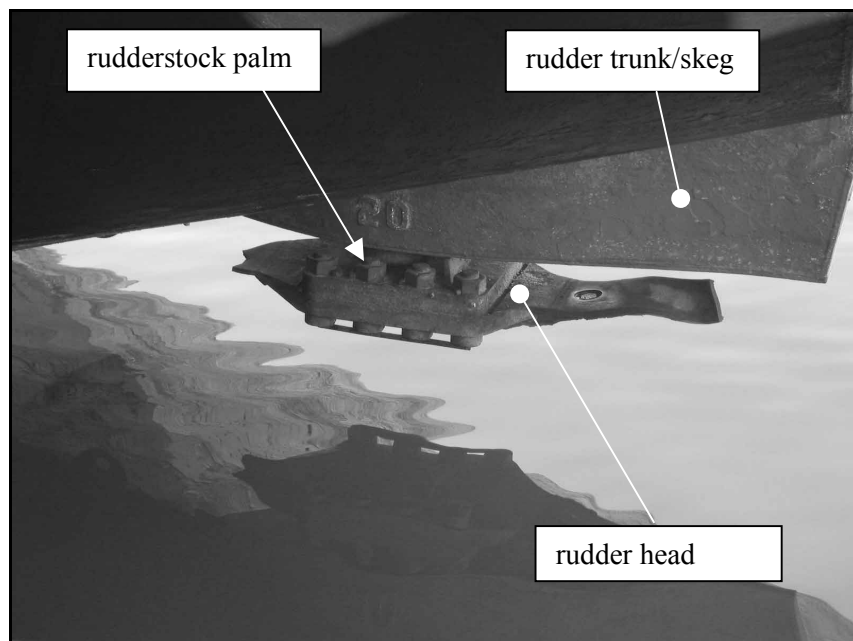
Figure 5
Remains of the rudder assembly in situ

1.5.1 The *Southern Tiare* lost the whole of the rudder below the rudder head, leaving the ship without any steering (see Figure 5).

1.5.2 Before the rudderstock and rudder head were removed, an underwater examination of the remaining rudder parts, propeller and adjacent ship's bottom was carried out. No damage to the propeller or surrounding ship's bottom was found.

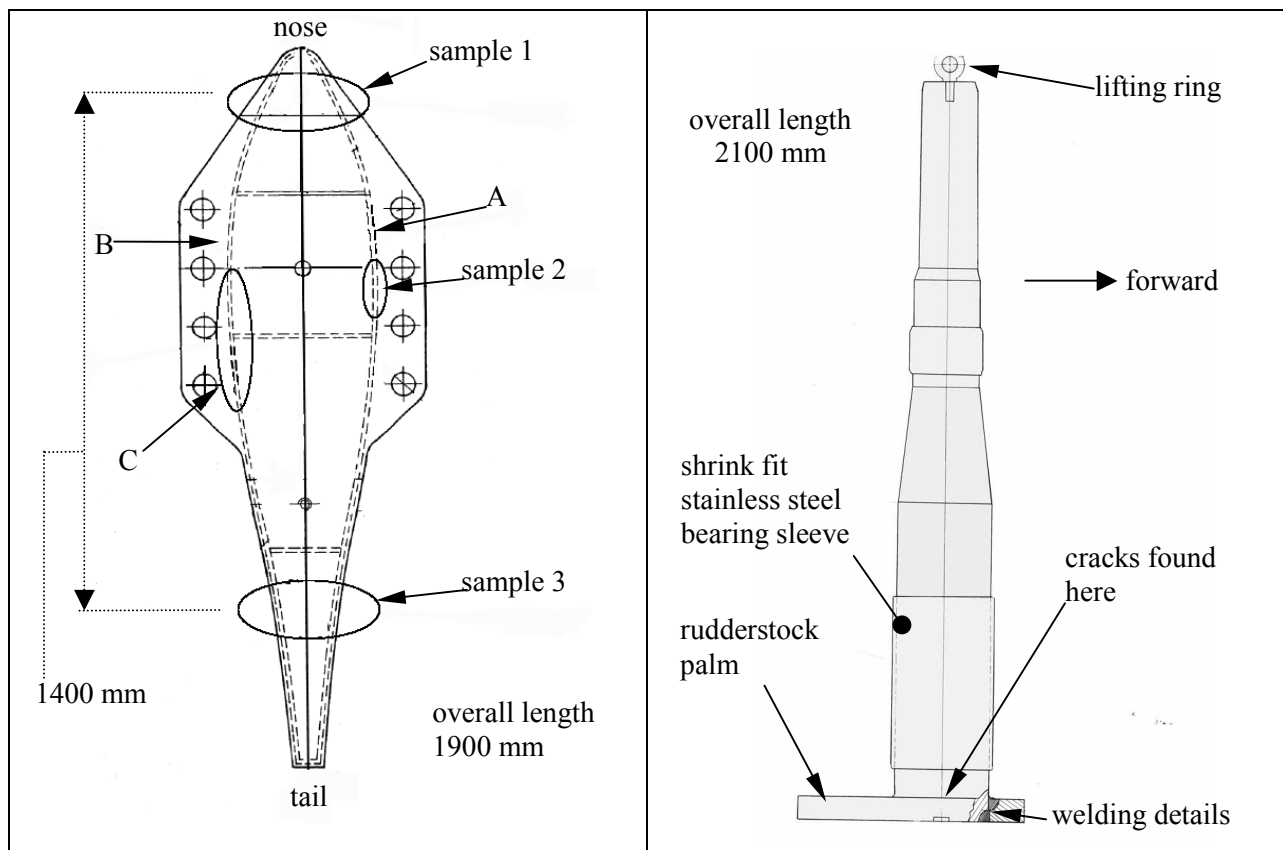
Figure 6
Plan of the rudder head and the rudderstock and palm

1.6.2 The rudderstock and rudder head were transported to a steel fabrication company in Auckland for further investigation and analysis prior to the fabrication of a new rudder blade. The rudder head and rudderstock were examined and an ultrasonic inspection of the crack at the junction of the rudderstock and rudderstock palm conducted. A metallurgist took samples from the rudder head for examination (see Figure 6).

1.6.3 The nose of the rudder head was bent downwards and showed signs of ductile tearing, indicating that it had detached at the time of the rudder blade failure. The tail of the rudder head also showed indications of deformation, including bending and twisting, with the fracture of the tail end showing indications of ductile rupture. Fractures in the welds over the remaining 1400 mm of the rudder head also showed indications of ductile tearing associated with plastic deformation at some locations along the fracture length, mostly near the tail. Growth of sea organisms was visible on what had been the inside of the rudder head.

- 1.6.4 The fracture along weld “A” (see Figure 6) appeared to be predominantly through the blade plate material near the toe of the weld. The fracture along weld “B” was observed to have occurred through the weld metal and at the weld to head connection. The fracture surface along weld “B” also contained a section of about 400 mm in length (Figure 6 “C”) that showed little remaining weld metal and little damage to the head.

- 1.6.5 A macro-section was prepared through the fracture section of sample 2 (see Figure 6). Examination of the macro-section indicated the presence of welds on both sides of the rudder skin. Examination of the fracture area indicated the presence of necking at the fracture surface, indicative of a ductile overload failure mechanism. Microscopic examination of the fracture surface showed grain elongation, further indicating a ductile overload mechanism. No indications of fatigue were observed.

- 1.6.6 A crack indication was visible over 80% of the circumference of the weld connection between the rudderstock and rudder palm. The fracture appeared to be through the weld connection at the change of profile. Ultrasonic testing through the shaft located the crack to a depth of 15 mm, while testing through the edge of the flange plate located the crack extending to a depth of 55 mm. The ultrasonic testing also detected significant lack of fusion, porosity and slag inclusion in the weld between the rudderstock and flange plate.

- 2.7 A significant portion of the fillet weld attaching the "B" side plate of the rudder blade to the head showed evidence of poor weld fusion and penetration, and a fracture surface ran through the remaining weld along the same line. These probably indicate poor weld quality because weld metal is usually stronger than the parent metal and a failure line could reasonably be expected to run through the parent metal rather than the weld.

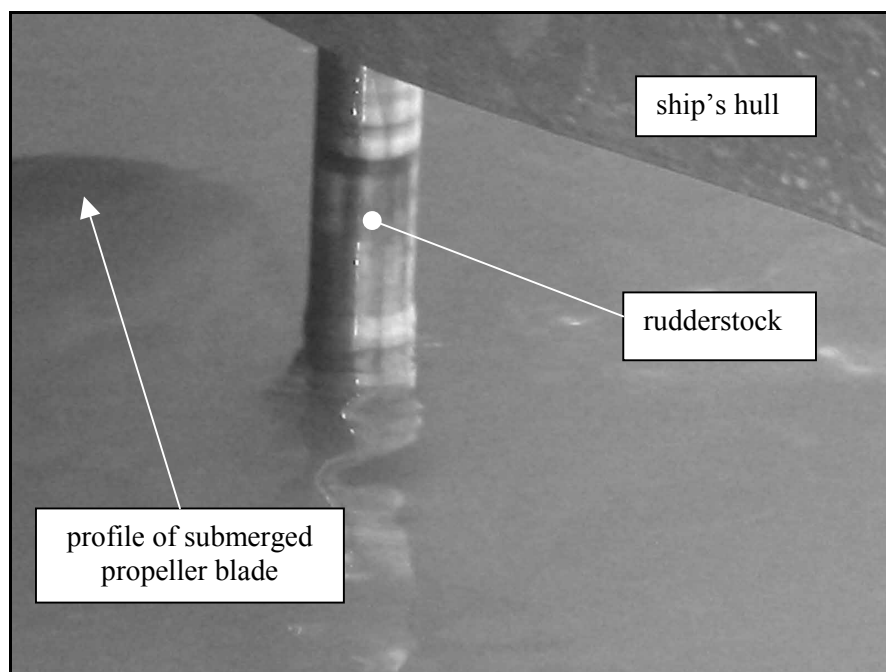
Figure 7

Rudderstock being lowered out of the *Southern Tiare* prior to repair. Note closeness of propeller blade to rudder

- 2.11 The underwater examination of the propeller and ship's bottom revealed no damage. The propeller was located close to the rudder and showed no indications of any damage so it is unlikely that a floating object hitting the rudder caused its failure.
