## MARINE OCCURRENCE REPORT

04-212 Fishing vessel *Iron Maiden*, foundering, off Pandora Bank, 16 August 2004  
Northland

### **Abstract**

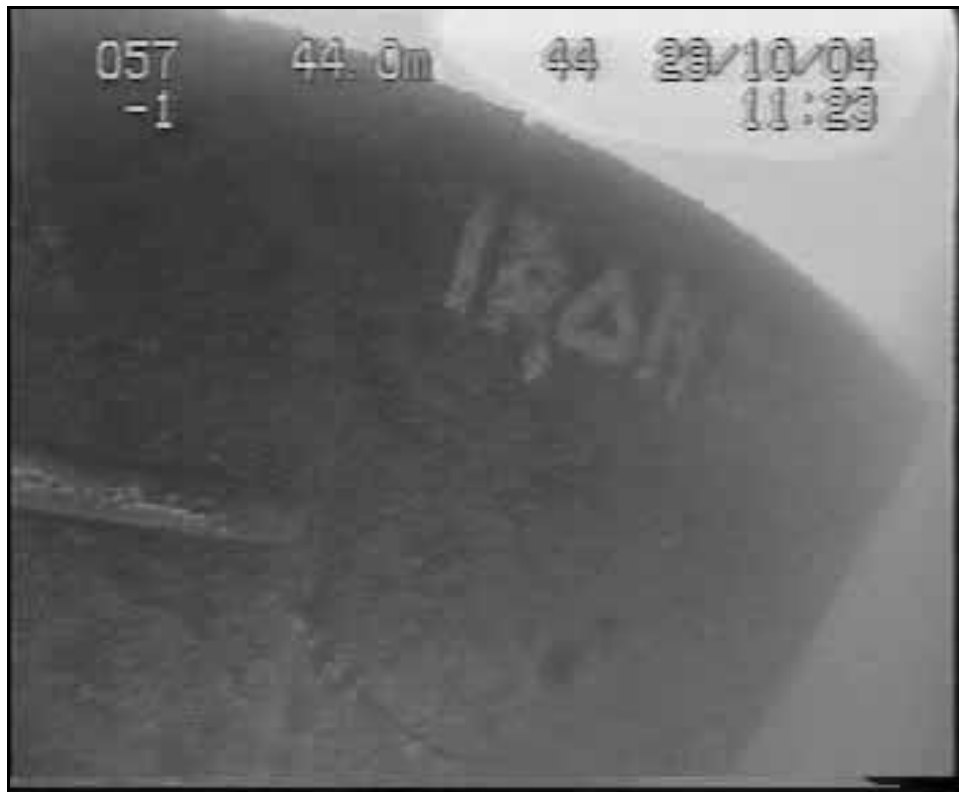
**Figure 5**  
**Bow of the wreck of the *Iron Maiden***

- 1.9.4 The boat was found in about 45 m of water, upright and sitting squarely on its keel. The hull was largely intact with few obvious signs of damage, except for the stern, which had been set in. The video footage revealed the following points:
- the stern was set in and the awning support damaged

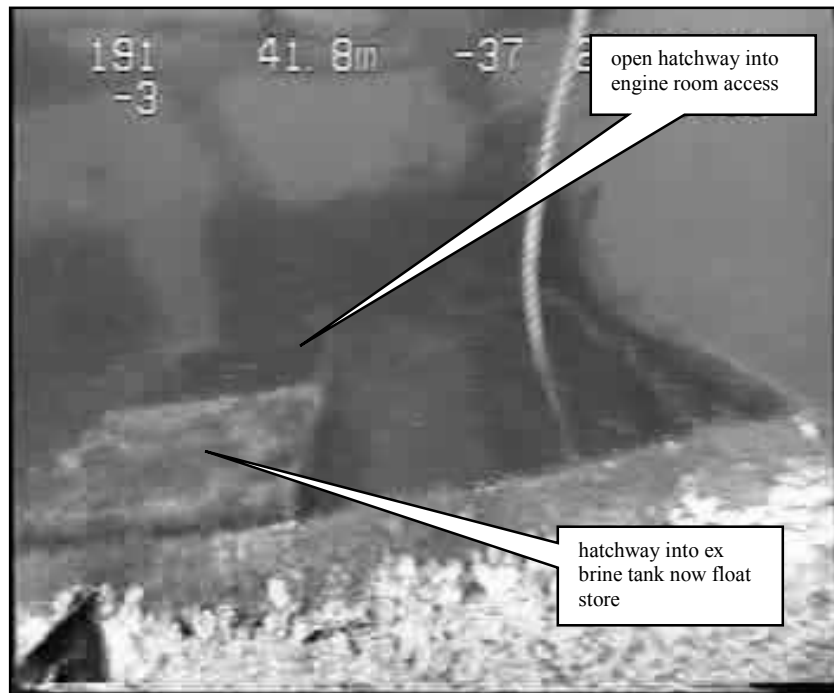
**Figure 7**  
**Afterdeck hatches**

- the engine room hatch lid was missing and the hatch open to the sea

- 2.1 The loss of the *Iron Maiden* appears to have resulted in it sinking stern first. This is supported by the only visible structural damage being at the stern of the boat, with the hull and awning framework in that area being set-in. Such damage would have required a considerable impact, which most likely occurred when the stern hit the sea bottom. Once the stern of the boat landed on the sea bottom, the tidal flow of up to 3 knots near the bottom would have been sufficient to topple the boat, on this occasion allowing it to land upright on its keel. The boat would have sunk stern first because the after end was the first to flood. It is probable that water entered the hatchway into the engine room access, flooding that compartment. The watertight door between the engine room access and the engine room was routinely secured in the open position and would allow free movement of water into the engine room.

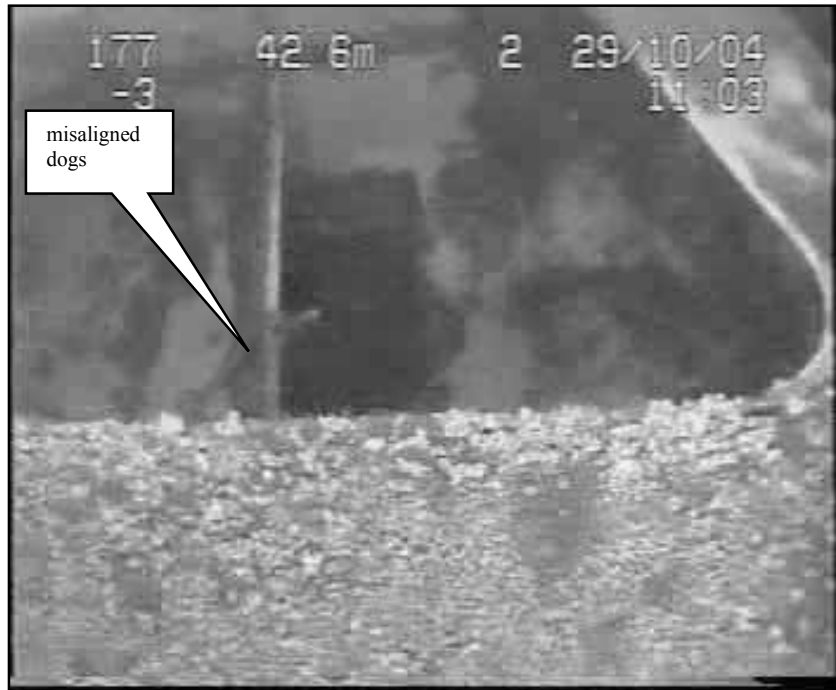
**Figure 8**  
**Port watertight door**

- the watertight door on the port side of the accommodation was open and the dog on its trailing edge looked to be misaligned

- 2.2 The glass in the starboard cabin window was most probably blown out by air pressure from within the boat as it sank. The watertight door on the port side appeared to have a misaligned dog on its trailing edge; this was possibly caused when the door was blown open or was an existing fault that allowed the air pressure to open that door while the starboard one directly opposite remained securely closed. It is unlikely that in those weather conditions the crew would have had that door open. It would be expected that the crew would have battened down the large fish hatch forward of the accommodation, but it showed no sign of the deformation that would be expected had it been blown open by the air pressure from the combined fish holds. The Navy ROV video did not show the securing clasps for that hatch and it may be that these failed. The immediate past skipper did say that he had left the hatch ajar to ventilate the hold and so some doubt as to whether the hatch was securely fastened exists. The condition of the hatches and doors when the boat left Mangonui could not be determined.

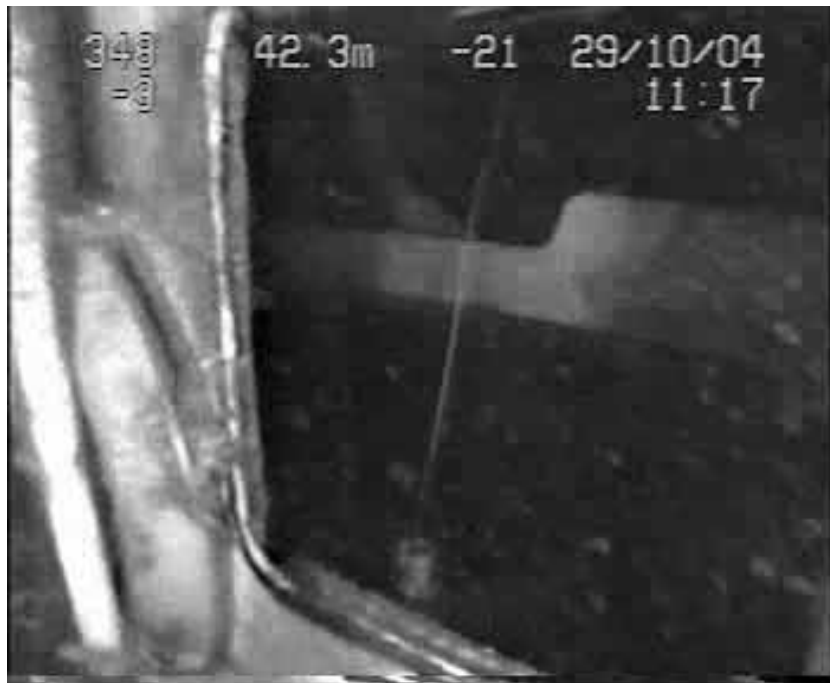
- the window for the cabin on the starboard forward side was missing

**Figure 9**  
**Cabin window, starboard side (note bunk visible)**

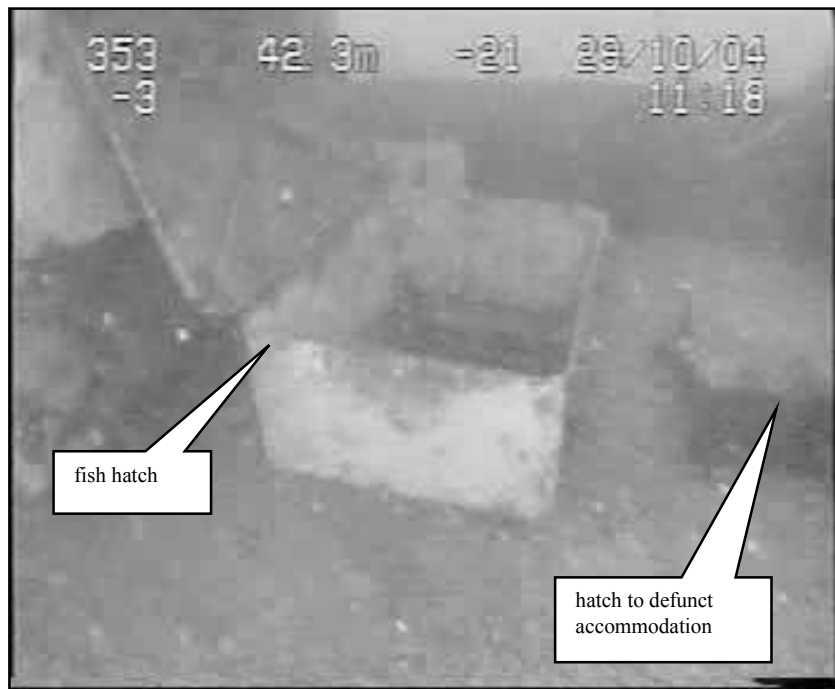
**Figure 10**  
**Foredeck hatches**

- the fish hatch immediately in front of the accommodation was open and laying back against the bridge front. There was no visible distortion to the hatch lid and the securing catches for this hatch were not visible

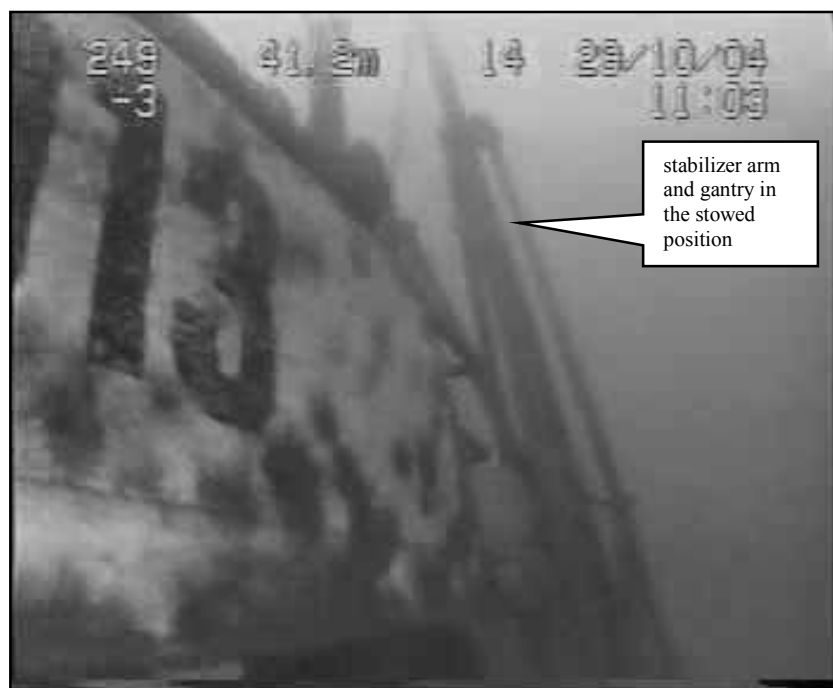
- the hatch to the old accommodation area forward of the fish hold was in place and securely dogged
- the stabiliser arm gantry was in the stowed position, with the arm hanging vertically down the side of the boat

**Figure 11**  
**Port side showing the stabiliser arm**

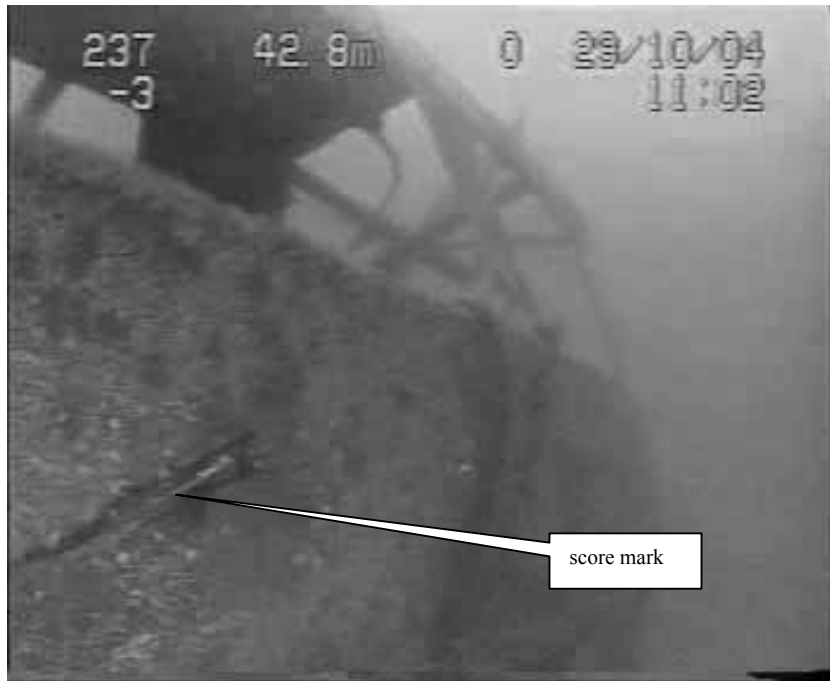
**Figure 12**  
**Port hull**

- there was an arced score mark on the hull where the foot of the stabiliser arm had rubbed

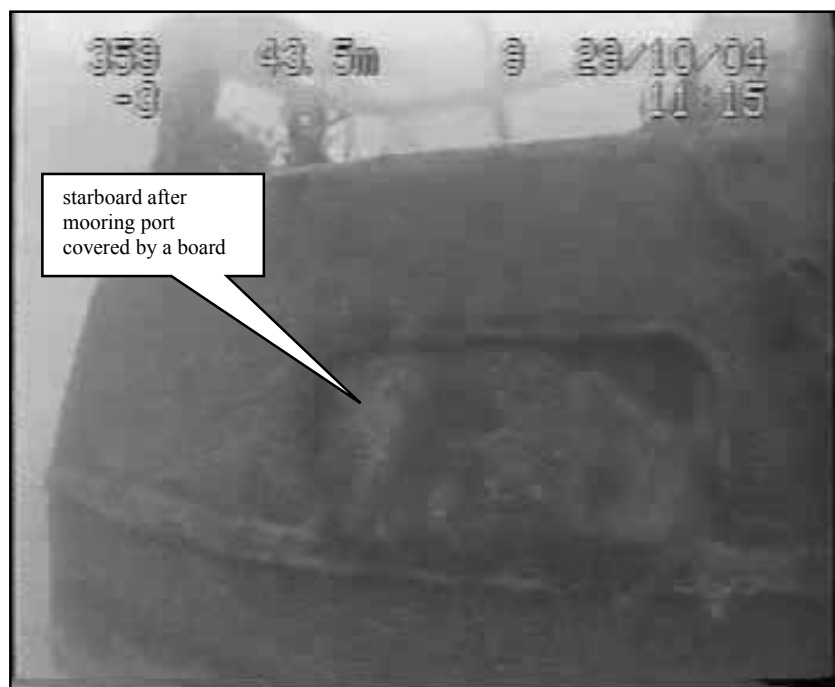
**Figure 13**  
**Starboard after mooring port**

- boards were fixed across the after mooring ports on the port and starboard quarters, thus preventing the free flow of water onto and off the afterdeck

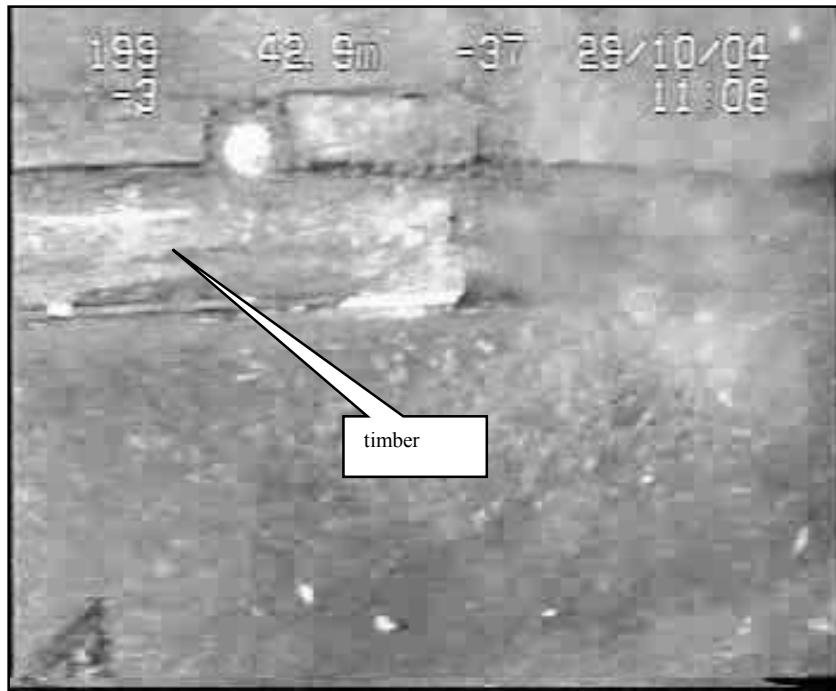
**Figure 14**  
**Scupper between bulwark and sheer strake**

- except across the transom, the scuppers between the bulwark and the sheer strake had been blocked by lengths of timber, further restricting the flow of water onto and off the deck

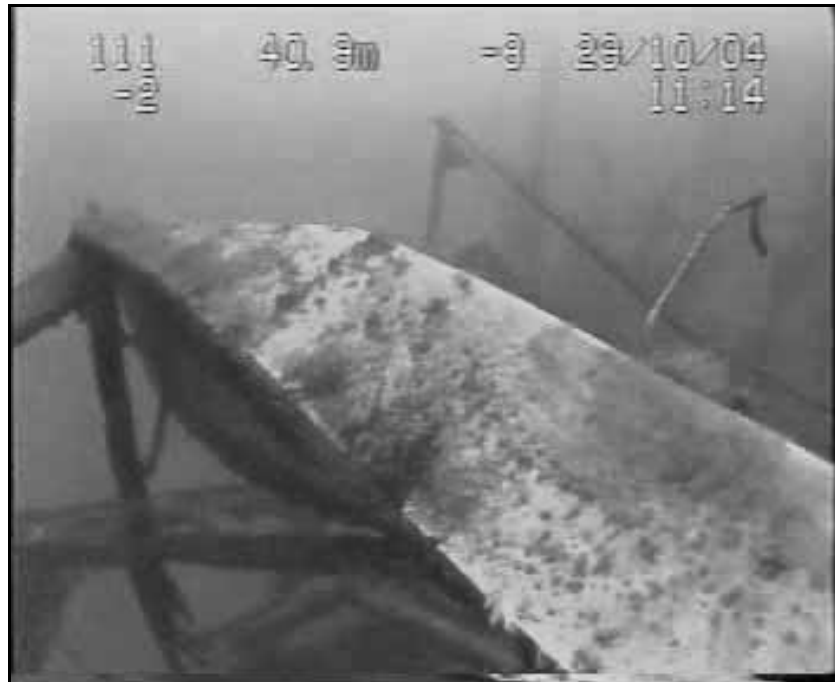
**Figure 15**  
**Damaged awning structure**

- the sea door in the after starboard bulwark was missing
- the sea door in the port transom bulwark was askew but still attached
- the awning framework that covered the afterdeck was set forward and severely bent

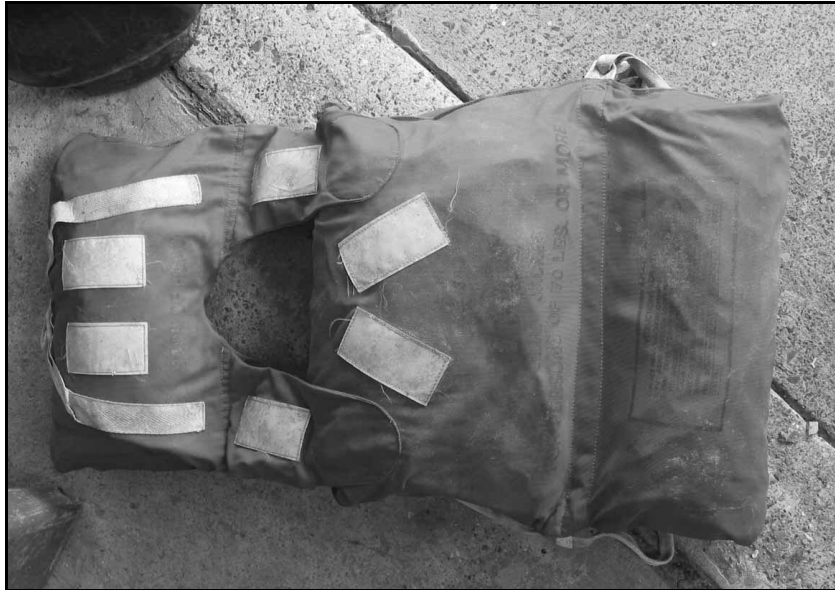
**Figure 16**  
**Lifejacket found on Twilight Beach**

- a lifejacket, of the same type worn by the skipper

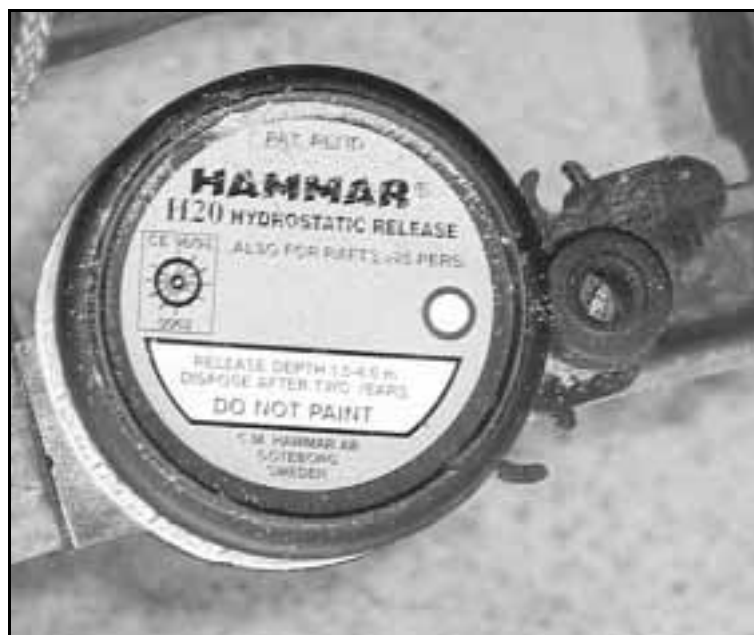
**Figure 17**  
**Hydrostatic release found on Twilight Beach**

- an activated Hammer H20 hydrostatic release

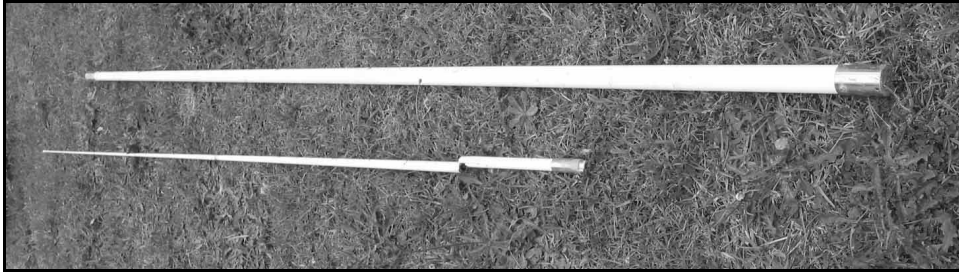
**Figure 18**  
**Two pieces of a whip aerial**

- a large whip aerial in 2 pieces
