MARINE OCCURRENCE REPORT

04-213

Restricted limits passenger ferry *Superflyte*, engine room fire,
Motuihe Channel, Hauraki Gulf

22 August 2004

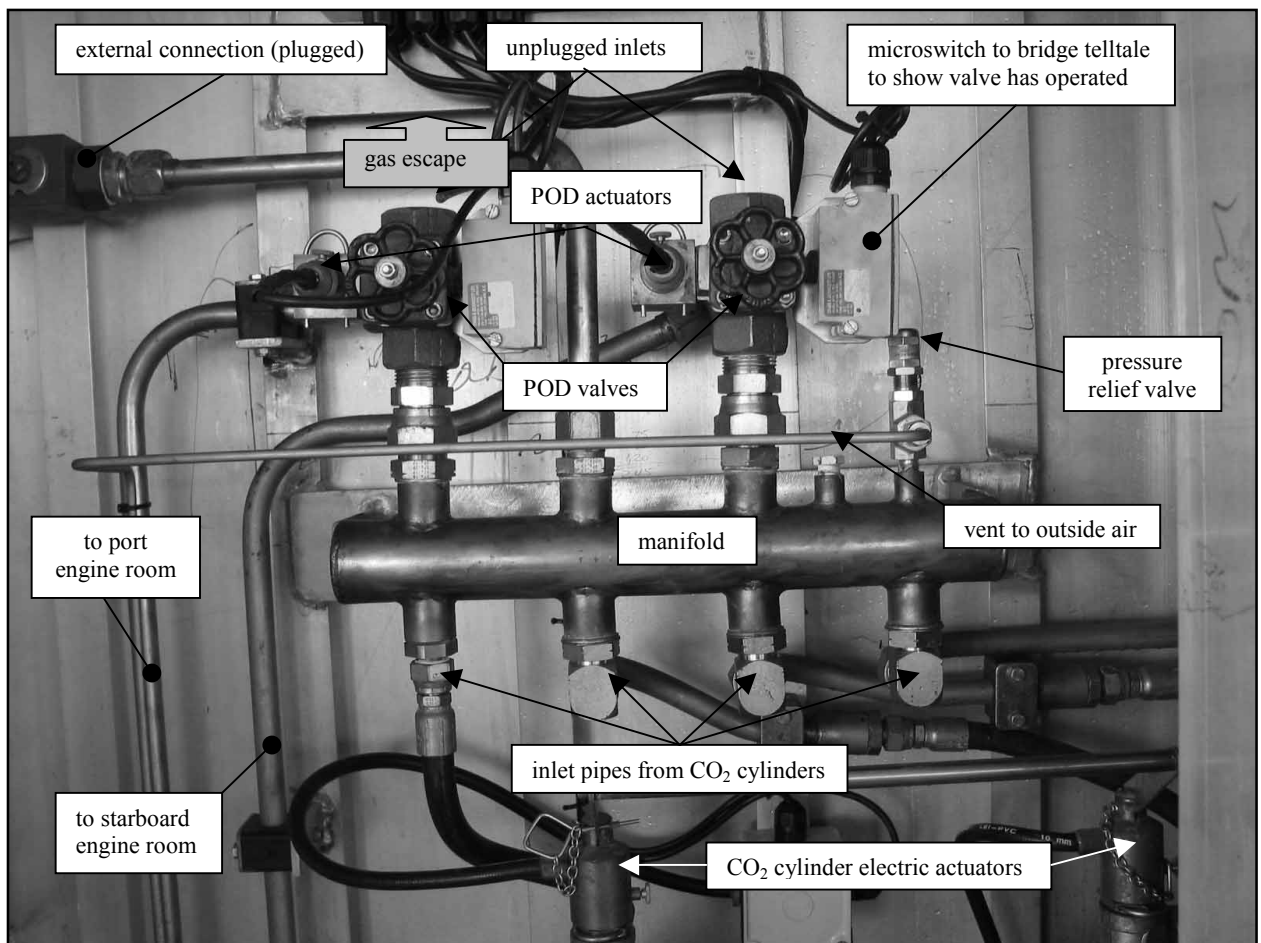
Figure 3
CO₂ manifold, connection pipes and POD valves

This allowed the CO₂ gas to pass from the cylinders through the connection manifold, operate the required POD by its own pressure and discharge into the engine room (see Figure 3).

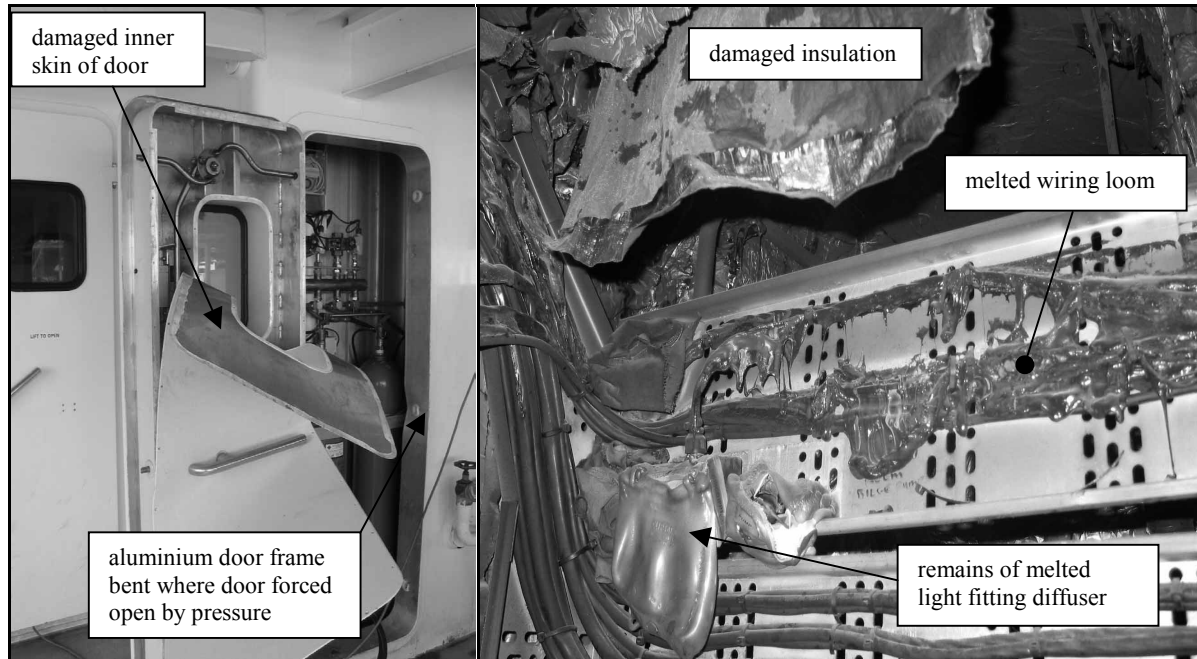
Figure 5
Damage sustained to CO₂ room door on left and in engine room on right

- 1.5.1 The port engine room sustained extensive damage to all electrical equipment and wiring contained within it (see Figure 5). Insulation on the deckhead of the engine room was extensively damaged, and an aluminium girder supporting the air intakes melted, indicating a temperature in excess of 660° C (see Figure 6).

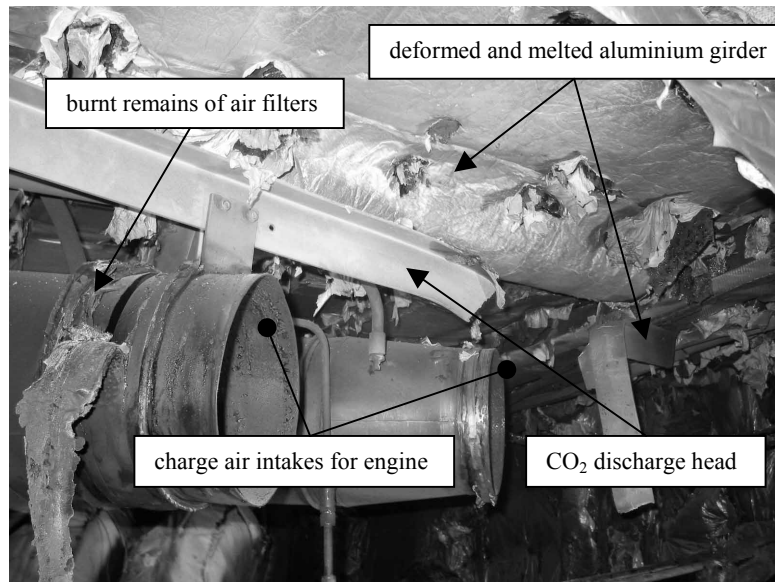
Figure 6

Damage to engine room deckhead showing melted aluminium girder and air intakes

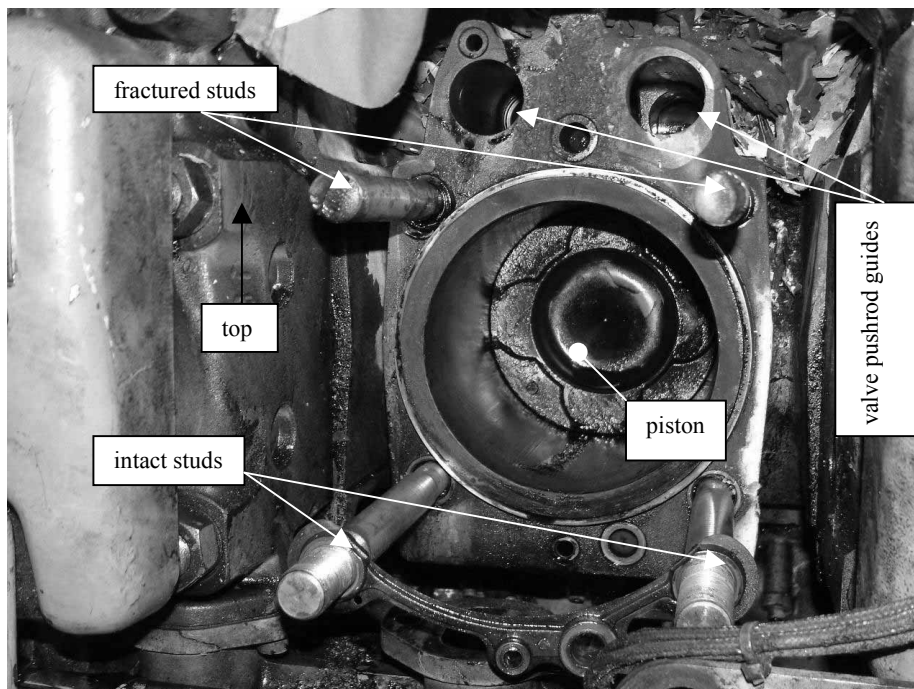
Figure 7

- 1.5.2 Two cylinder head studs on cylinder B6 of the port engine failed, requiring all 4 cylinder head studs on this cylinder to be renewed. The forces generated by the loose cylinder head lifting on the compression and firing strokes caused the air inlet manifold to crack, and the bellow joints in the exhaust manifold for that cylinder to crack. During the fire, the air intake filters near the top of the engine ignited, possibly while the engine was still running. The engine had to be completely stripped down to ensure no foreign or burnt matter had been ingested (see Figure 7).

No. 6B cylinder with the head removed showing fractured studs

- 3.3 Crew fatigue was not considered to be an issue in this occurrence.
- 3.4 The fire was caused by the fracture of 2 cylinder head studs on cylinder B6 of the port engine allowing a flow of hot lubricating oil, combustion gases and unburnt fuel to escape from the cylinder and on to the hot exhaust manifold.

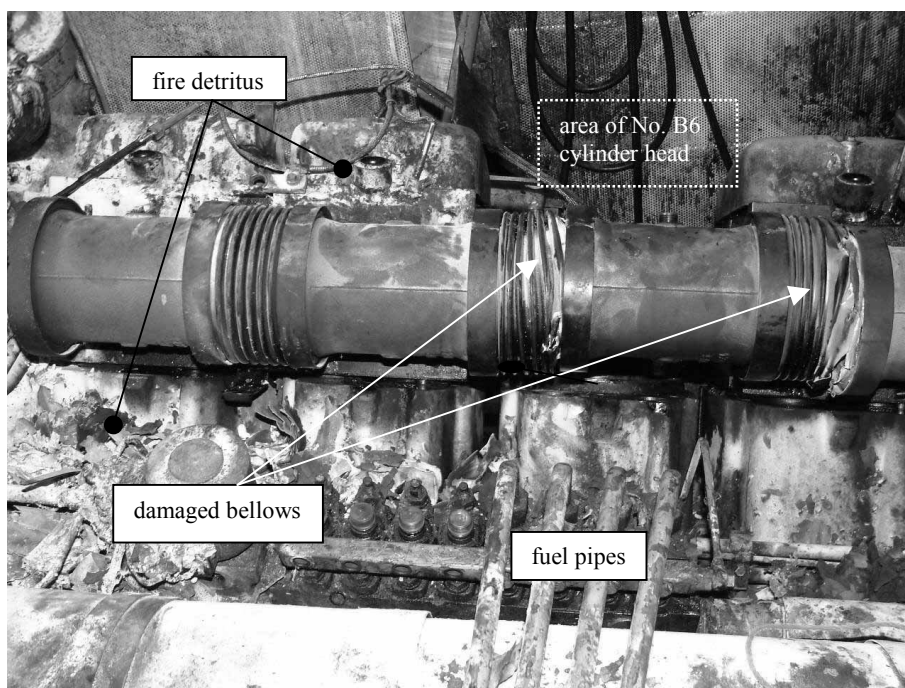
- 1.6.4 The fracture of the 2 top cylinder head studs on cylinder B6 allowed exhaust gases, possibly some unburnt fuel from the cylinder, and lubricating oil from the feed from the crankcase to the cylinder head to spray up under the shroud over the exhaust manifold.

Figure 8
Damaged exhaust manifold with shrouding removed

- 2.3 When the cylinder head studs fractured, combustion gasses, unburnt fuel and lubricating oil would have sprayed over the exhaust manifold out of the failed joint between the cylinder head and block. Fire resulted because the temperature of the exhaust manifold was above the auto ignition temperature of the fuel and lubricating oil.

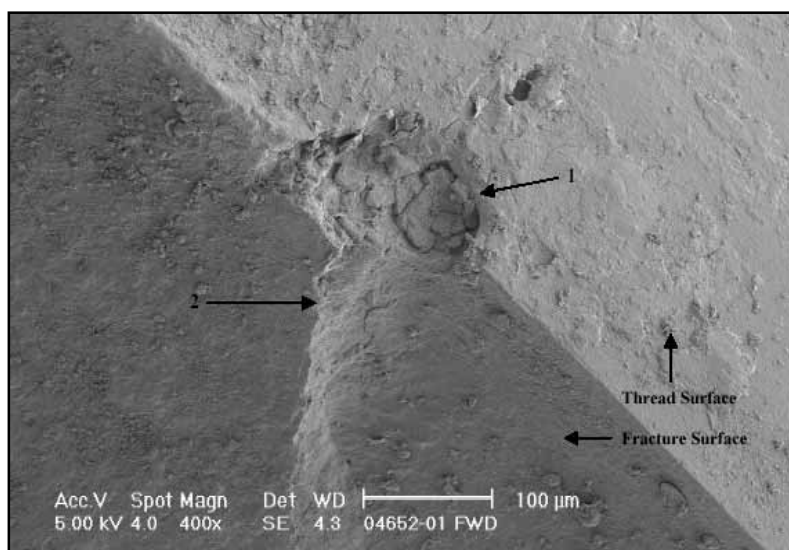
Figure 9

1.6.9 The 2 fractured cylinder head studs were sent for further examination and analysis. Preliminary examination of the forward stud indicated that the fracture was a result of unilateral bending fatigue cracking, initiated in the base of the stud thread. The fatigue cracking appeared to be low cycle and had propagated over 80% to 90% of the fracture surface. Final failure from bending overload had resulted in a shear lip. Microscopic examination indicated cracking had probably initiated at corrosion damage, pitting, occurring at the base of the thread.

An SEM micrograph of pitting on thread surface [1] associated with ratchet mark [2] on forward stud

- 1.6.12 The fractured surfaces of the failed stud ends were prepared and examined under a scanning electron microscope (SEM) (see Figures 9 and 10). This examination indicated the presence of some localised corrosion on both stud thread surfaces adjacent to the thread surfaces. Corrosion on the thread of the forward stud was more prevalent than on the after stud. One ratchet mark on the forward stud surface was observed to have an associated micro-pit.

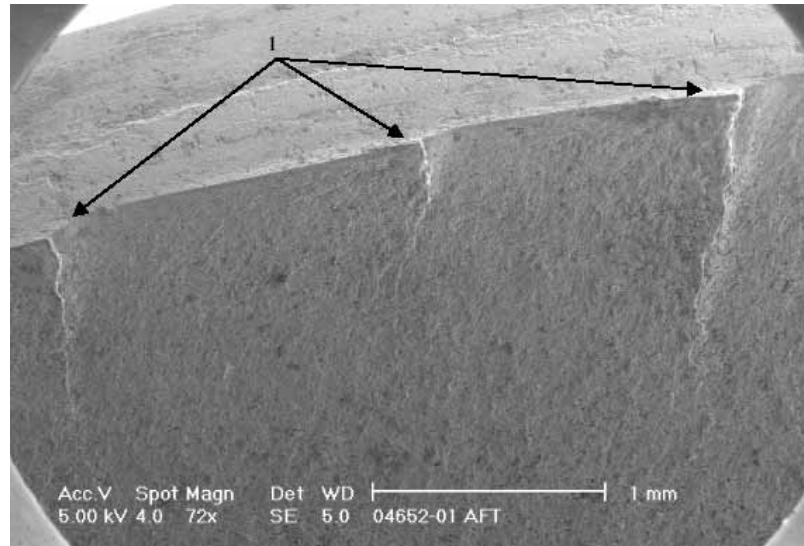
The metallurgist stated that microscopic examination indicated the fatigue crack may have initiated at corrosion damage, but indications of corrosion were not as distinctive as observed on the forward stud.

An SEM micrograph of the after stud fracture surface with 3 consecutive ratchet marks [1] with no significant micro-pitting observed
