## MARINE OCCURRENCE REPORT

04-214

passenger freight ferry *Aratere*, loss of mode awareness  
leading to near grounding, Tory Channel

29 September 2004

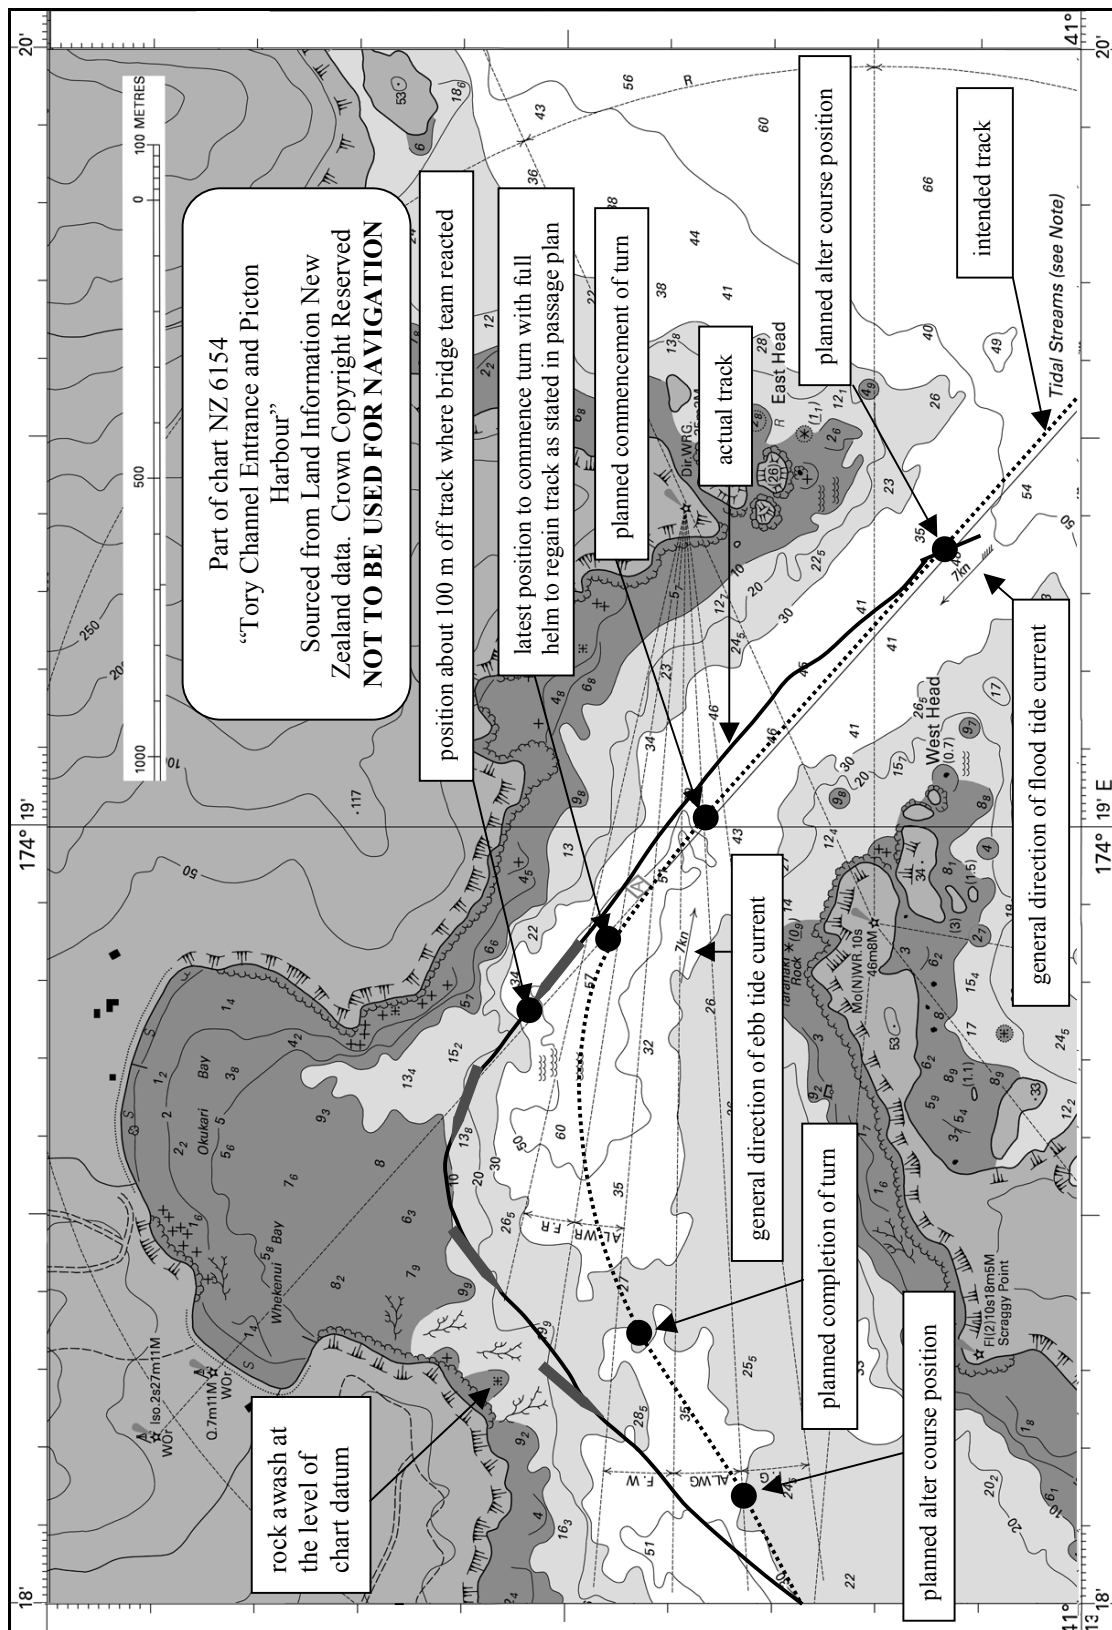
**Figure 2**  
 Plan showing the actual versus intended track of the *Aratere*

- 1.1.10 The *Aratere* reacted to the helm and swung rapidly to port. The master brought the ship around to a course of about 230° before steadying it up on the track as plotted on the DB2000. However, the ship came within about 100 m of a rock awash at chart datum and was close to grounding (see Figure 2).

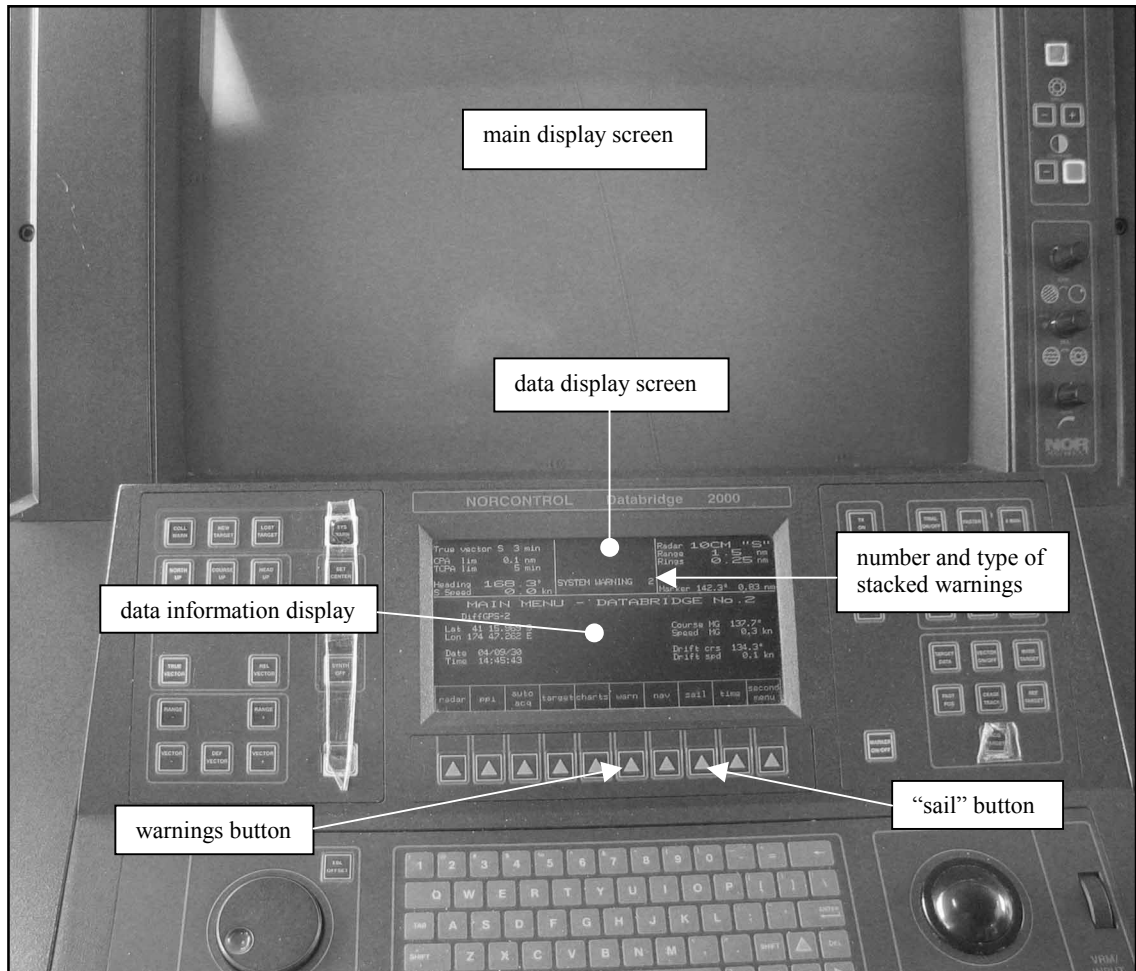
**Figure 5**  
**Radar and data screen of the DB2000**

- 1.3.12 Each DB2000 also had a data screen below the main radar screen (see Figure 5) used to display relevant information concerning the: ARPA radar; ship's position, course and speed; and radar, operational and system warnings. The system warnings became stacked, with the display showing the number of warnings stacked (see Figure 5). These warnings could be viewed by pressing each warning button below the display. This action cycled through the warnings, displaying the warning and cancelling it. Although each radar operated independently and received its signals from separate scanners, the data screen displayed information relevant to the

radar above it and the combined operational and system warnings. Cancelling an operational or system warning on one DB2000 also cancelled the warning on the second DB2000.

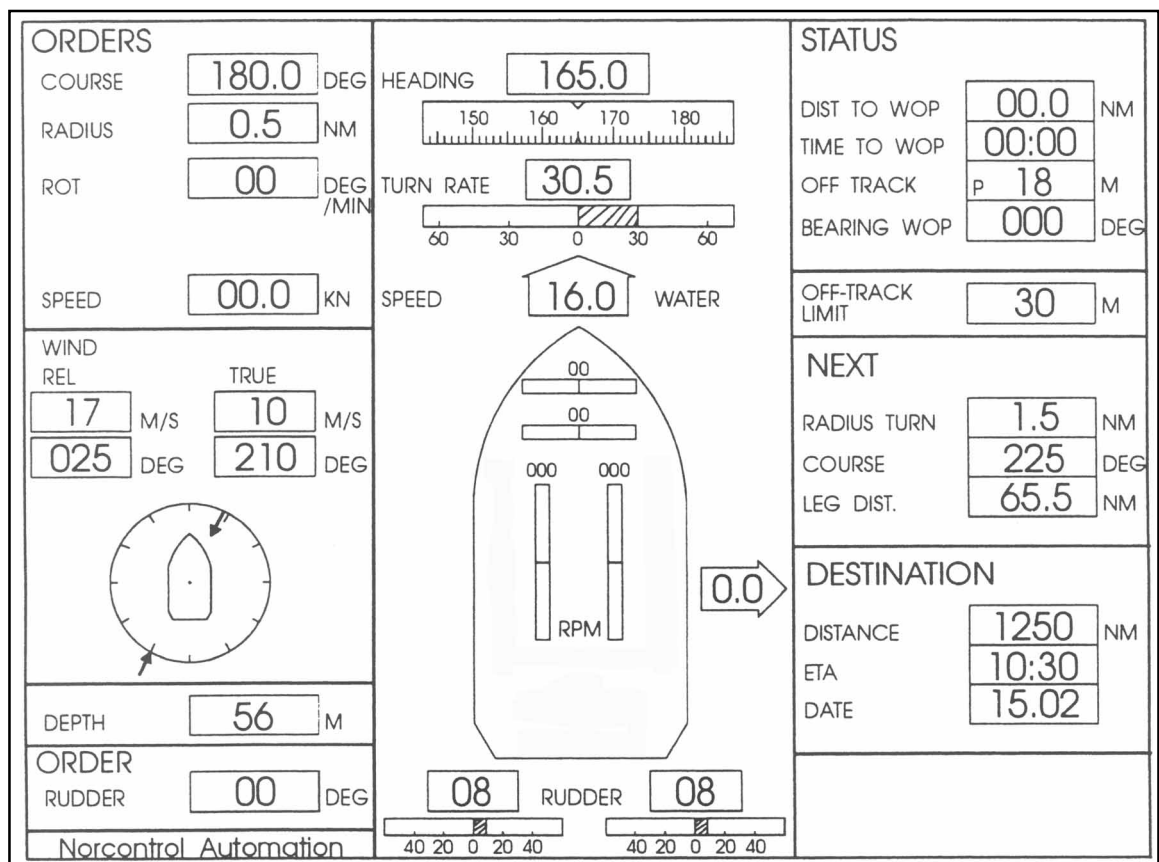
**Figure 6**  
**Layout of a conning display screen**

- heading
- rate of turn
- speed
- engine settings
- rudder settings
- bow thruster settings
- wind direction and speed
- depth of water
- waypoint and course information
- off-track limits and distance off track
- course and rudder orders
- mode of operation in differing colours dependent upon mode:
  - manual steering mode, text colour blue-green
  - automatic steering mode, text colour blue
  - ANTS steering mode, text colour yellow.
