MARINE OCCURRENCE REPORT

04-219

restricted limit passenger vessel *Tiger 111*, grounding, Cape Brett

18 December 2004

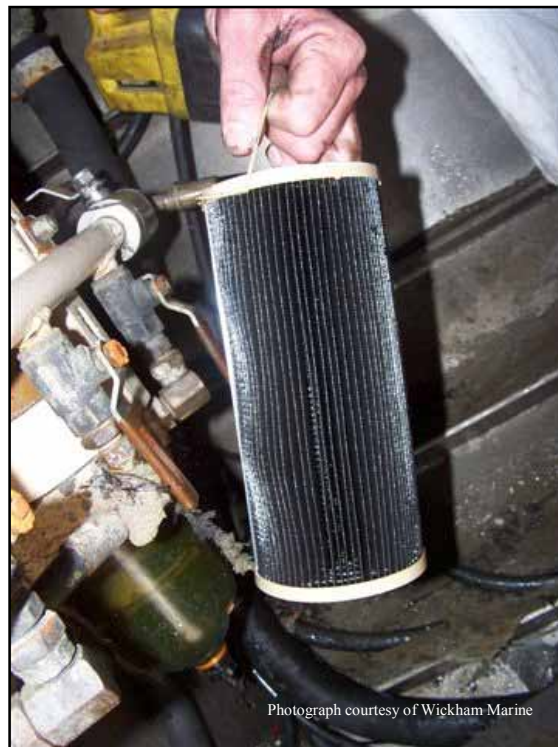
Figure 4
Filter cartridge from the port inboard Racor primary fuel filter

1.3.5 The debris found in the port inboard Racor filter was analysed in February 2005 and found to be a combination of aluminium particles, paint particles and ferrous material. The sample also showed diesel bug infection and the slime associated with it. The filter cartridge was saturated by seawater (see Figure 4).

- 1.3.16 When recovered, the primary Racor filter cartridge was withdrawn and the contents of the filter were sent for examination. The filter cartridge was found to be saturated by dirty seawater, but did not appear to be clogged by solid matter as would be expected had the filter been blocked before the fuel tank was ruptured. Solid particulate debris, mainly paint and aluminium, was found on the filter cartridge. The cartridge showed signs of collapse inward, consistent with the filter being totally blocked and the engine trying to draw fuel through it.

- 2.17 The aluminium particles and paint particles found in the port inboard Racor filter matched the material of the hull, and were consistent with the tearing of the hull during the grounding. The ferrous material was likely to be the waste from grinding discs used to prepare the paintwork having impregnated the paint. This shows that the auxiliary alternator was still running and drawing fuel after the grounding.

- 2.18 There had been no prior incidence of microbiological contamination in the fuel of the *Tiger III*. The contamination found was restricted to the port inboard Racor filter, with no growth found in the port fuel tank as would be expected if contamination were present throughout the fuel system. Therefore, it was probable that the microbiological organisms grew during the period between the grounding and the wreckage being recovered and the contamination did not contribute to the accident.

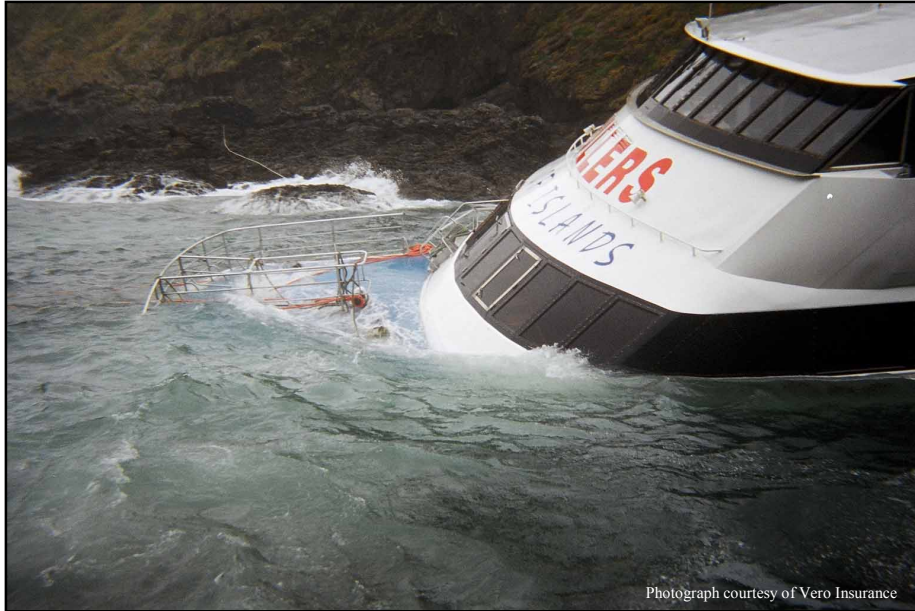
Figure 5
The *Tiger III* at high water some days after the grounding

- 1.7.1 An attempt to salvage the vessel was made in the days following the grounding. However, the weather conditions were such that by the time salvage vessels and equipment arrived at Cape Brett, both hulls of the *Tiger III* were so damaged that there was insufficient buoyancy to float the whole boat off the rocks on which it had become impaled (see Figure 5). On Wednesday 22 December 2005 the *Tiger III* was declared a constructive total loss.

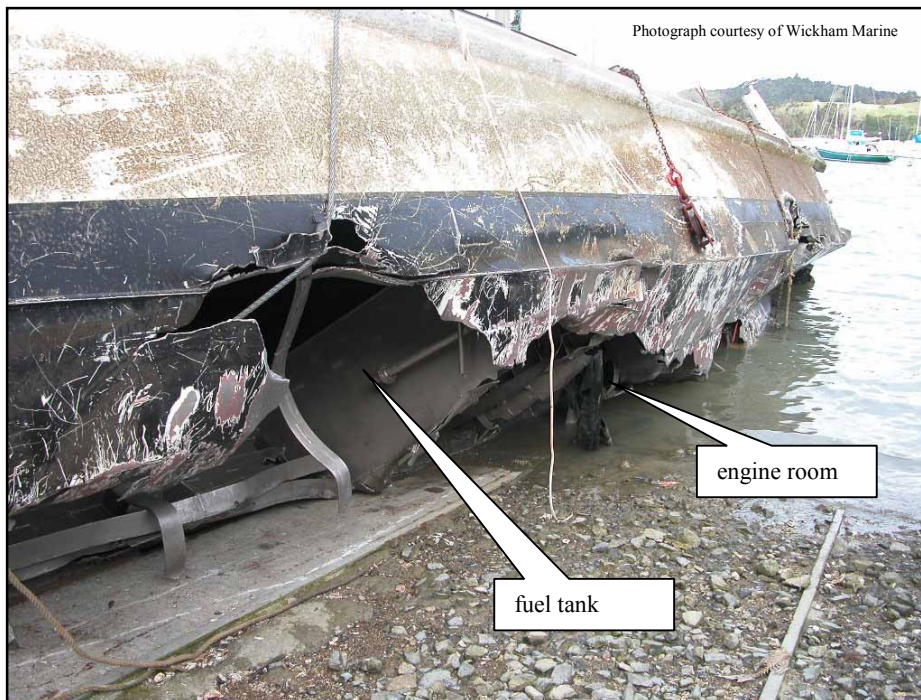
Figure 6
Port hull of the *Tiger III* being dragged up the slipway at Opua

- 1.7.3 Each hull was recovered in one piece. During the month that the boat had sat on the rocks, the port hull had been pounded, with virtually the entire lower part of the hull missing or crumpled (see Figure 6). The hull had been completely submerged at high tide; consequently when recovered, all the equipment that was not watertight was filled with, or saturated by, seawater.

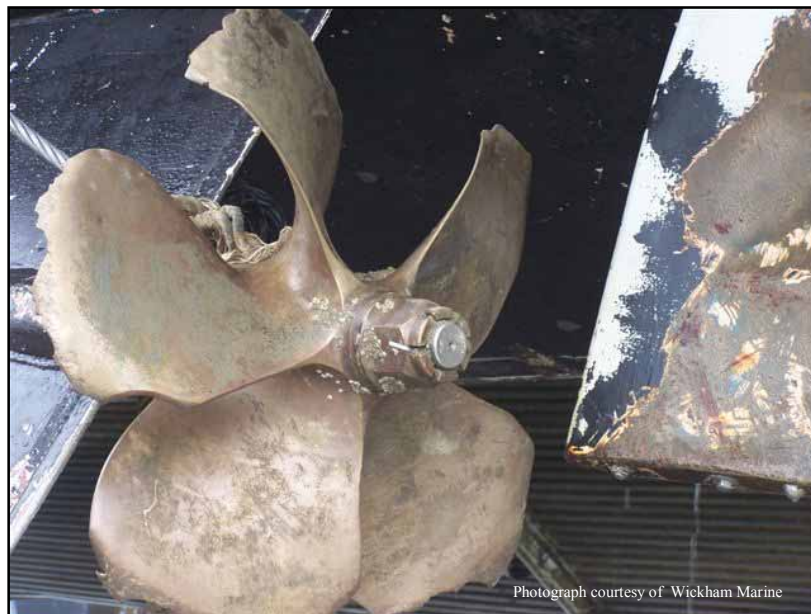
Figure 7
The port propeller showing severe damage to every blade

- 1.7.4 The propellers were extensively damaged, with the port one showing the greatest mutilation (see Figure 7). The tips of all 5 blades of the port propeller were bent over with many scallops out of them. The greatest damage was to the trailing edges, those on the back of each blade when going ahead, which were bent forward.

- 1.7.5 Photographs of the port propeller were sent to 3 propeller experts and 2 marine engineers for their opinions on the damage to the propeller. In each case the respondent opined that the propeller was rotating under power at the time of the grounding.

- 2.15 The condition of both propellers, but more particularly the port one, indicated that it was still turning under engine power at the time that it struck the rocks. In actual fact, the blades being bent forward and the trailing edges showing more damage indicated that the propeller was driving astern and the boat was moving astern at the time of impact. Given the distances and the times involved, it was probable that the vessel had already grounded and the port engine stalled prior to the Master putting the control into neutral and trying to restart the engine.

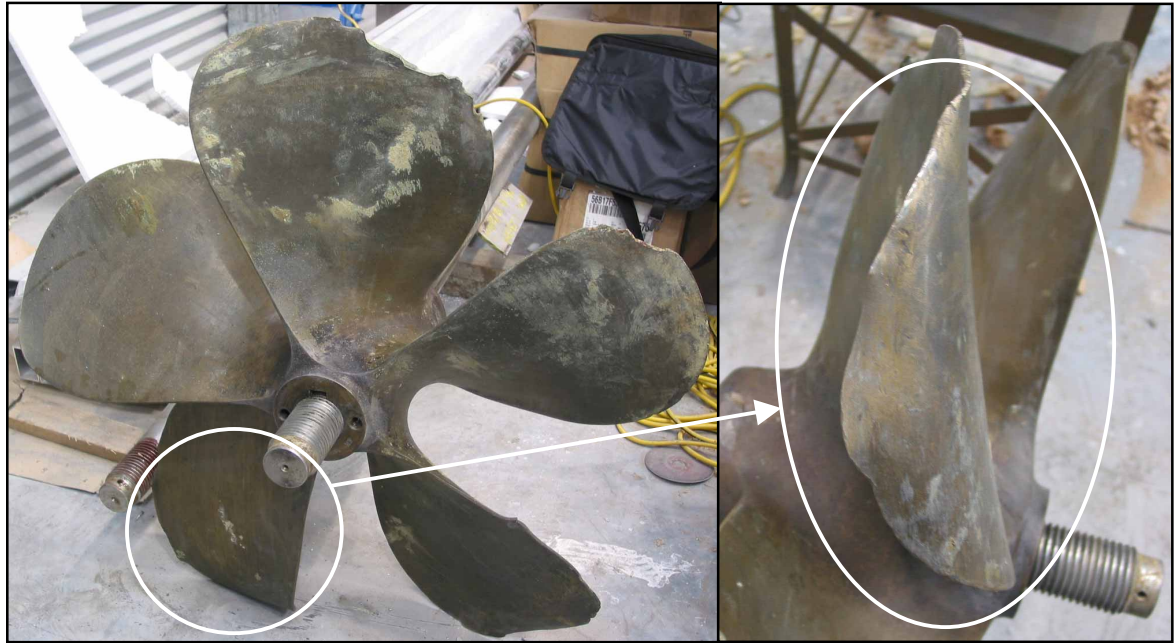
Figure 8
Starboard propeller showing one blade that had been bent forward

- 1.7.6 The starboard propeller had impact marks on all the blades, but only one blade was badly bent forward (see Figure 8).
- 1.7.7 After the *Tiger III* was tied up alongside the rocks in the gut, and all the passengers had been evacuated, the Master tried to start the port engine locally in the engine room. At this time water had flooded the engine room to just below the bottom of the gearbox and engine. The engine failed to turn over, even though the starter motor sounded as if it was trying to turn the engine. He then went to the starboard engine room and managed to start that engine, and off it ran the emergency bilge pump to suck water from the port engine room. The pump had insufficient capacity to prevent the progressive flooding of the port engine room.
