AVIATION OCCURRENCE REPORT

05-001

Gulfstream G-IV ZK-KFB and Piper PA 28 ZK-FTR , loss of separation, near Taupo

7 January 2005

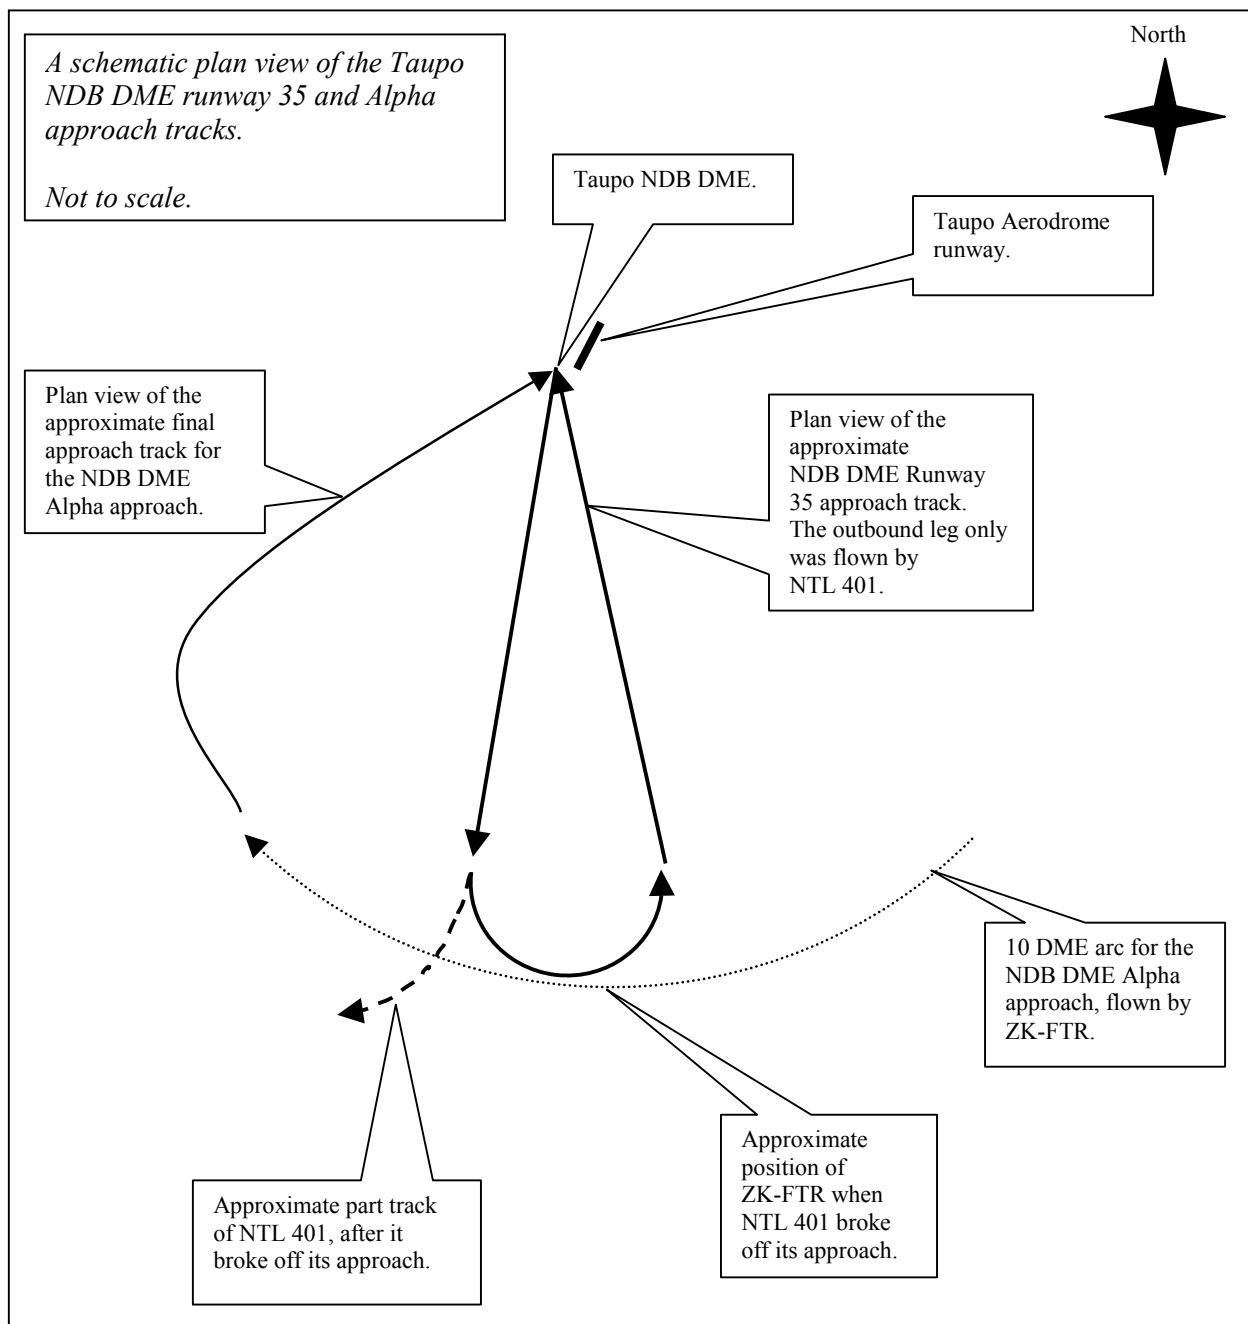
Figure 1
Plan view depiction of the approximate part approach tracks flown by each aeroplane

- 1.1.4 After take-off NTL 401 was cleared by the ATC controller to 11 000 feet, also on the direct Napier to Taupo track.
- 1.1.5 After ZK-FTR had reached its cruising altitude, the pilot advised the controller that he intended to do an NDB (non-directional beacon) DME (distance measuring equipment) Alpha arc approach at Taupo (see Figure 1).

- 1.1.14 ZK-FTR descended and joined the arc at 6900 feet. About 2 minutes after the co-pilot had broadcast that NTL 401 had finished its reversal turn, the pilot of ZK-FTR also broadcast on the local Taupo Aerodrome frequency that he was on the arc for the NDB DME Alpha approach and passing 6200 feet. The published procedure for the approach required aircraft to fly the 10 DME arc from Taupo no lower than 4900 feet on the first sector until passing relative bearing 010°, and then no lower than 4000 feet on the second sector until established inbound.

2.3 Had the crew of NTL 401 continued to follow the published approach procedure, NTL 401 would have turned left and, at 10 DME, both aeroplanes would have been flying toward each other at similar altitudes, until NTL 401 had completed its base turn. The radar data plot showed that had this occurred, ZK-FTR would have passed under NTL 401, having descended through its altitude. In this situation, the crew of NTL 401 probably would have received a TCAS “resolution advisory”, and taken avoiding action by following the aeroplane flight director commands.
