AVIATION OCCURRENCE REPORT

05-007

Piper PA34-200T Seneca II, ZK-MSL, Wheels-up landing,
Napier Aerodrome

7 July 2005

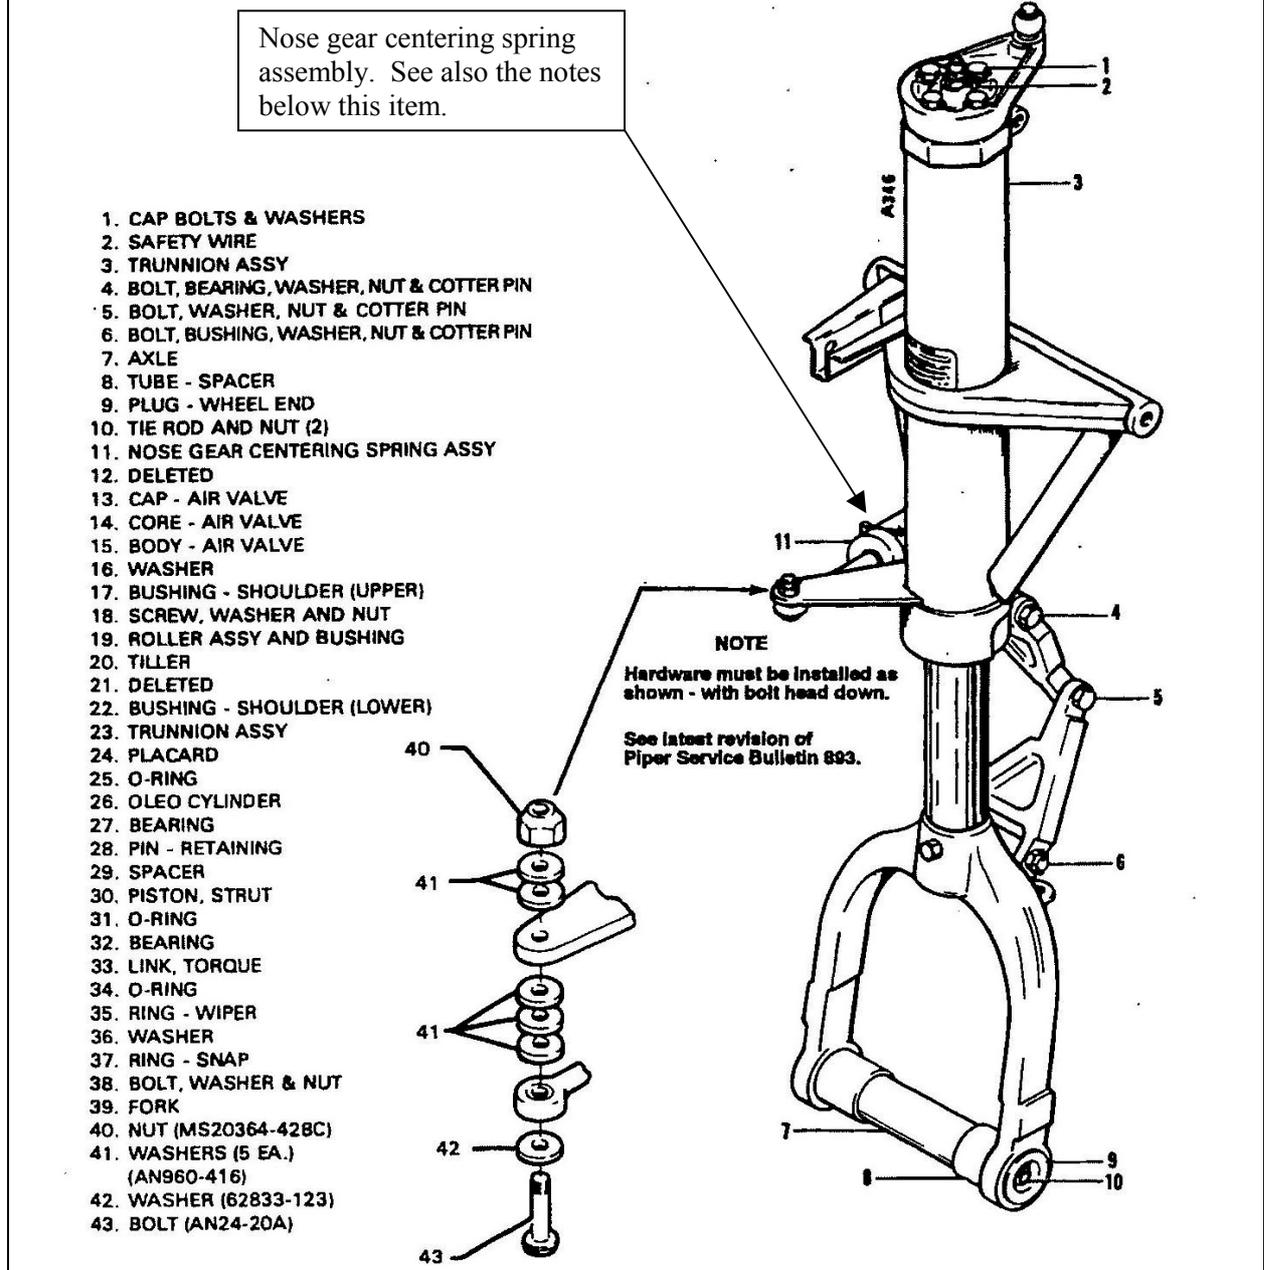
Figure 1
PA34 nose gear oleo strut assembly

- 1.4.8 A centering spring assembly was installed on the nose strut to ensure that the nose gear was centred during the retraction sequence (see item 11, Figure 1).

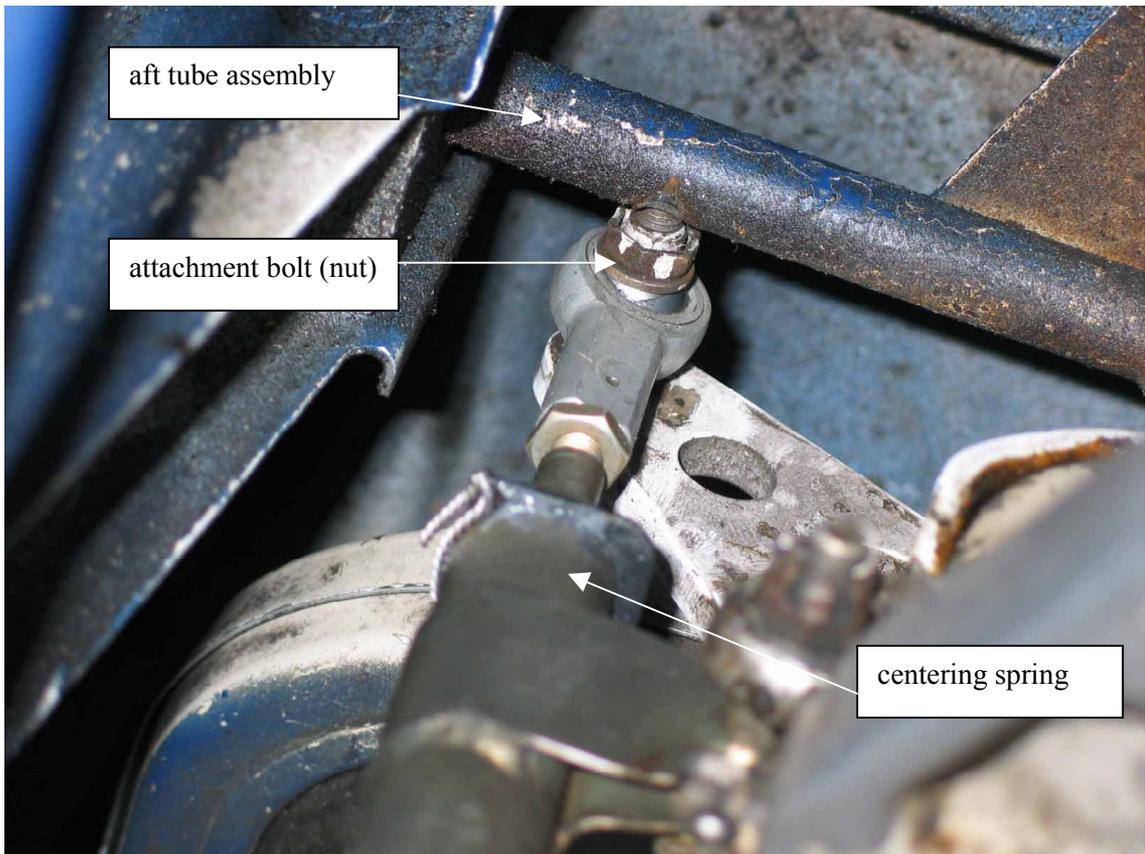
Figure 2
Attachment bolt contacting aft tube assembly (gear retracted)

- 1.6.3 By manually restricting the speed at which the nose wheel lowered from the retracted position, it was found that the nose gear centering spring attachment bolt was rubbing on the gear door aft tube assembly. A clevis-head bolt was fitted, but it was installed incorrectly, with the head up. The thread end of the bolt had worn a groove almost through the thickness of the tube wall, and the interference sometimes prevented nose gear extension (see Figures 2, 3 and 4).

- 2.1 The operation of ZK-MSL on 7 July 2005 was uneventful until the pilot selected the landing gear down on approach to Wairoa Aerodrome, and discovered that the nose landing gear would not extend. Later inspection showed that the nose gear centering spring attachment bolt was not installed correctly, and that the thread end of the bolt had contacted the nose gear door aft tube assembly. Binding of the aft tube assembly was a known cause of the nose gear failing to extend.

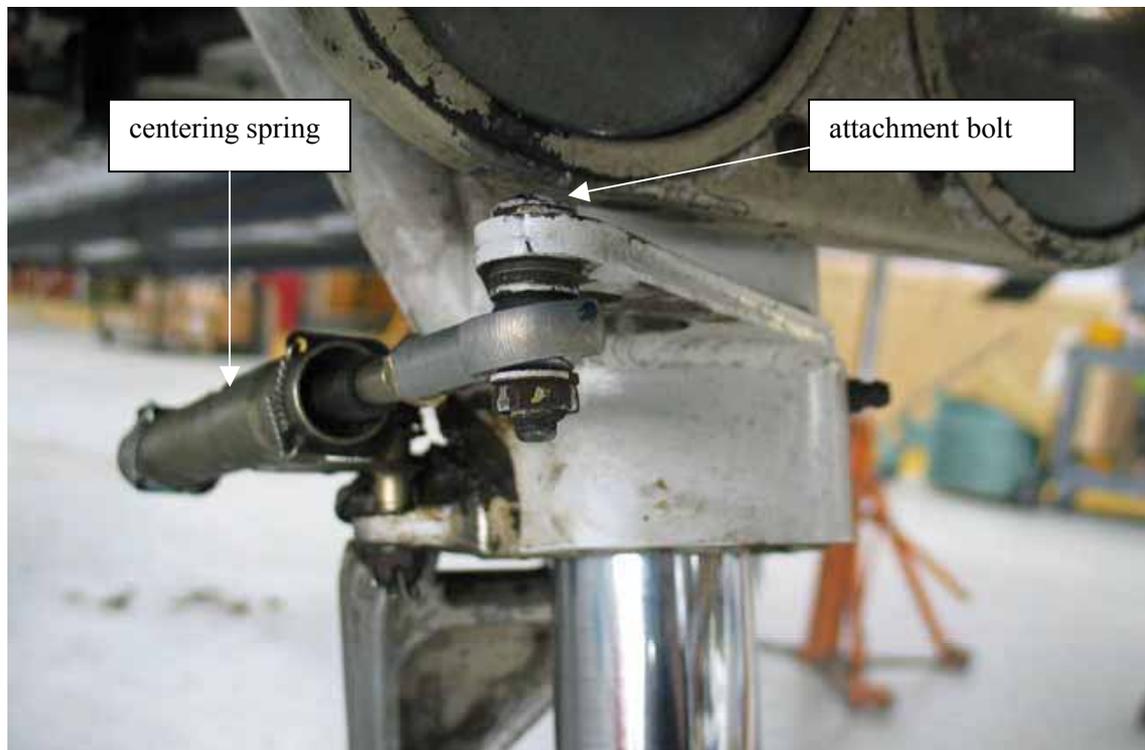
Figure 3
Attachment bolt, incorrectly installed with head up (gear extended)

1.4.20 If installed incorrectly, there was reduced clearance between the bolt end and the aft tube assembly when the nose gear was retracted.

1.4.25 The relevant page of the IPC was with the task card. The trainee recalled seeing the IPC page but stated that he did not read it. He did not check the SM or IPC prior to the task. At the time, the trainee was not aware of Piper SB 893. He said he thought the job was simple and he probably would have installed the bolt in what he thought was the standard way, head up.
