AVIATION OCCURRENCE REPORT

05-008

Cessna U206G, ZK-WWH, loss of control on take-off,
Queenstown Aerodrome

10 August 2005

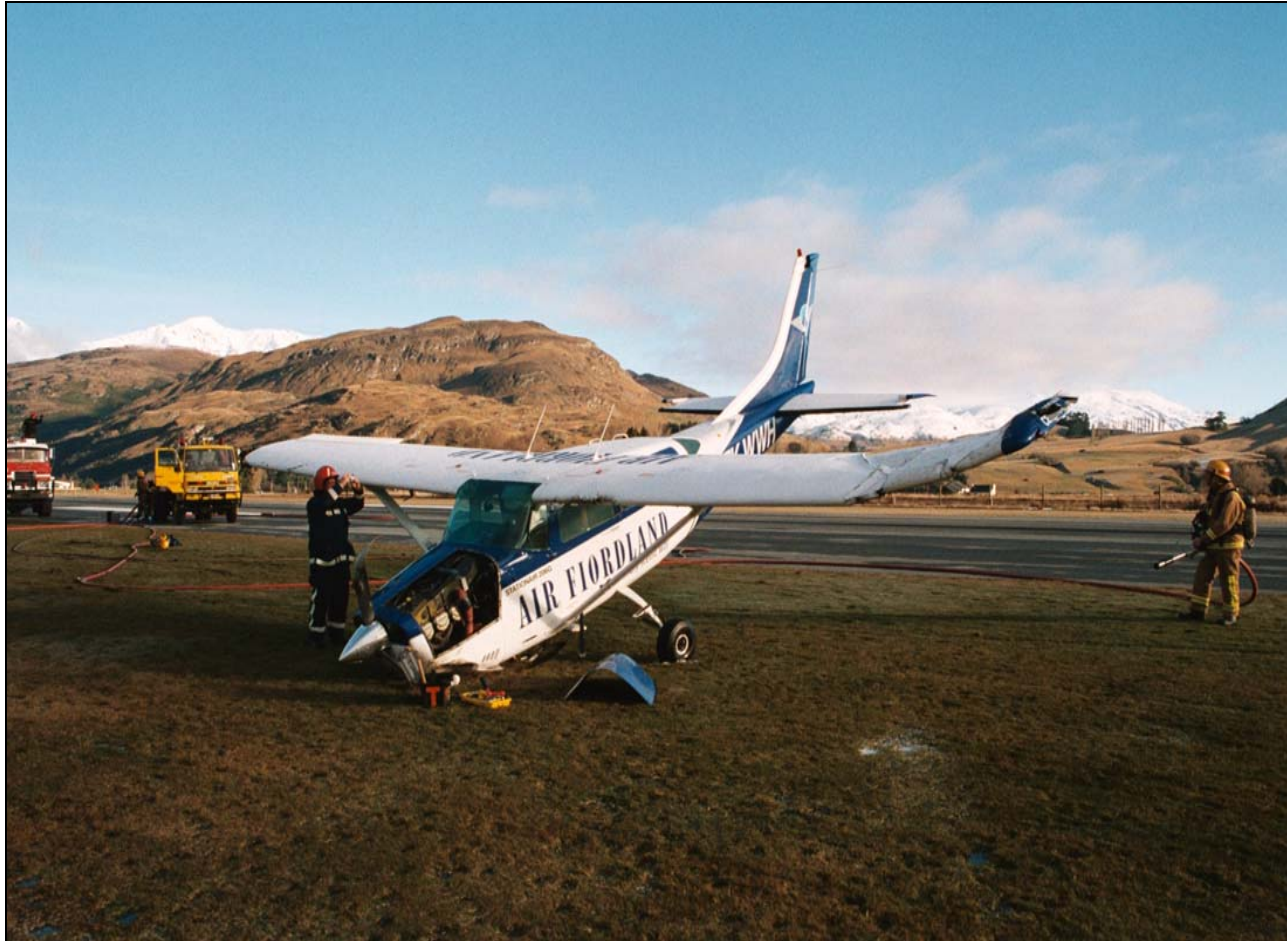
ZK-WWH after the accident

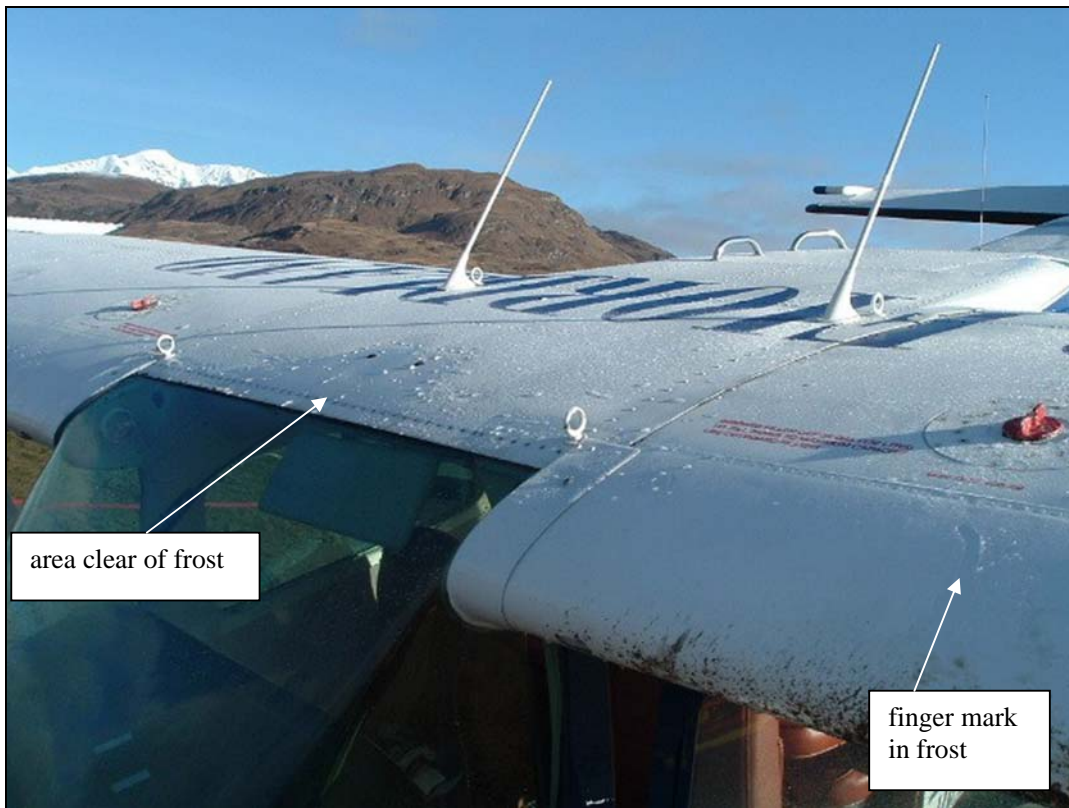
Figure 2
ZK-WWH, about 30 minutes after the accident
(photograph courtesy of Milford Flightseeing Limited)

- 1.6.4 For the purposes of the investigation, the Commission engaged a meteorologist. He examined some photographs of ZK-WWH taken after the accident, including those shown in Figures 2 and 3. He said that the photographs clearly showed a naturally formed hoar frost with a depth and uniformity of coverage that he expected would have taken some hours to form under the conditions that prevailed. He noticed that close examination of Figure 3 showed some mud on top of the frost layer.

- 1.6.7 The meteorologist found some of the “lumps” seen in Figure 2 on the cabin roof difficult to explain. He thought they could be frozen raindrops from 2 nights earlier, which were too big to evaporate during 9 August when the aircraft did not fly, or water from melted frost that had coalesced and run forward while the aircraft nose was tipped down. He thought that the frost clearance above the windshield was possibly caused by the relatively warm propeller wash.

- 2.5 The first persons on the scene immediately after the accident said that there was frost on the wings, and probably the tail plane, when they arrived. The copy of the digital photograph that the pilot took before RFS action had commenced was too indistinct to enable any reliable conclusion to be drawn about the condition of the wings. However, another photograph showed mud on top of the frost, which confirmed that frost was present at the time of the accident. The short police video supported the police report of a hard layer of frost on the outer wings.

- 2.6 The mud overlaying the frost was contrary to the operator's suggestion that RFS action had caused the frost seen in the photographs. In addition, the meteorologist said that RFS water spray would not have formed hoar frost. The observed frost was of fairly uniform density across the wingspan, and probably the tail plane, surfaces that had not been sprayed by RFS.

- 2.7 Expert meteorological and operational opinion was that, even though frost could have been formed up until an hour after the accident, the amount of frost seen in the photographs could not have formed in the time available between when the pilot said he cleaned the aircraft and when the photographs were taken. Therefore, the pilot's brushing had not removed all of the frost and ice, and additional frost was probably deposited before the flight commenced.

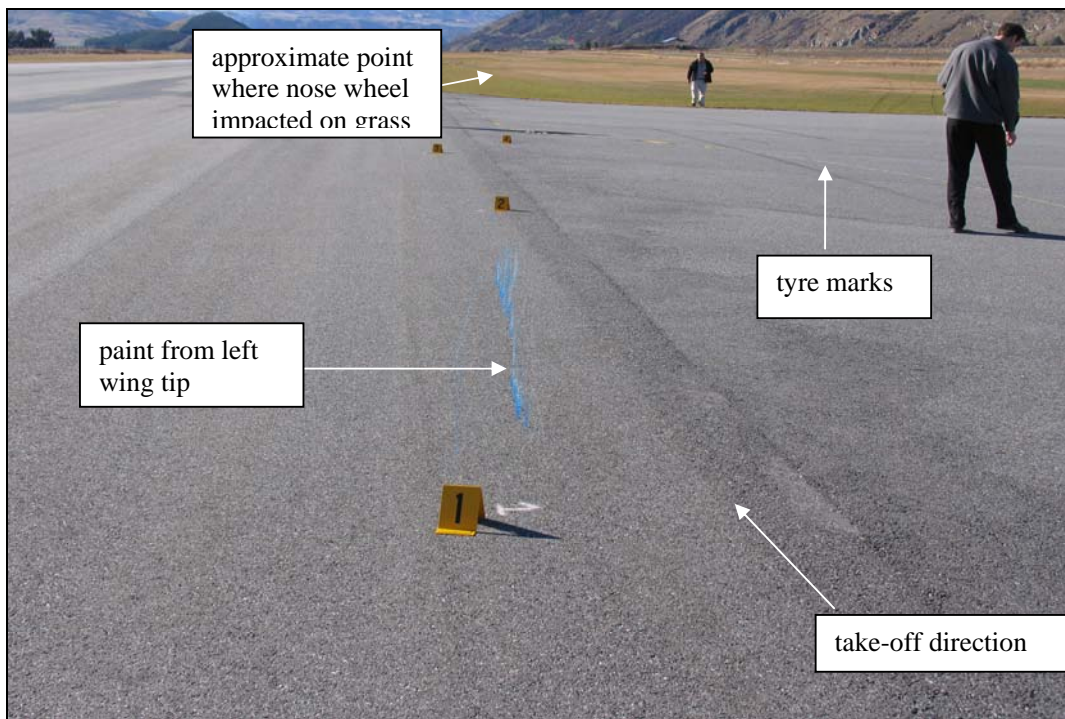
Figure 4
Impact marks on runway 05 and taxiway C
 (photograph courtesy of New Zealand Police)

- 1.8.2 A blue paint scrape, about 3 m long, was found near the right edge of runway 05, by the intersection with taxiway C. Abeam the end of the paint scrape were tyre marks across about 7 m of taxiway C, and almost parallel to the runway direction. The spacing of the tyre marks indicated that, at the time they were made, ZK-WWH was yawed to the left (see Figure 4).
