AVIATION OCCURRENCE REPORT

05-009

Eurocopter AS350 BA Squirrel, ZK-HGI, roll over on landing,
Franz Josef Glacier

17 August 2005

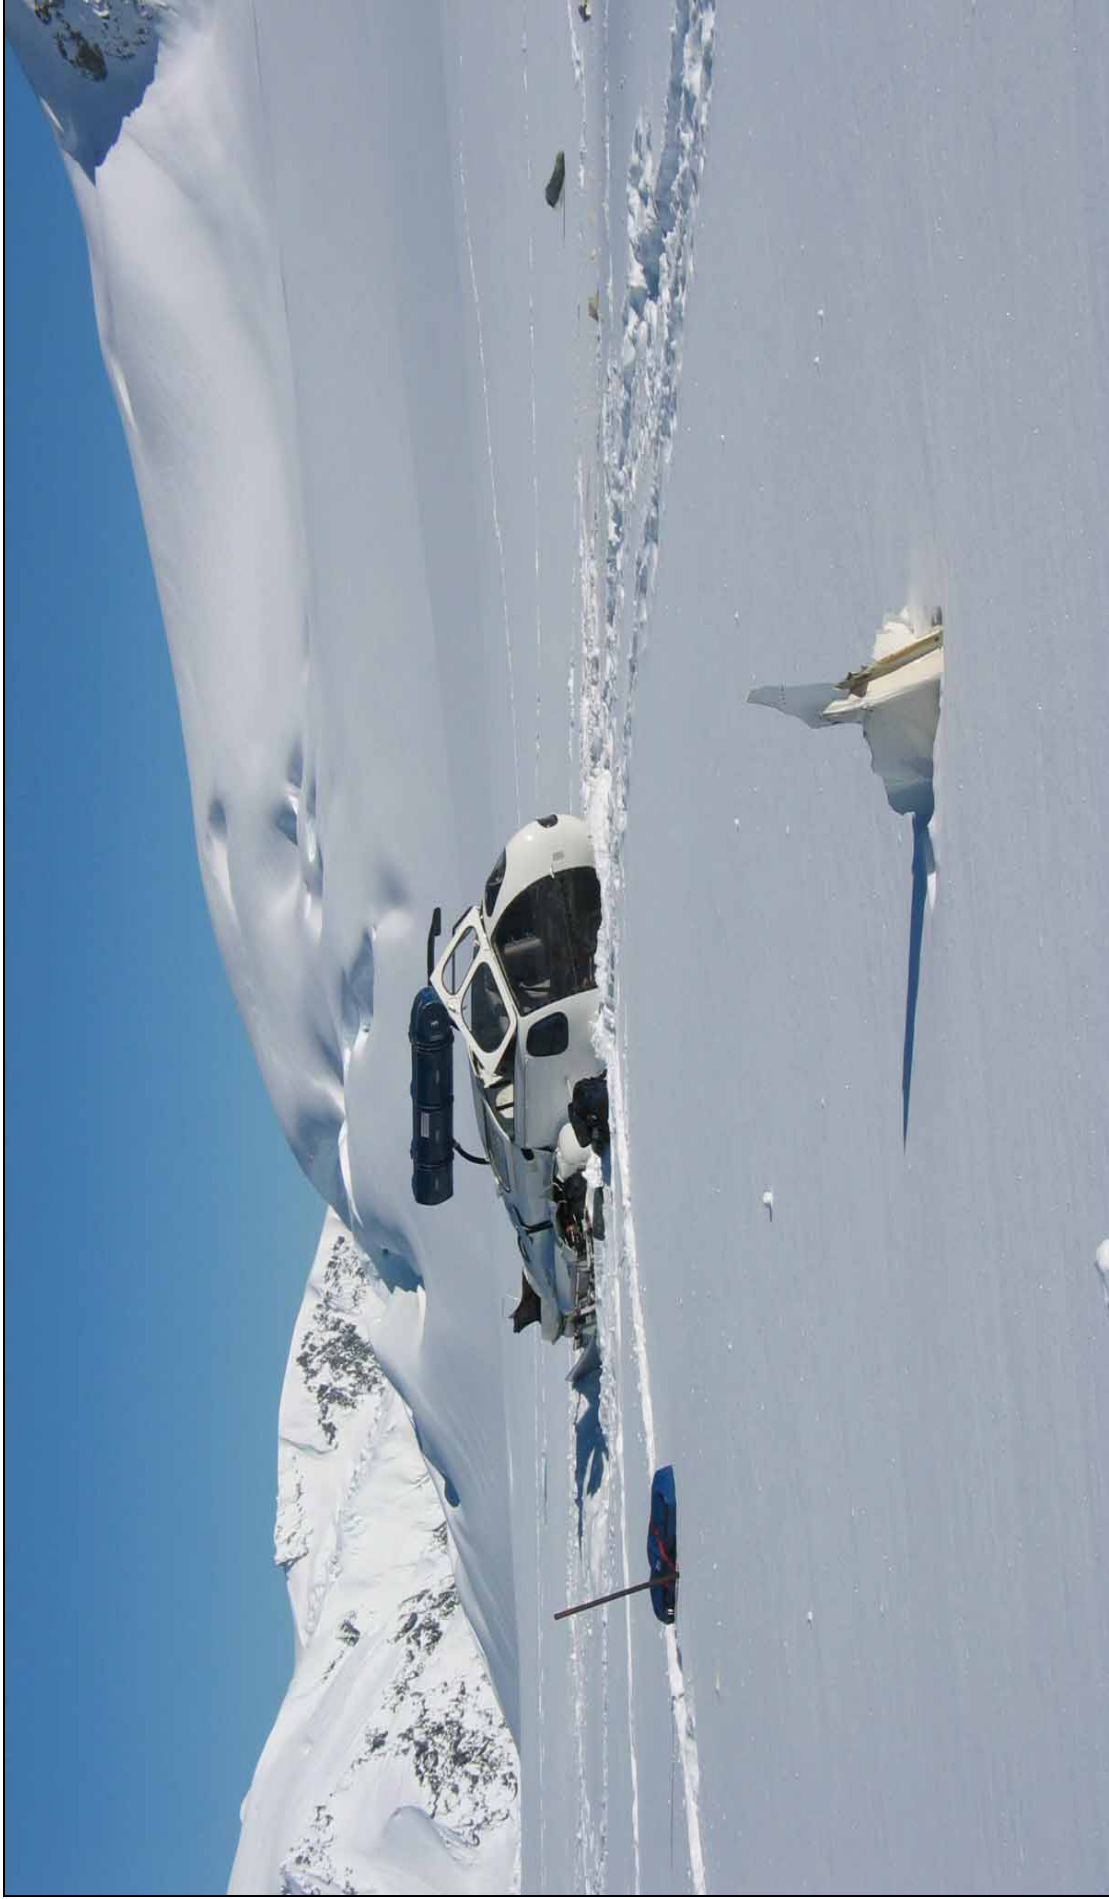
**Wreckage of ZK-HGI
Geikie Snowfield, Franz Josef Glacier**

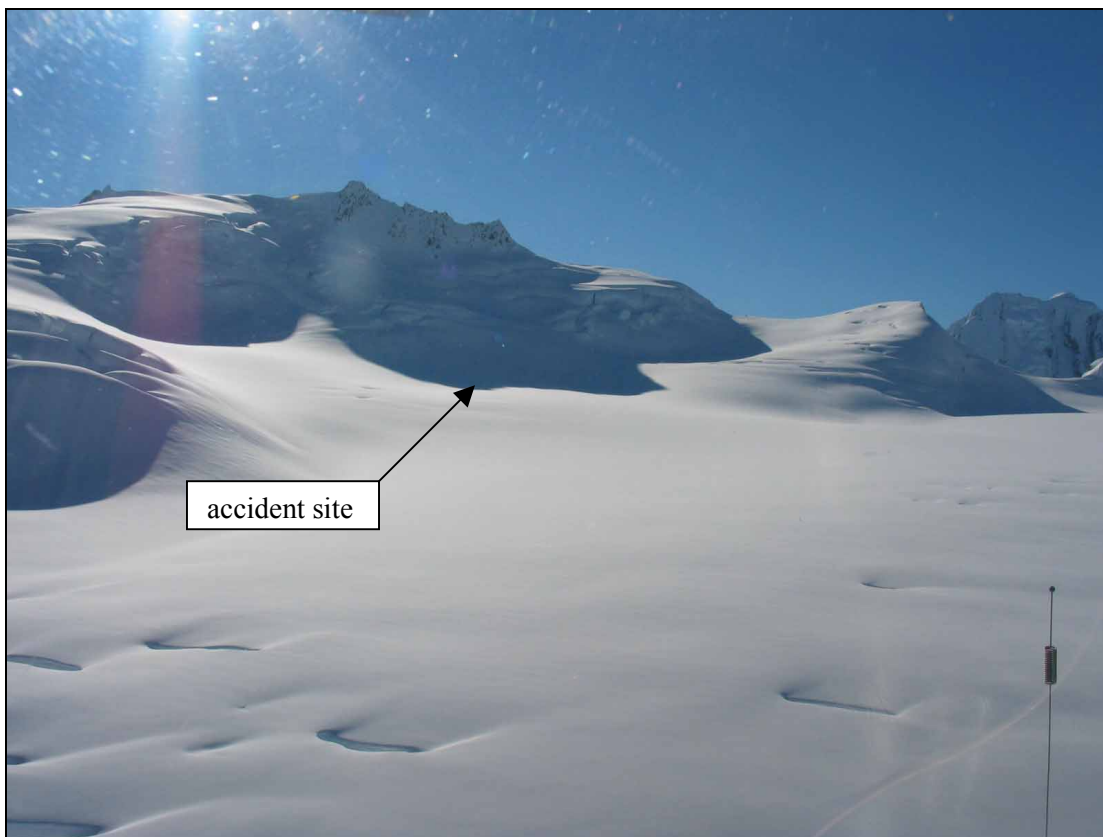
Figure 2
Geikie Snowfield looking north
(taken at 1030 on 18 August 2005)

- 1.8.1 The accident site was on the northern section of Geikie Snowfield, below Drummond Peak, at an elevation of about 7000 feet (2135 m).
- 1.8.2 The area around the site was generally flat, but the slope fell away gradually to the southwest as the snowfield fed into the top of the glacier. Immediately to the north of the site, the ground rose sharply towards a range of peaks that rose about 1200 feet (380 m) above the site. On the day after the accident, the peaks cast a shadow over the site until about 1045, after which it remained exposed to the sun for most of the day. The area was snow-covered but some rocky faces were exposed near the top of the peaks (see Figure 2).

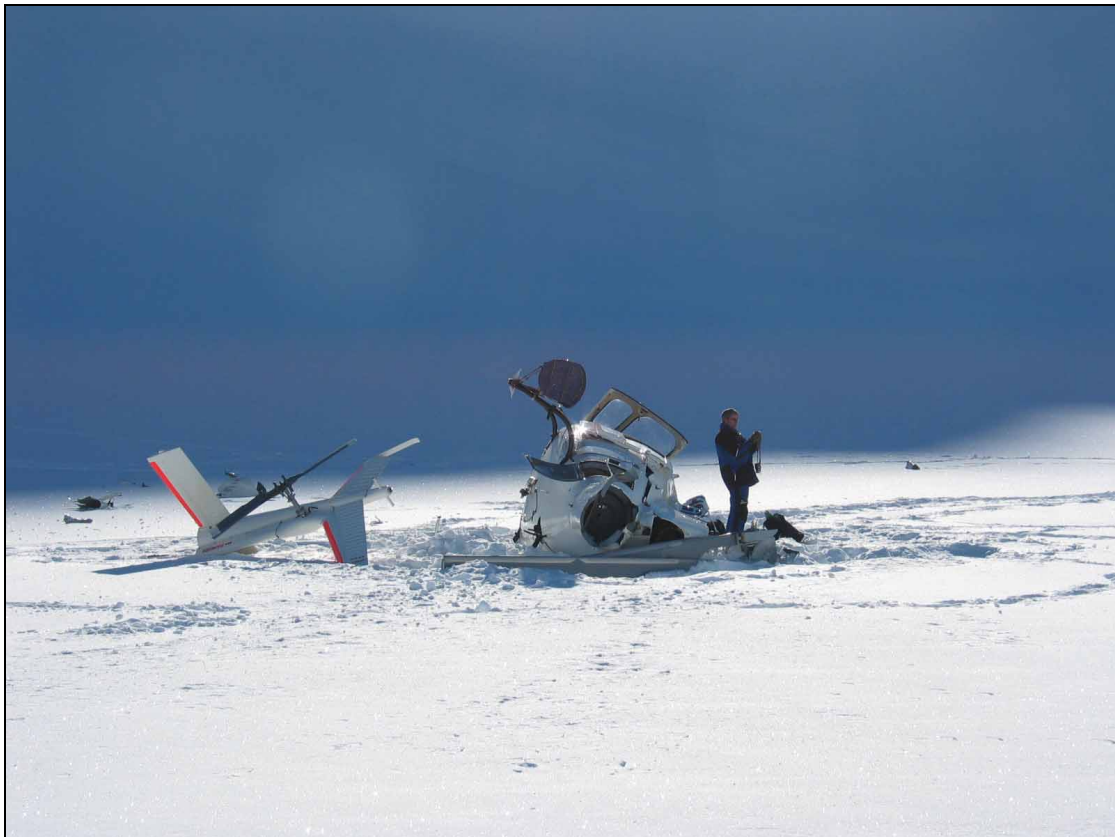
Figure 3
Accident site looking north-north-west
(taken at 1045 on 18 August 2005)

- 1.8.3 ZK-HGI was lying on its right side in about 40 cm of soft snow, on a heading of about 030° (see Figure 3). All of the helicopter was accounted for at the site. Debris, including sections of tail rotor drive shaft and pieces of fuselage, had been thrown up to 80 m from the helicopter. The tail boom had been severed and lay near the fuselage. The marks on the boom and main rotor blades were consistent with the blades striking the boom causing the separation. The main transmission had been partly torn from its mounting.

- 1.8.4 The main rotor head and blades were severely damaged. The starflex arms on the rotor head displayed 45° fractures, the orientation of which were consistent with the initial rotor strikes occurring while under power, followed by some residual inertia before rotation ceased. The collective lever control was found at about half the collective pitch setting.
- 1.8.5 The fuel remaining was estimated to be equivalent to about 28% on the fuel quantity gauge, or about 160 litres. That was sufficient for about another 45 minutes of flying. The fuel lever had been pulled through to the shut-off position.
