MARINE OCCURRENCE REPORT

05-202 and 05-204 passenger freight ferry *Aratere*, steering malfunctions,
Wellington Harbour and Queen Charlotte Sound,

9 February and
20 February 2005

TRANSPORT ACCIDENT INVESTIGATION COMMISSION
NEW ZEALAND

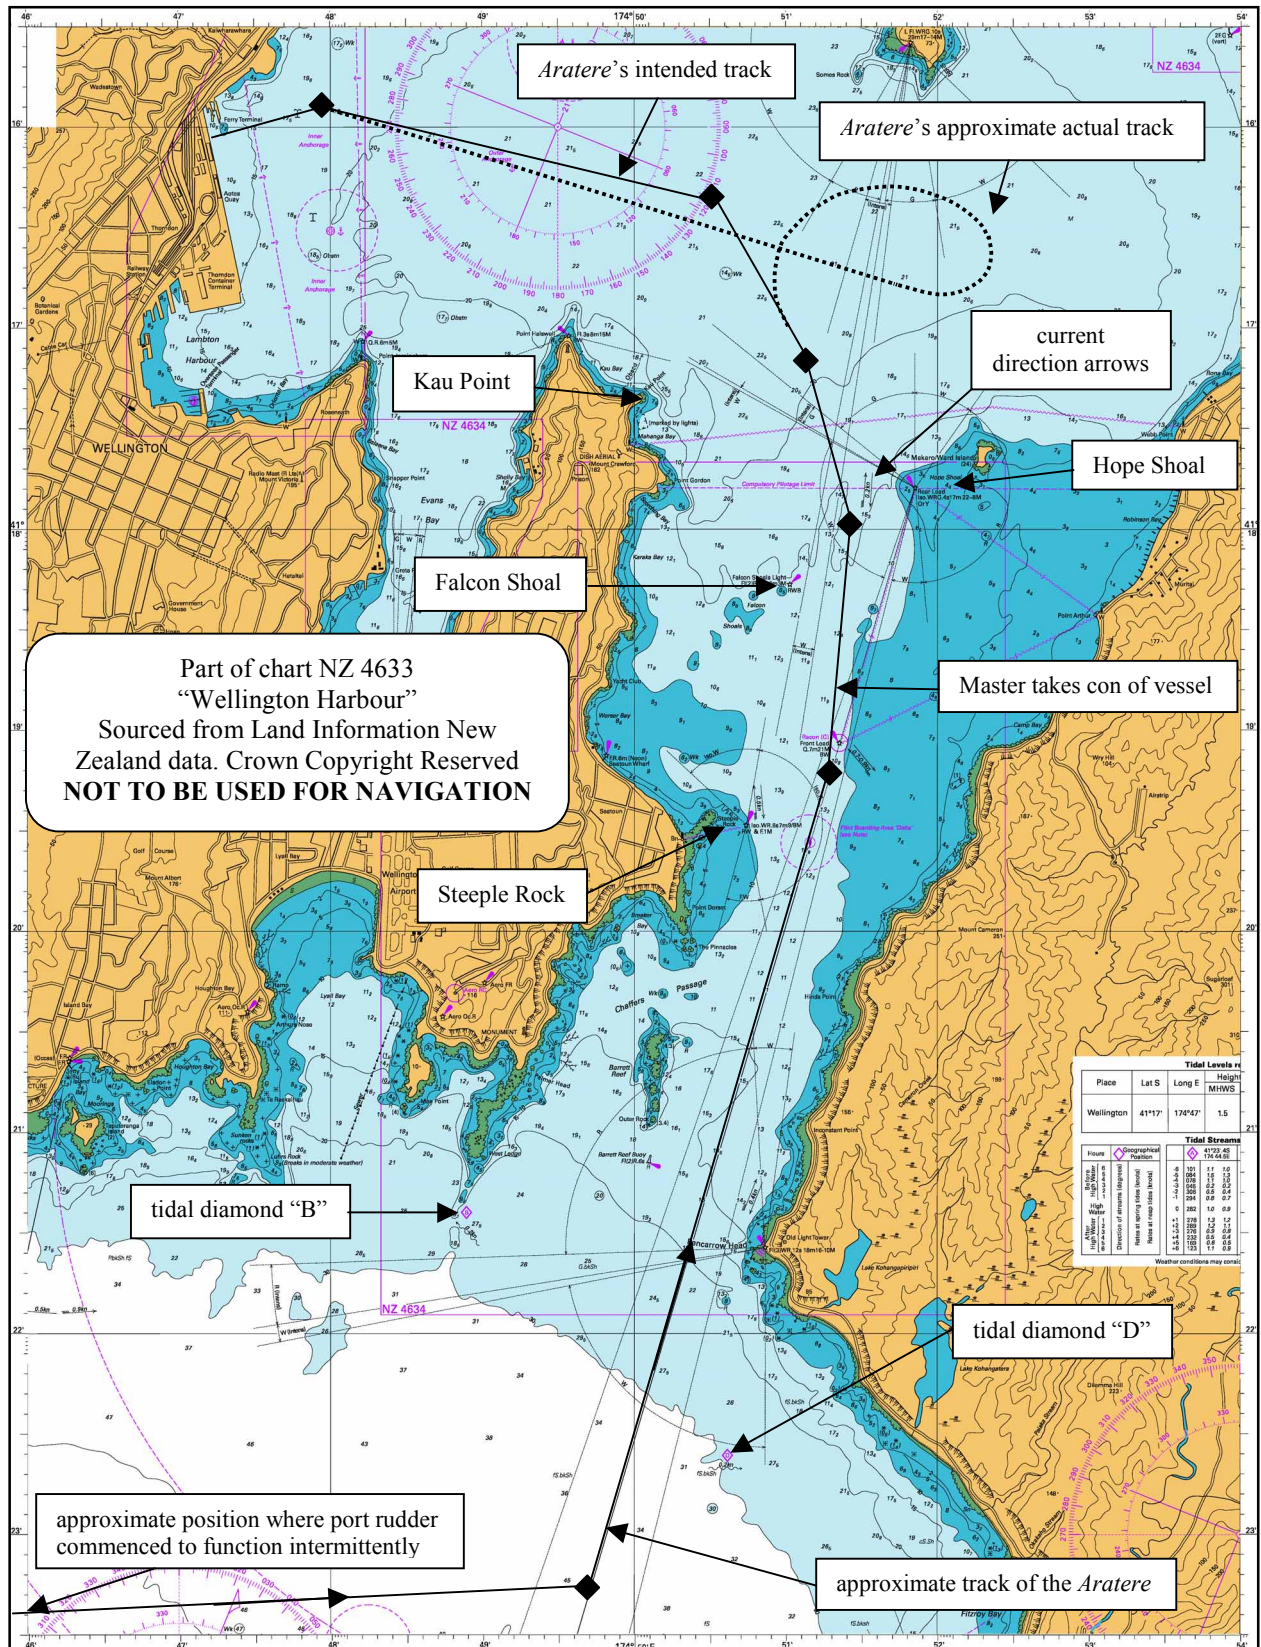
Figure 1
General area of the incident 05-202

- 1.1.5 The Second Officer conned the vessel into the entrance to Wellington Harbour and lined the *Aratere* on the entrance leading lights on a course of 016°T (see Figure 1). The helmsman experienced no difficulty in maintaining the course.

- 1.1.9 At about 2120, as the helmsman steadied the *Aratere* on 330°T, he informed the Master that he was having difficulty maintaining the course. The Master looked at the rudder indicators on his steering console and noticed that the indicator for the port rudder showed a steady 5° to 6° to starboard. The Master thought that the port rudder had stuck in that position because the starboard rudder continued to follow the helm commands.

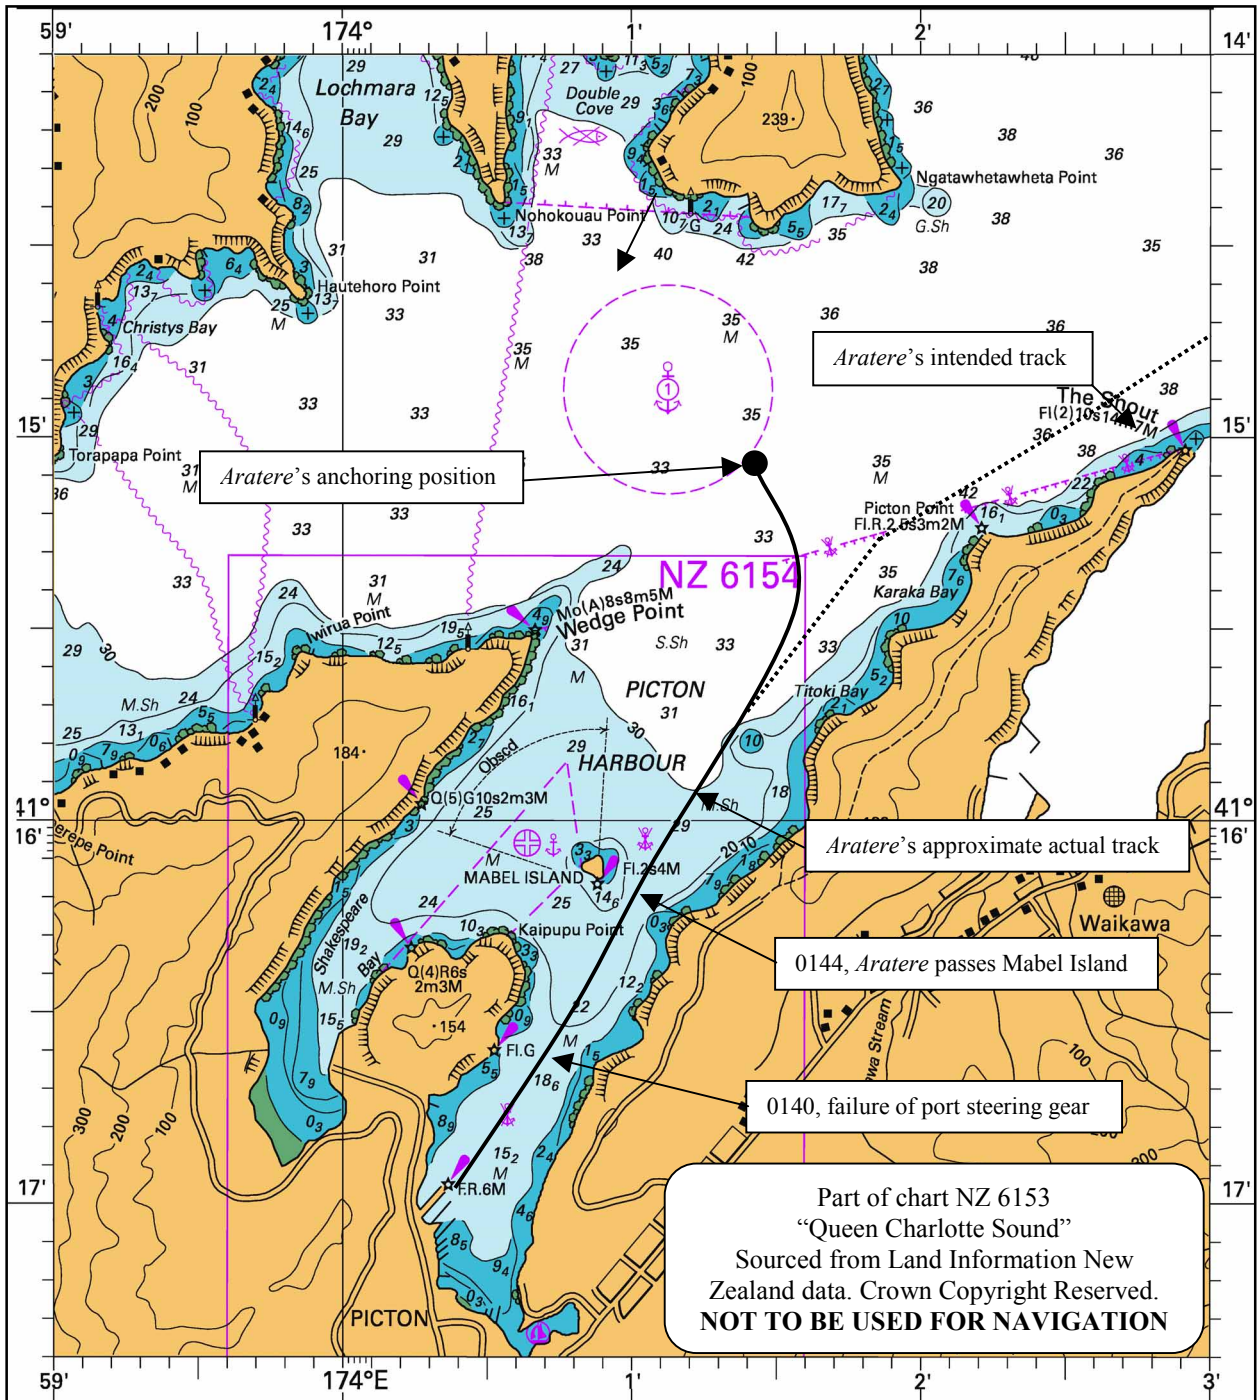
Figure 2
General area of the incident 05-204

- 1.1.23 The Master conned the vessel towards the designated anchorage area in Queen Charlotte Sound (see Figure 2), and at about 0210 he ordered the port anchor to be let go. The Master then informed the Harbourmaster via Picton Harbour Radio, and Interislander of his actions.

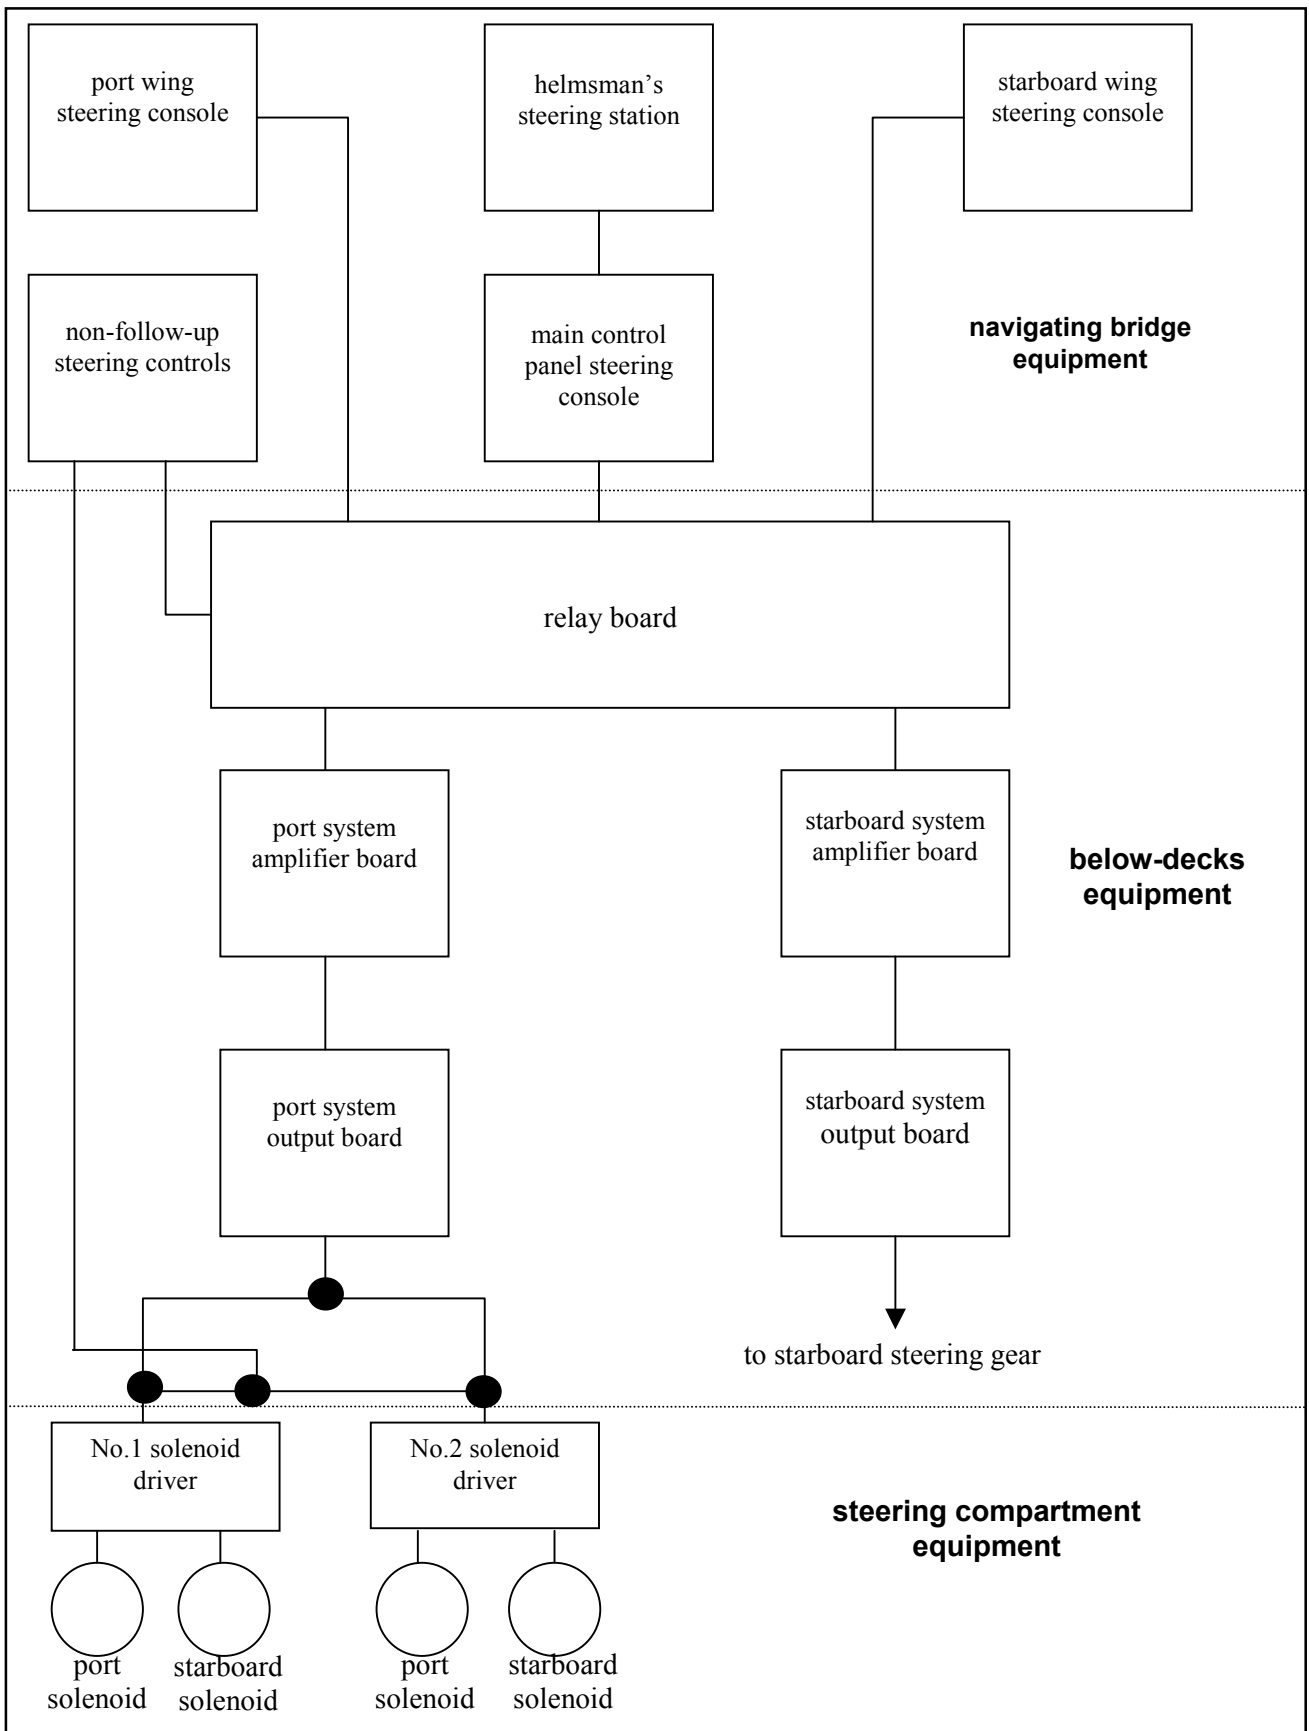
Figure 3
Diagram of the port rudder control circuit on board the *Aratere*

1.1.25 The Electrician checked the below-deck equipment located under the navigating bridge. He found that the port amplifier board (see Figure 3) was not receiving an electrical signal for the port rudder to go to port. The Electrician interchanged the port and starboard output circuit boards but the fault remained on the port rudder. He then interchanged the port and starboard amplifier circuit boards, and both the port and starboard systems worked correctly. He then checked and cleaned the edge connectors on the port and starboard amplifier circuit boards. This appeared to remedy the fault, but the Electrician could not prove that dirty contacts were the cause of the fault.

- 3.3 A dirty edge connector on the port rudder's amplifier PCB may have caused the steering malfunction in both incidents.
- 3.4 The fault was more likely to be a power supply problem within the follow-up amplifier assembly, and unrelated to the amplifier card or its edge connector.

- 3.5 The faulty diode bridge on the power supply in the port follow-up amplifier assembly may have been the main cause of both steering malfunctions.
- 3.6 The action of replacing the boards probably physically disturbed the actual fault and rectified it.

- replaced suspect capacitors on both the port and starboard servo system power supplies
- replaced the bridge diode network on the port servo system power supply
- replaced the amplifier integrated circuit on the port amplifier PCB
- carried out a full system alignment following the manufacturer's instructions
- corrected errors and adjusted the helm servos.

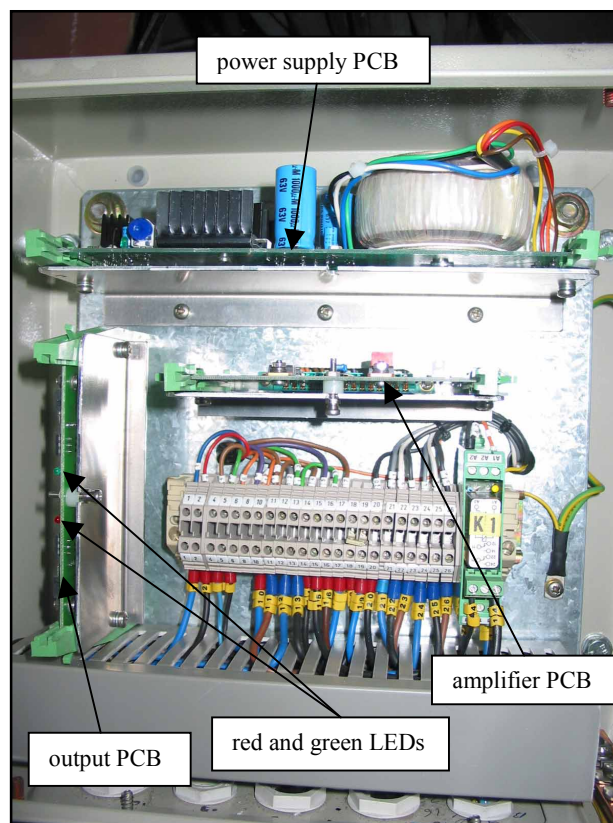
Figure 6
Interior of the port follow-up amplifier assembly cabinet

- 1.3.7 Within the servo follow-up amplifier cabinets (see Figure 6) there were 3 PCBs:
- a power supply board
 - an amplifier board,
 - an output board.
- The output board had red and green LED status lights and also provided volt-free relay contacts to interface with the alarm systems. From the on board documentation the purpose of the LEDs was not clear but they appeared to indicate a healthy power supply status for the 24 VDC power supply.

- 2.13 The main clue was the power supply LED in the port follow-up amplifier assembly being off. This indicates a power supply failure or a poor connection between the power supply board and the output board. The problem was that the purpose of this LED was not very clear. The crew thought that it indicated the lack of a port drive signal to the solenoid valves but it appeared more likely to indicate the failure of the negative 24 VDC power supply within the follow-up

- 2.17 Although not clearly stated, the shore technicians' report appeared to say that the LEDs were still flickering and a diode bridge on the power supply in the follow-up amplifier assembly was found to be faulty (intermittent connection) and replaced. A temporary replacement was fitted then a proper replacement fitted when the ship berthed. The output amplifier was also replaced at the same time. This did not fix the intermittent problem. Several errors were then discovered in the accuracy of the servo tracking system, but repairs seemed to concentrate upon the follow-up amplifier assembly under the bridge and ignored the pump starter units, solenoid power supply, relay cabinet and interconnecting cables.
