## MARINE OCCURRENCE REPORT

05-206

passenger freight ferry *Arahura*, loss of propulsion, Cook Strait

24 April 2005

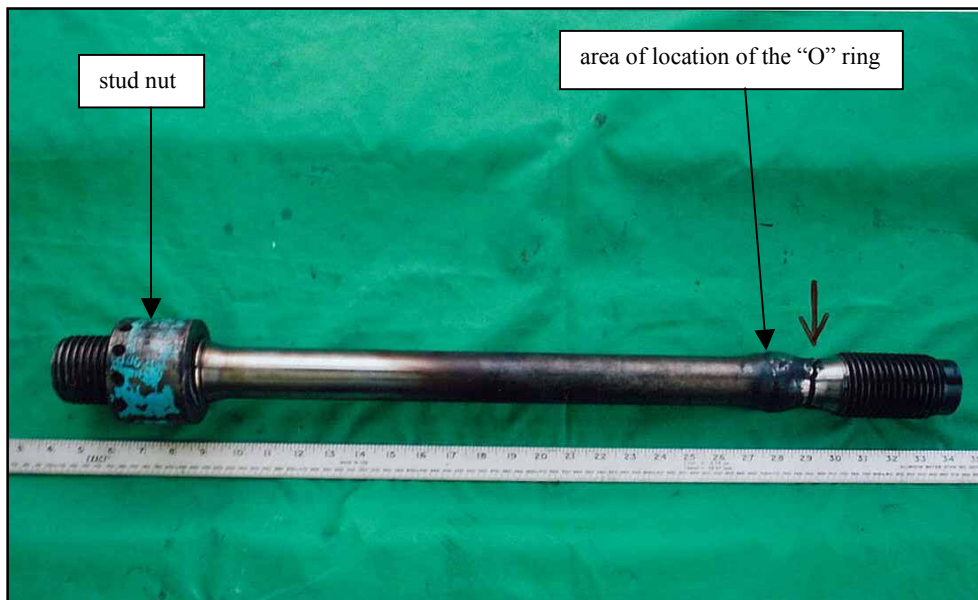
- 1.4.7 When the ship's engineers examined No.1 diesel generator after the incident they found that one of the cylinder head studs had fractured below the "O" ring seal (see Figure 4).

- 1.4.9 The fracture of the cylinder head stud allowed combustion gases and possibly some unburnt fuel from the cylinder to enter and pressurise the cooling water system. As the system became pressurised, water was expelled from the cooling water header tank to fall like rain over the engine room, and through the gap between the head and entablature caused by the fractured stud.

**Figure 4**  
**General picture of the damaged stud; the arrow points to the fracture**

- 1.7.1 One cylinder head stud on No.1 diesel generator in the forward engine room failed, requiring all 4 cylinder head studs on this cylinder to be renewed.

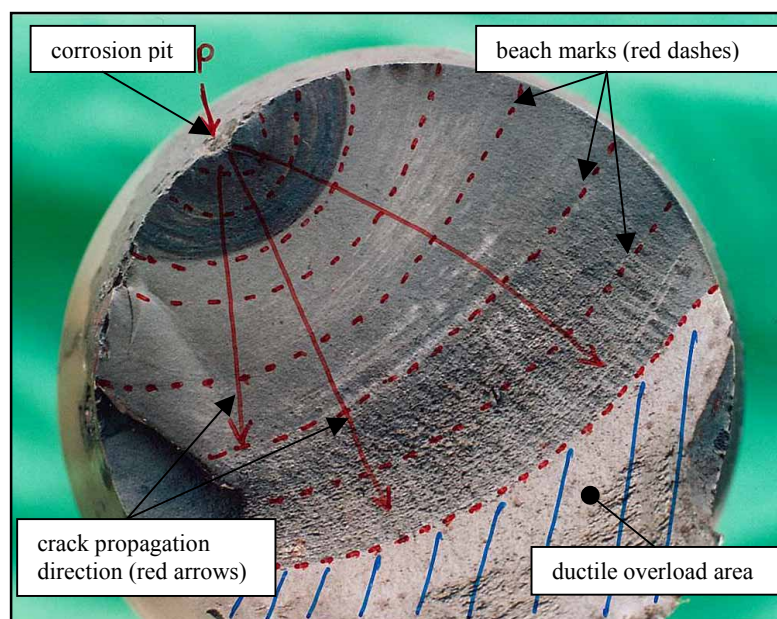
- 1.4.18 A metallurgist examined the broken stud after the failure. The metallurgist noted that the fracture had initiated where the local stud diameter had been decreased [waisted] and the stud showed localised corrosion pitting within this region consistent with exposure to an isolated corrosive liquid event. A black carbonaceous product was removed from the corrosion pits and this substance also covered approximately 15% of the initial fatigue crack propagation surface, showing that the corrosive liquid had been present for a significant proportion of the stud's service life. Analysis undertaken showed that the black carbonaceous product was consistent with that of a mixture of stud metal oxide corrosion products and oxidised oil.

- 1.4.19 Examination of the fracture face showed beach marks characteristic of fatigue crack propagation radiating from a corrosion pit. Fatigue crack propagation was evident through approximately 70% of the stud cross-section. The remaining 30% of the cross-section showed evidence of a rapid ductile overload fracture that completed the final failure.
- 1.4.20 The metallurgist estimated that fatigue crack propagation had probably been occurring for a period in excess of 3 to 5 years.
- 1.4.21 The underside of the stud nut showed no evidence of fretting so it was unlikely that crack initiation and propagation were associated with in-service loosening.

**Figure 5**  
**Stud fracture surface showing corrosion pit "P", beach marks, crack propagation and ductile overload**

- 2.12 The most probable cause of the failure of the cylinder head stud was corrosion pitting. This cause was one of those detailed in the service letter and it occurred in the region below the “O” ring seal identified in the service letter. Wärtsilä had properly identified a problem and had instigated procedures to remedy it.
