## M A R I N E   O C C U R R E N C E   R E P O R T

05-210      restricted limit passenger vessel *Milford Mariner*, engines' stall      18 September 2005  
resulting in grounding, Harrison Cove, Milford Sound

## **Report 05-210**

**restricted limit passenger vessel  
*Milford Mariner***

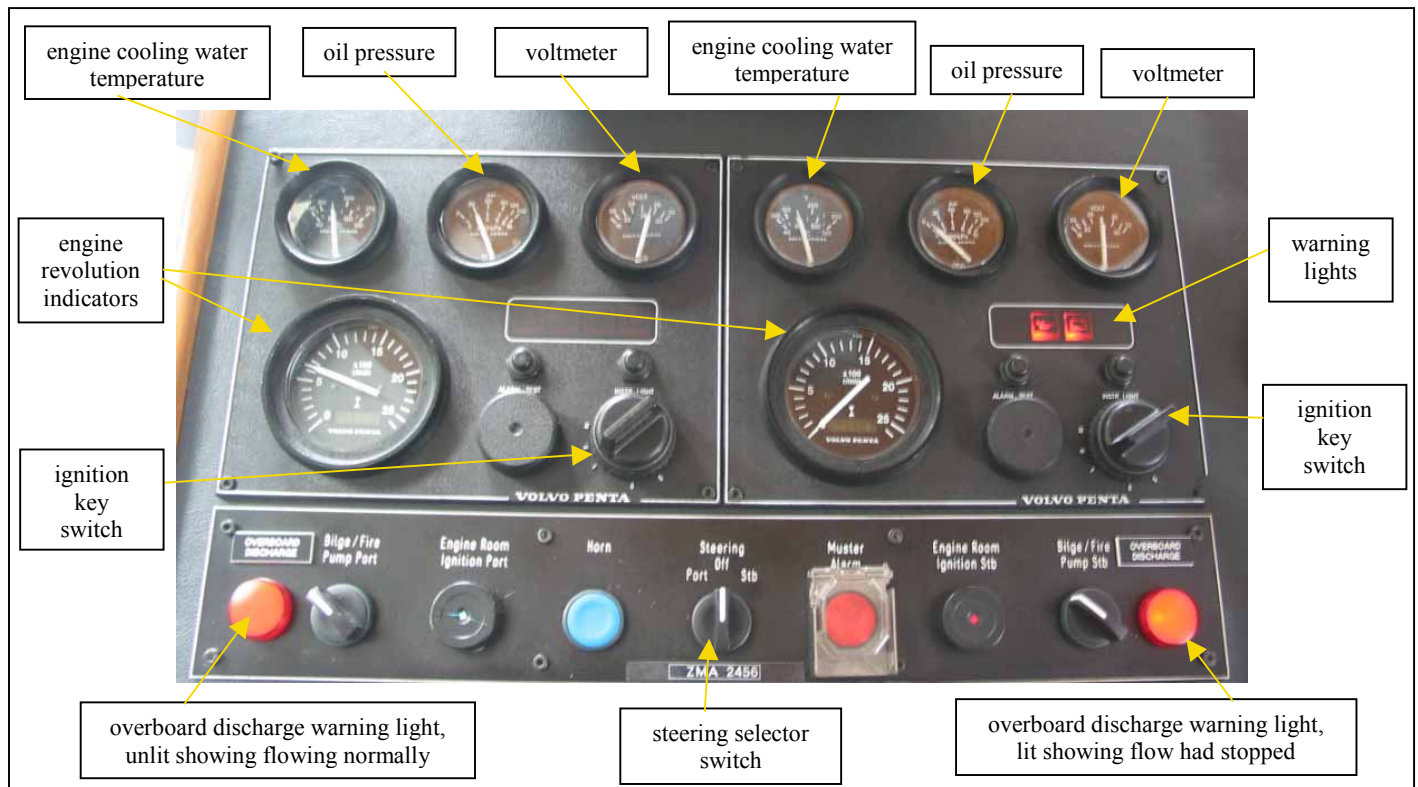
**Figure 4**

1.2.7 The Volvo Penta engine control and instrumentation panels were mounted on the bridge console (see Figure 4). The Commander EC 200 was interlinked with the Volvo Penta engine control system. The starting sequence for the engines was:

**Engine control panel – port engine running and starboard engine stopped but ignition switch on**

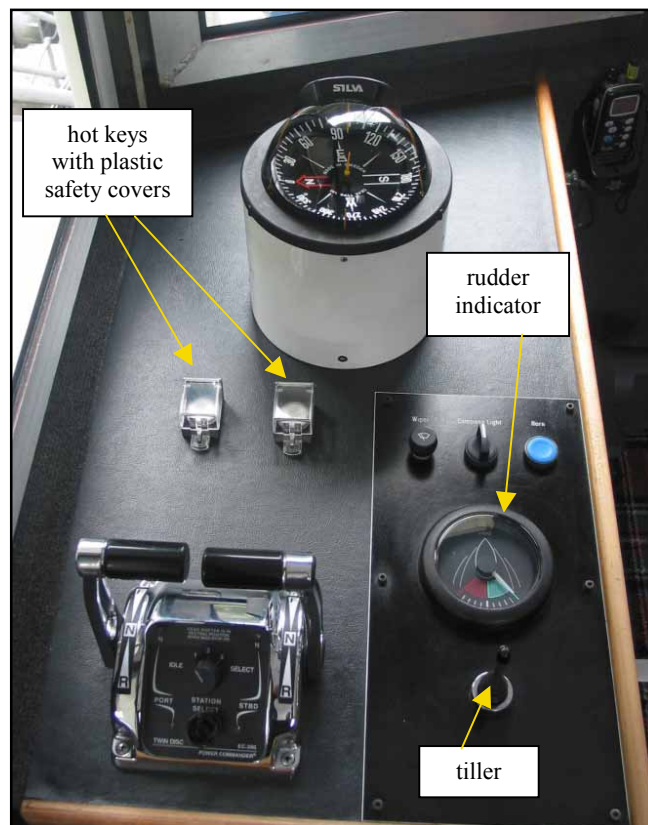
**Figure 5**  
**Port control station**

- 1.2.13 Soon after the ship had been launched, the ship’s masters noticed that it had a tendency to stall when the engines were put astern, particularly when it was moving ahead at a speed above 6.5 knots. On one occasion, the engines had stalled while approaching the wharf at the Milford Deep Underwater Observatory, causing the ship to collide with, and damage, the wharf and a building on the wharf. The controls for starting the engines were situated at the central console and the Master manoeuvred either from that or the port control station. Should the engines stall while the Master was conning the ship from the port control station, he had to go to the central console to restart them, which took time. To reduce the time necessary to restart the engines, hot keys were retrofitted at the port control station that allowed the engines to be restarted at the push of the buttons without going through the full engine start sequence (see Figure 5).

- 1.2.14 On this occasion, after the Master had gone to the port control station and used the hot keys to start the engines, he still did not have control of the engines. He pressed the “select station” button on the port engine control head but the Commander EC 200 system was inactive, because the ignition key switches had probably been left in the off position after the previous attempts to restart the engine from the centre console.

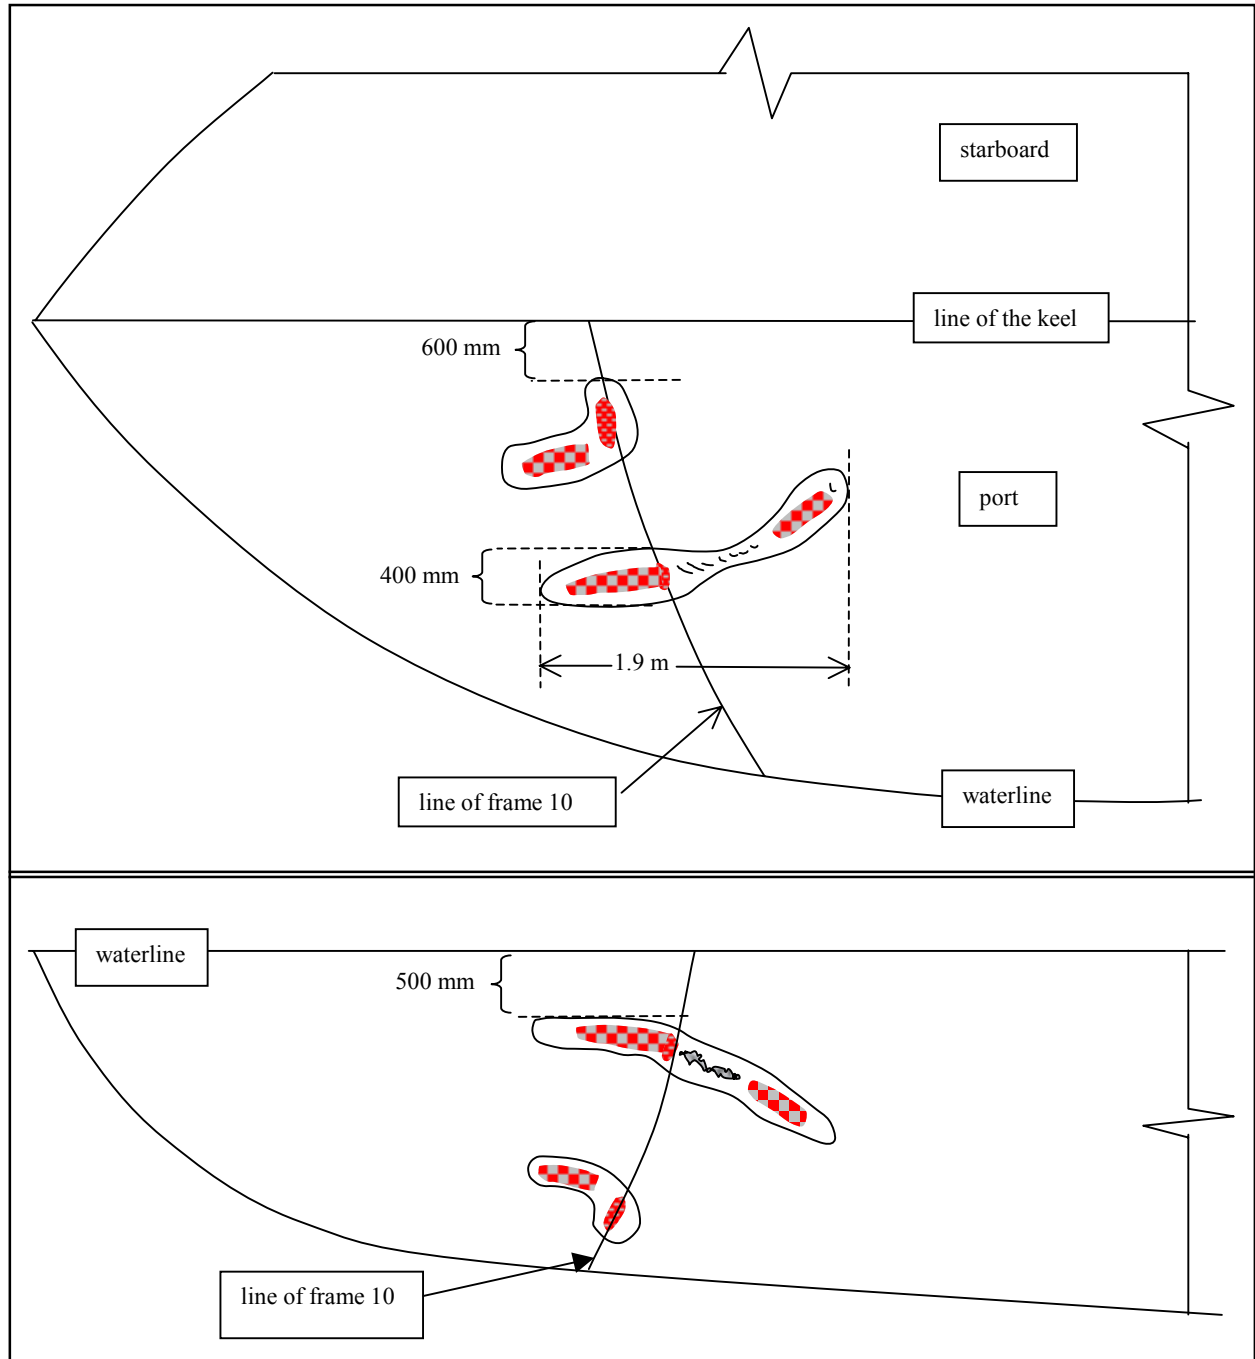
**Figure 6**  
**Plan and profile drawings as completed from the dive inspection**

- 1.9.1 The damage to the *Milford Mariner* was limited to the hull in way of the port bow. There were 2 areas of the hull where the plating was gouged and indented, but not punctured (see Figure 6). The maximum indentation was about 100 mm and frame 10 was deformed about 100 mm inwards. The watertight bulkhead at frame 8 remained undamaged and intact.

- 1.9.2 Only the forepart of the ship made contact with the ground. There was no damage to the propulsion or steering systems.
- 1.9.3 No passengers or crew were injured during the grounding.

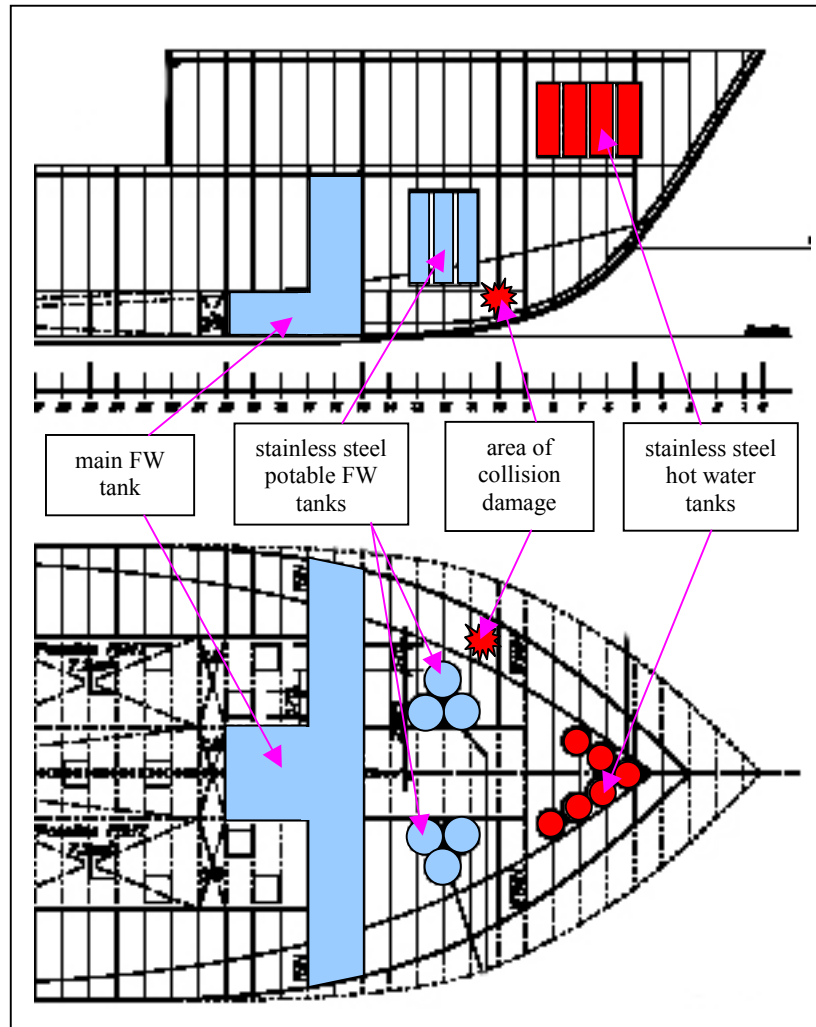
Figure 7

- 1.10.1 The *Milford Mariner* had a 31.2 m<sup>3</sup> main FW tank in the double bottom, which extended up the side of the ship for part of its length (see Figure 7). In addition, situated forward on the lower deck there were 6 stainless steel free-standing tanks for potable FW, which had a total capacity of 5 m<sup>3</sup>. On the main deck right forward were 6 electric hot water tanks that had a total capacity of 2.7 m<sup>3</sup>.

Forepart of the *Milford Mariner* showing the position of the water tanks and the area of hull damage

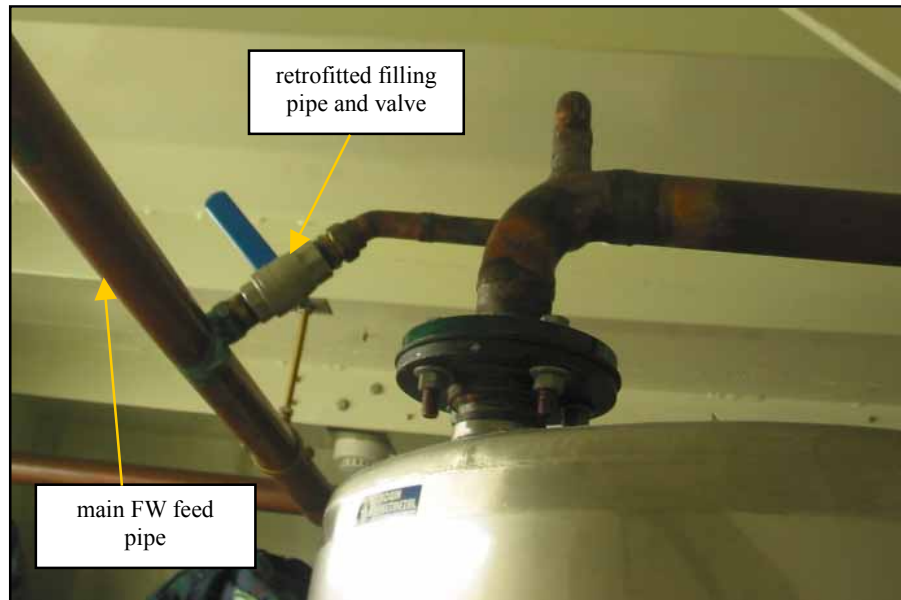
**Figure 8**  
**Stainless steel potable FW tank showing the retrofitted filling pipe and valve**

- 1.10.2 Separate filling pipes were provided for the main FW and potable FW tanks. The filler pipe for the main FW tank was 75 mm internal diameter while the pipe for the potable FW tanks was 50 mm. In the time available between trips, the masters found it difficult to fill the potable FW tanks through the smaller pipe, especially as they were filling 6 relatively small tanks through a single pipe. Consequently the masters, in conjunction with the company, had devised a “work-around” and had fitted a connecting pipe and valve between the water feed line from the main FW tank and the filler line for the potable FW tanks (see Figure 8). This allowed the smaller tanks to be filled slowly from the main tank during the voyage and so removed the necessity to fill them while alongside. It was the valve between the 2 systems that the Master had gone below to open at the time the engines stalled.

- 1.10.3 As part of the electronic vessel management system there was complete monitoring of the water system. However, the sensor in the potable FW water tanks had recently malfunctioned and so the masters were unable to monitor the amount of water in those tanks. Because of this, the Master decided to leave filling the potable FW tanks until near the end of the voyage, so that by the time they arrived back at the berth the tanks would be full and overflowing.

- 2.25 The designed FW system on the ship had been altered such that it defeated the purpose of having 2 separate systems. It would have been preferable to address the problems of filling the potable FW tanks directly rather than make alterations that compromised the system and necessitated the Master's attention during the voyage. The malfunction of the sensor necessitated the Master leaving the bridge and this contributed to the failure sequence.
