M A R I N E O C C U R R E N C E R E P O R T

05-211

container ship *Spirit of Resolution*, collision with bridge,
Onehunga

8 October 2005

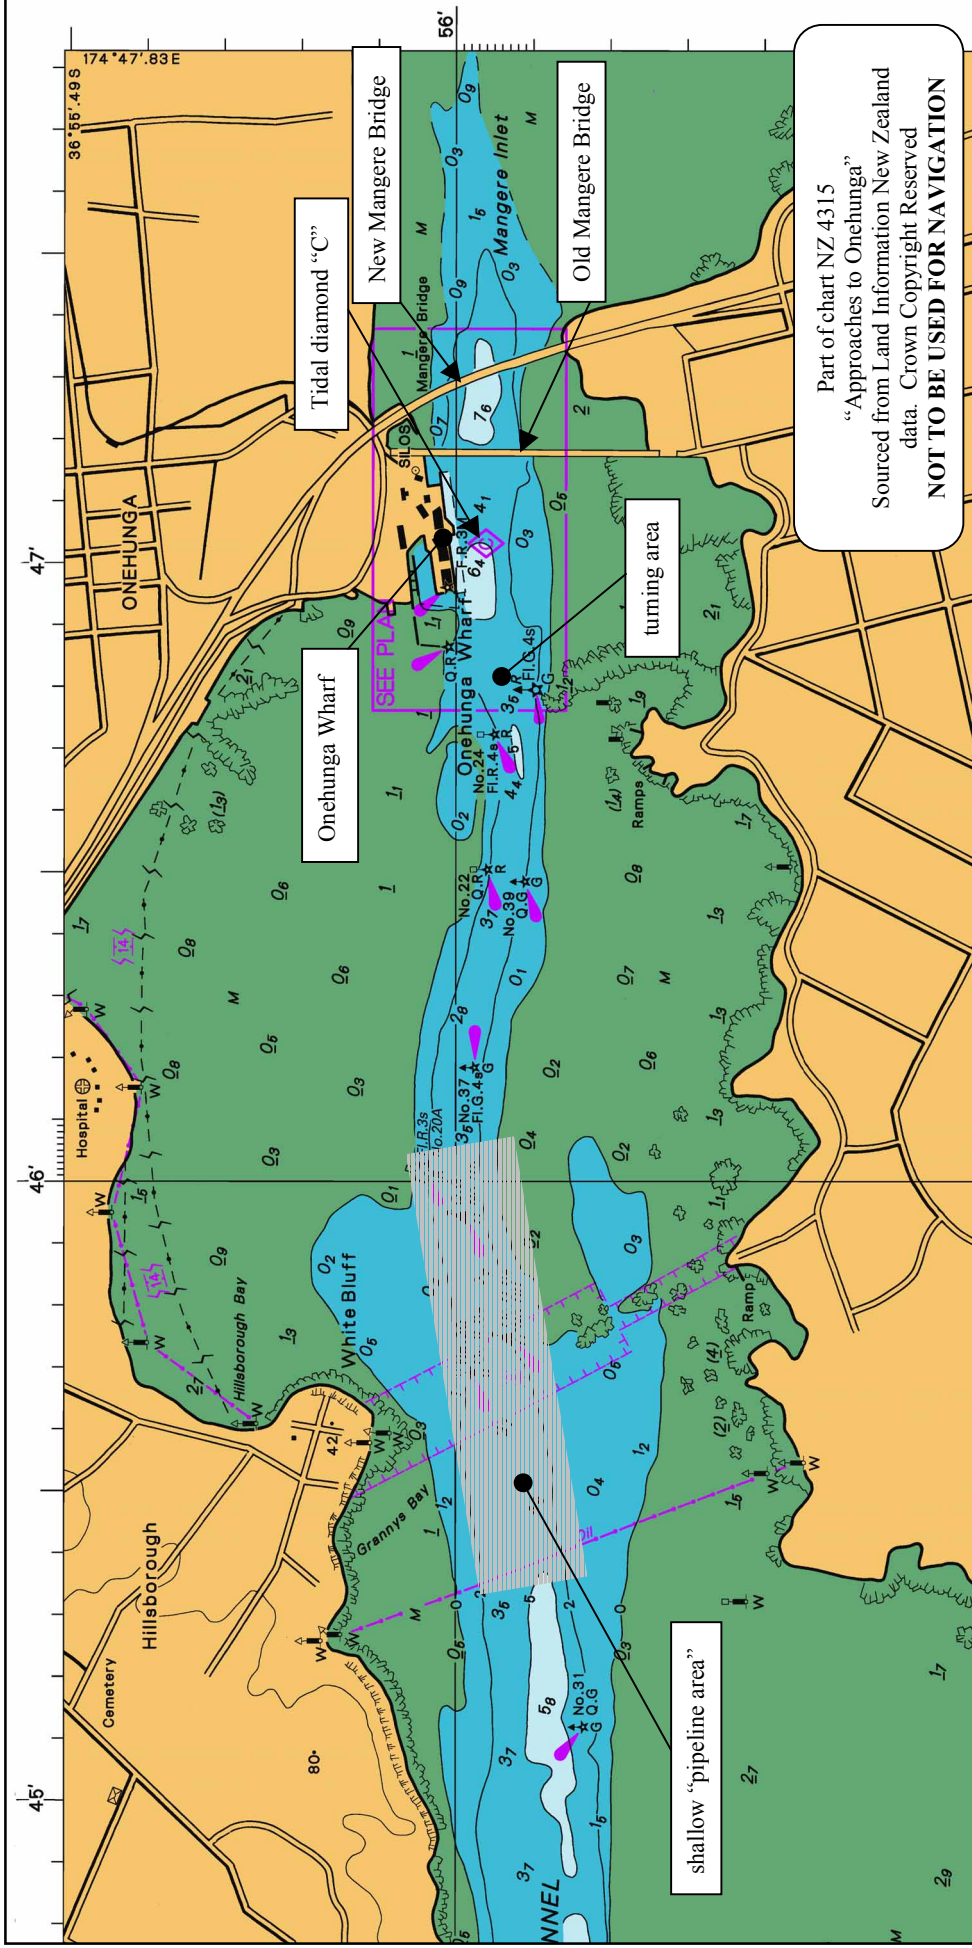
Figure 2
Onehunga Wharf and approaches

- 1.1.2 The *Spirit of Resolution* successfully crossed the Bar without incident, the Master reporting a 3 m swell occasionally rising to 4 m to 5 m. The ship proceeded across Manukau Harbour, along the Wairopa Channel to Onehunga (see Figure 1), where the Master berthed port side to the Wharf at “B” berth, on an ebb tide (see Figure 2).

- 1.1.7 The Master later stated that he decided to depart from Onehunga using the available tidal window to cross the shallows in the region of a pipeline (see Figure 2) in order to transit the Wairopa Channel and then anchor in the area of Big Bay or elsewhere in the Papakura Channel and await the Bar opening. He also stated that the company wished him to go and “have a look at the Bar”, although he had no intention of crossing the Bar and his plan was to go to anchor.

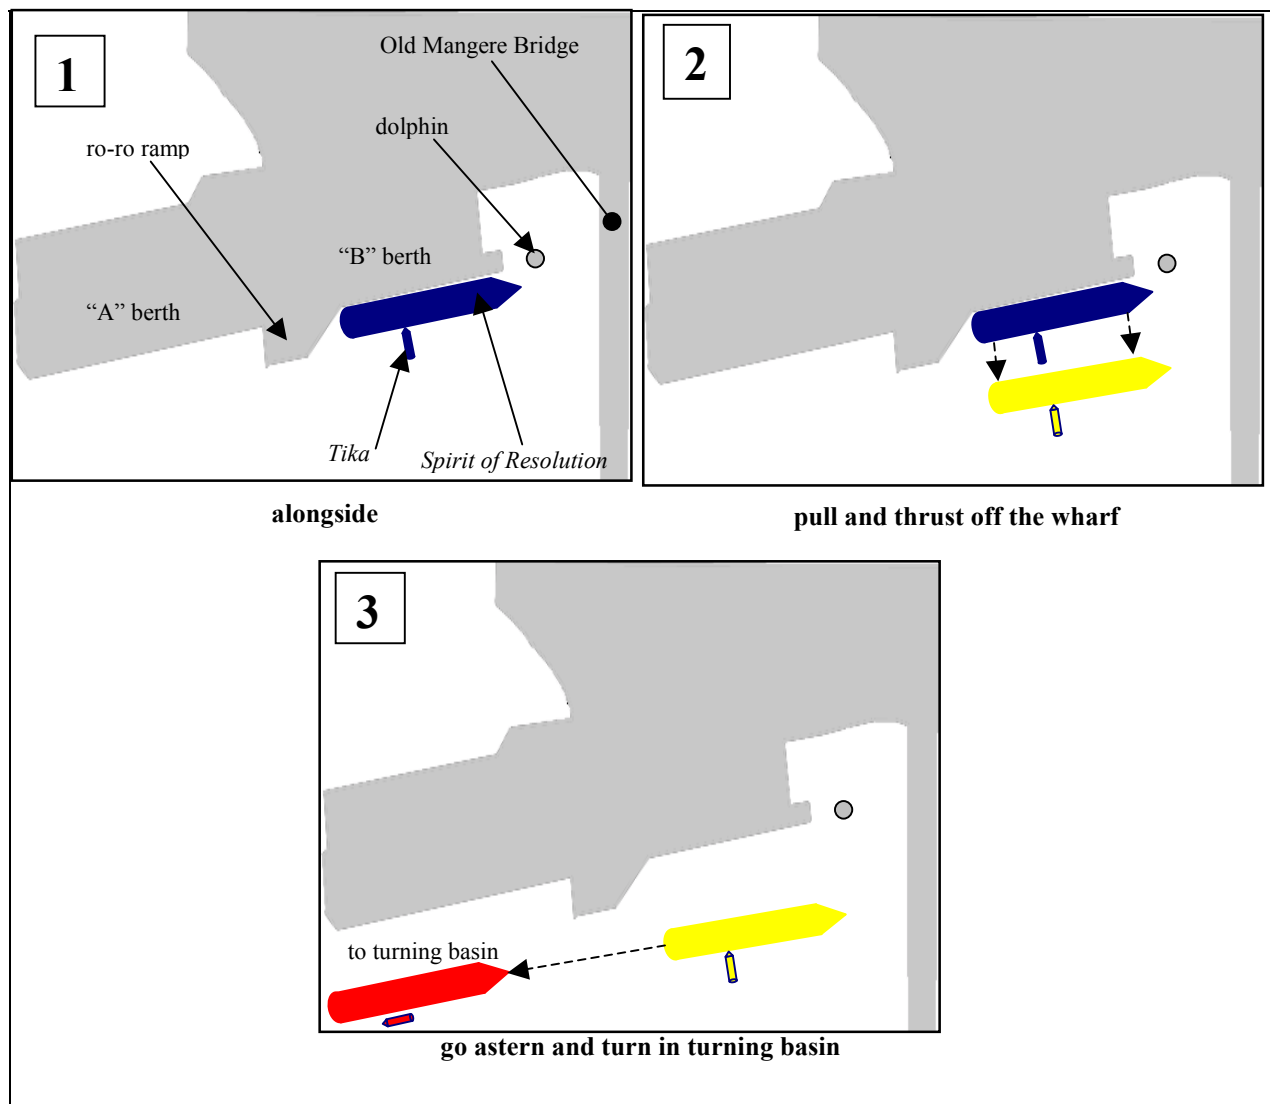
Figure 3
Diagram of Master's intended departure plan

1.1.11 The Master's plan was to let go the mooring lines, use the tug and bow thruster to move the ship off the Wharf, manoeuvre the ship stern first to the first pair of beacons that mark the start of the channel and at that point turn the ship and proceed out (see Figure 3). The Master stated later that this was not a manoeuvre he had done before, however it was a manoeuvre the ship had completed previously although he did not know when or in what weather conditions.

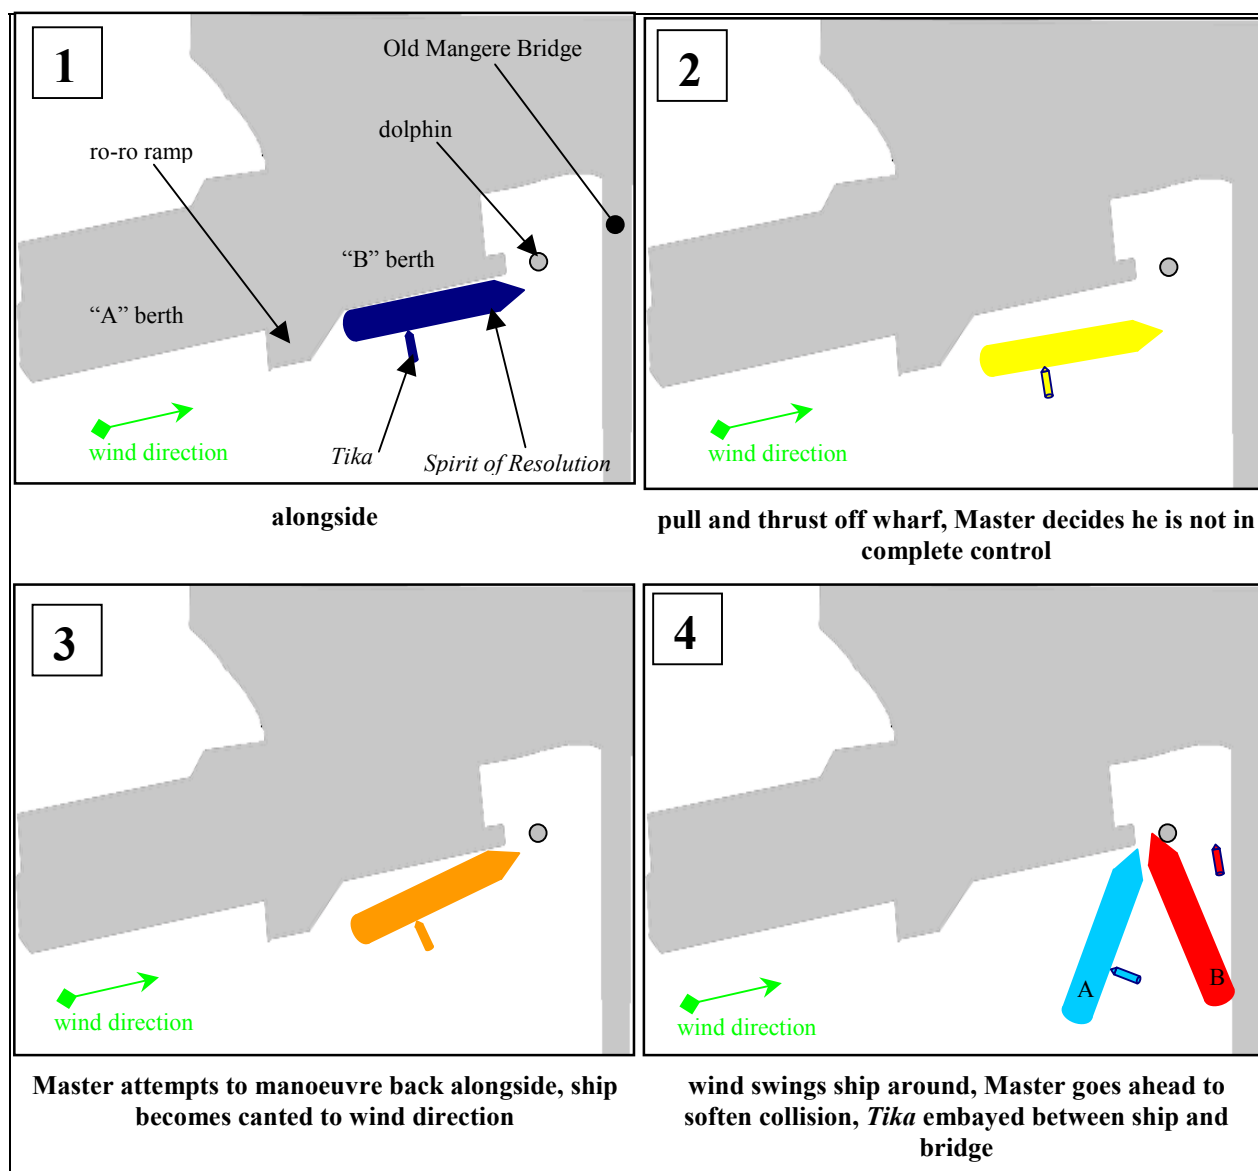
Figure 4
Diagram showing sequence of actual events

1.1.13 At about 1258, the Master ordered the forward and aft mooring parties to let go all mooring lines. As the lines were let go, the Master ordered the tug Skipper to pull off with full weight, and increased the thruster power to full to starboard. The ship slowly came clear of the Wharf. The Master found that he had to increase the pitch on the controllable-pitch propeller to 50% astern thrust to maintain the ship's position in relation to and parallel to the Wharf (see Figure 4, diagram 2).

- 1.1.14 At about 1303 the Master realised that he was not in full control of the ship, and after a short discussion with the First Mate, made a clear decision to re-berth the ship. He used the portable VHF and UHF radios to inform the 2 mooring parties and the tug Skipper of his decision.
- 1.1.15 The Master then told the 2 mooring parties to attempt to run some mooring lines as soon as possible. He also told the tug Skipper to push on, and adjusted the bow thruster to full to port.
- 1.1.16 The bow of the *Spirit of Resolution* started to move to port and the forward mooring party was able to send a head line ashore where a shore-side worker fastened it to the bollard on the dolphin. They also managed to send a spring line ashore that was fastened to a bollard on the Wharf (see Figure 4, diagram 3).

- 1.1.20 Realising that the stern of the *Spirit of Resolution* was going to collide with the Old Mangere Bridge, the Master applied full starboard helm and adjusted the pitch on the propeller to give a strong kick ahead in an attempt to soften the impact of the starboard quarter with the Bridge. As a result the bulbous bow was pushed between one of the piles supporting the dolphin walkway and the dolphin itself. The starboard side of the bulbous bow finally rested against the side of the dolphin, with the starboard quarter of the ship against the Bridge. The ship was held in this position by the flood tide and westerly wind, embaying the tug (Figure 4, diagram 4, B).

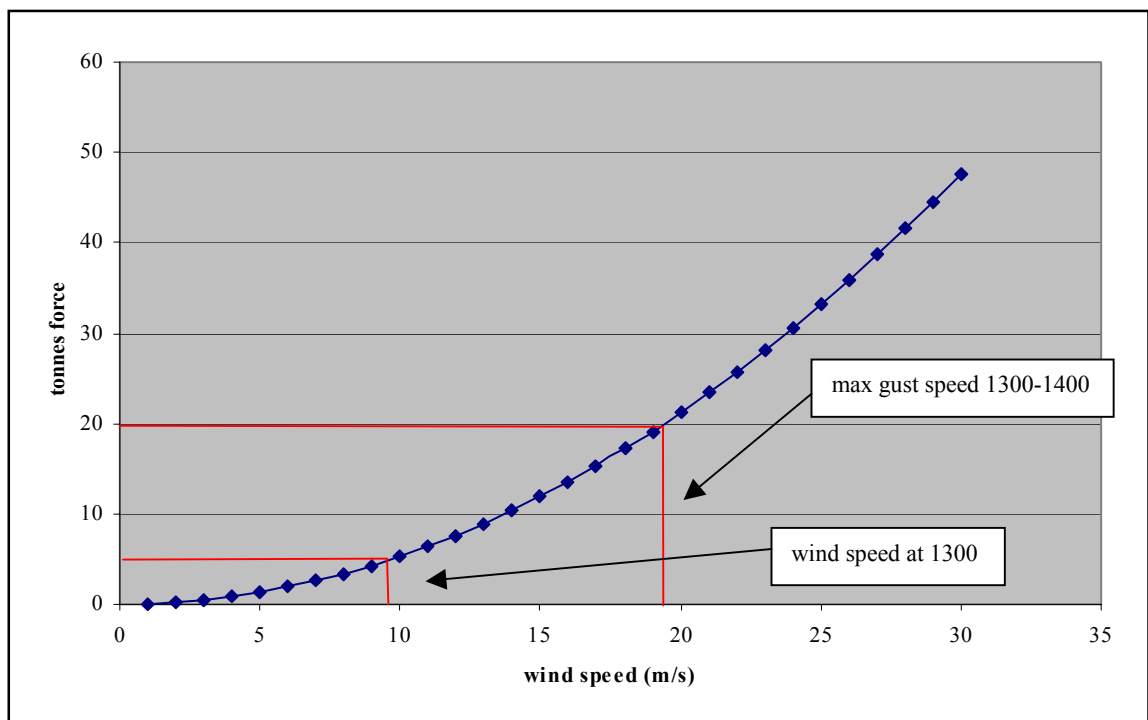
Figure 5
Graph of wind force on the beam windage area of the *Spirit of Resolution*

- 1.2.4 After the incident the windage area of the ship including the deck cargo was calculated to be about 954 m². The force of the wind acting on this area can be calculated from the formula²: Force (t) per 1000 m² = wind speed² (m/sec)/18. Thus the strength of the wind force on the *Spirit of Resolution* varies exponentially to the speed of the wind in metres per second (see Figure 5).
