## M A R I N E   O C C U R R E N C E   R E P O R T

- 05-212            restricted limit passenger vessel, *Milford Sovereign*, loss of      20 November 2005  
directional control, Milford Sound
- incorporating:
- 06-206            restricted limit passenger vessel *Fiordland Navigator*,      8 July 2006  
heel due extreme wind gust in Milford Sound

## **Report 05-212**

### **restricted limit passenger vessel *Milford Sovereign***

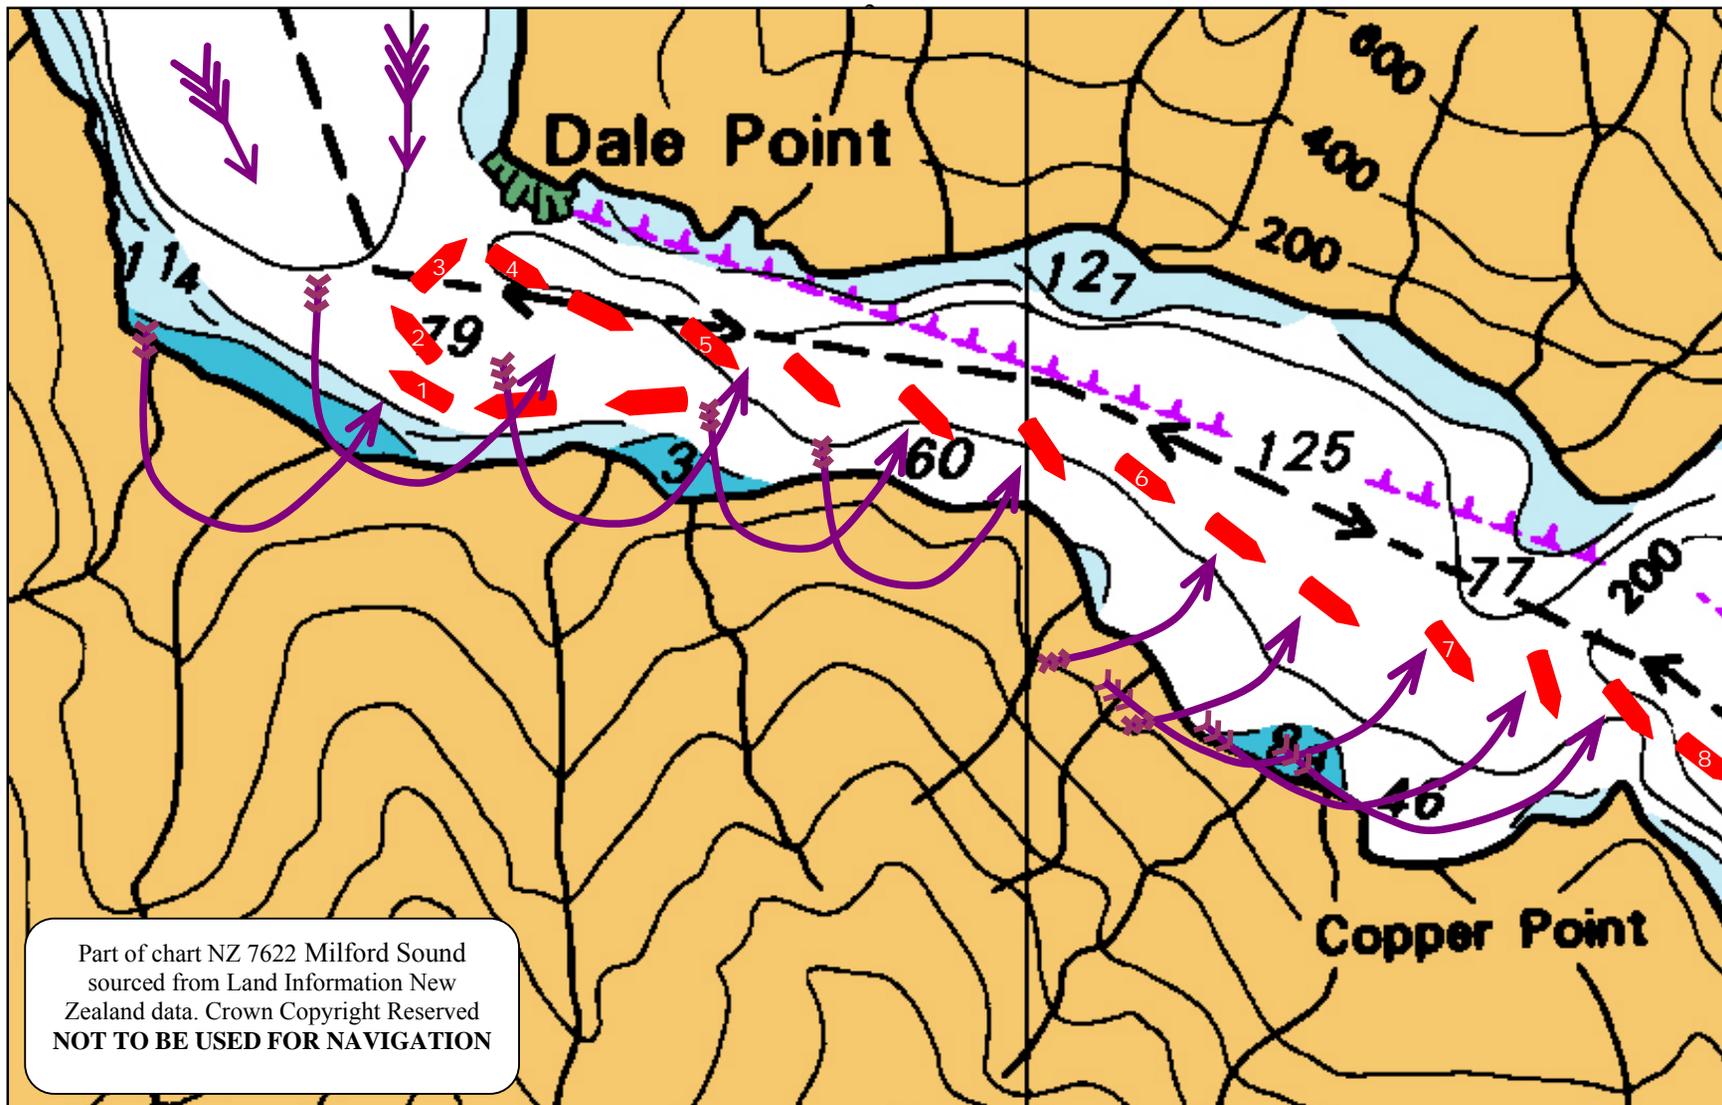
Figure 2  
Chart showing incident sequence

Position number	Estimated		Approx heading	Approx intended course	Remarks
	Wind direction	Wind strength (knots)			
1	SW	60+	290	290	Gust of wind hits the port bow of the ship. Master attempts to maintain the ship's intended track
2	SW	60+	310	290	Ship fails to respond to engine and helm. Master decides to turn the ship around and return to inner Sound
3	SW	60+	020	turning	Starboard engine astern, port engine ahead, ship continues to turn to starboard, putting its stern through the wind
4	SW	<60	110	110	Ship steadies on a course to return to the inner Sound
5	SW	60+	130	110	Starboard quarter of the ship hit by gust of wind, causing the ship to deviate again from its course. Master unable to return the ship to its intended course. Ship carries on down the Sound approximately in its intended direction but lying across the wind
6	SW	30	125	125	Wind eases and Master brings the ship back to its intended course

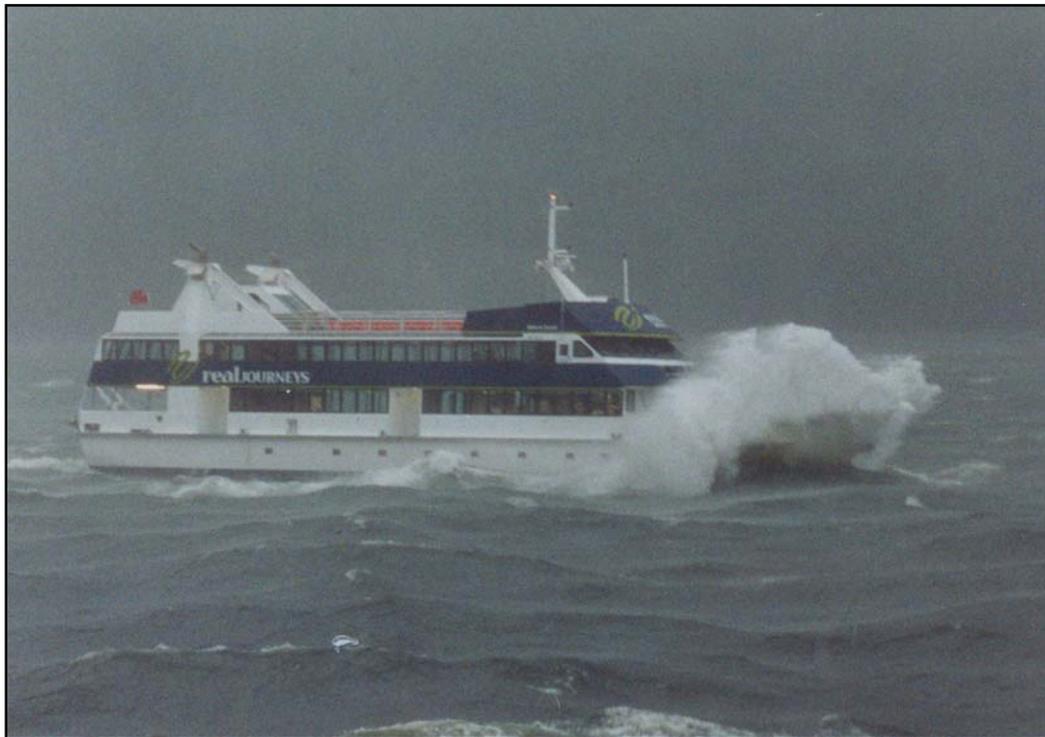
**Figure 3**  
**The *Milford Sovereign* on 19 February 2004**  
**An example of the weather that can be experienced in Milford Sound**

- 1.6.2 On 19 February 2004 (see Figure 3) and 21 February 2004, extreme weather conditions were experienced in Milford Sound and a number of loss-of-control incidents involving the *Milford Sovereign* occurred on those days. No ship incident reports were completed, so the record of these incidents was limited to an internal report from the shore-based Area Manager for Milford Sound and a later report by the Safe Ship System Manager/Chief Launchmaster. On both days the Master had trouble controlling the ship, but on 21 February that loss of control almost resulted in the Master deciding to ground the ship intentionally.

- 1.6.4 During the period of bad weather between 19 February 2004 and 21 February 2004, the wind was of sufficient force to cause damage to the roof of the Milford Sound tourist centre and to a number of cars in the car park to the south of the tourist centre. In comment on the preliminary report, Real Journeys said that there was anecdotal evidence that the anemometer on the bridge of the *Milford Sovereign* indicated 110 knots during the incident on 21 February 2004.

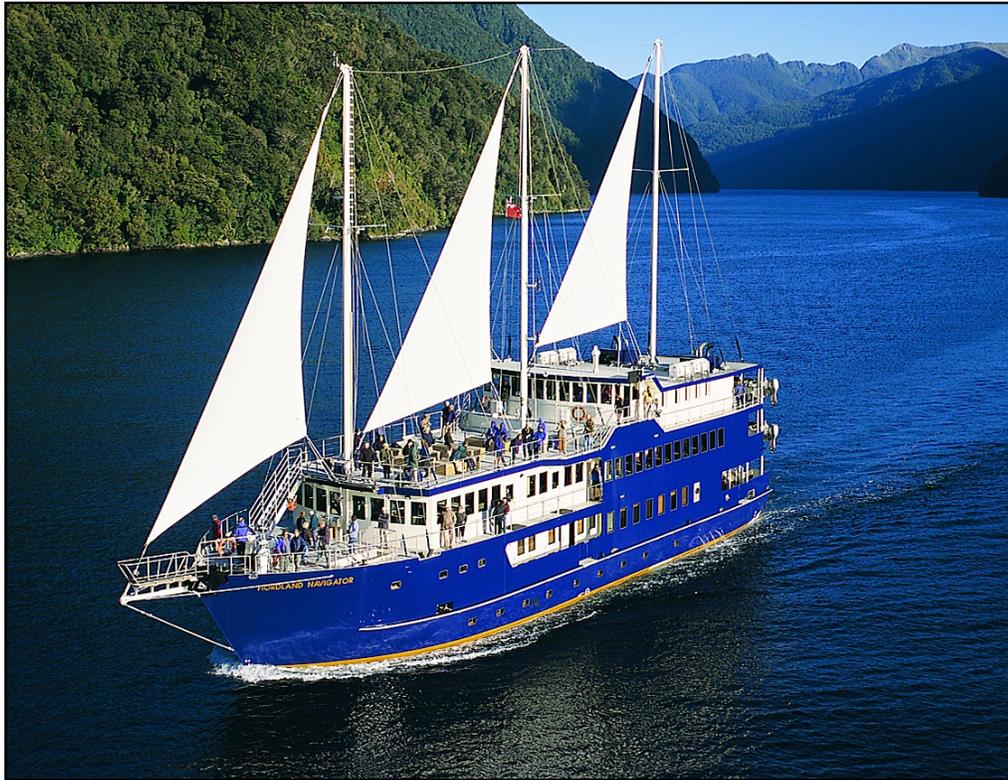
**Figure 5**  
**The *Fiordland Navigator***

- 1.12.8 The *Fiordland Navigator* was purpose built for the Fiordland tourism industry. It was a restricted limit passenger ship, of monohull form. Real Journeys built the ship at its facility in Bluff. The keel was laid in 2000 and construction was completed in November 2001. The ship was certified to carry 100 passengers in the enclosed area and could carry, and had berths for, 85 passengers in the inshore area. The ship had a length overall of 40.0 m, a gross tonnage of 693, a breadth of 10.0 m and an operating draught of 1.9 m.

- 2.26 The *Fiordland Navigator* had a high superstructure and masts similar to those on the *Milford Mariner*, the ship it was replacing in the Milford Sound operation. The Master of the *Fiordland Navigator* had trouble maintaining a course during the return inward passage as they passed along the northern side of the Sound. This suggested that the directional control of the ship was less than optimal and that a keel, as recommended by the independent naval architects for the *Milford Sovereign*, would be equally advantageous for the *Fiordland Navigator*. Although the Master did not estimate the sideways slippage during the heeling event, he was unable to manoeuvre out of the situation, which further suggested that the vessel had poor directional control in these conditions.

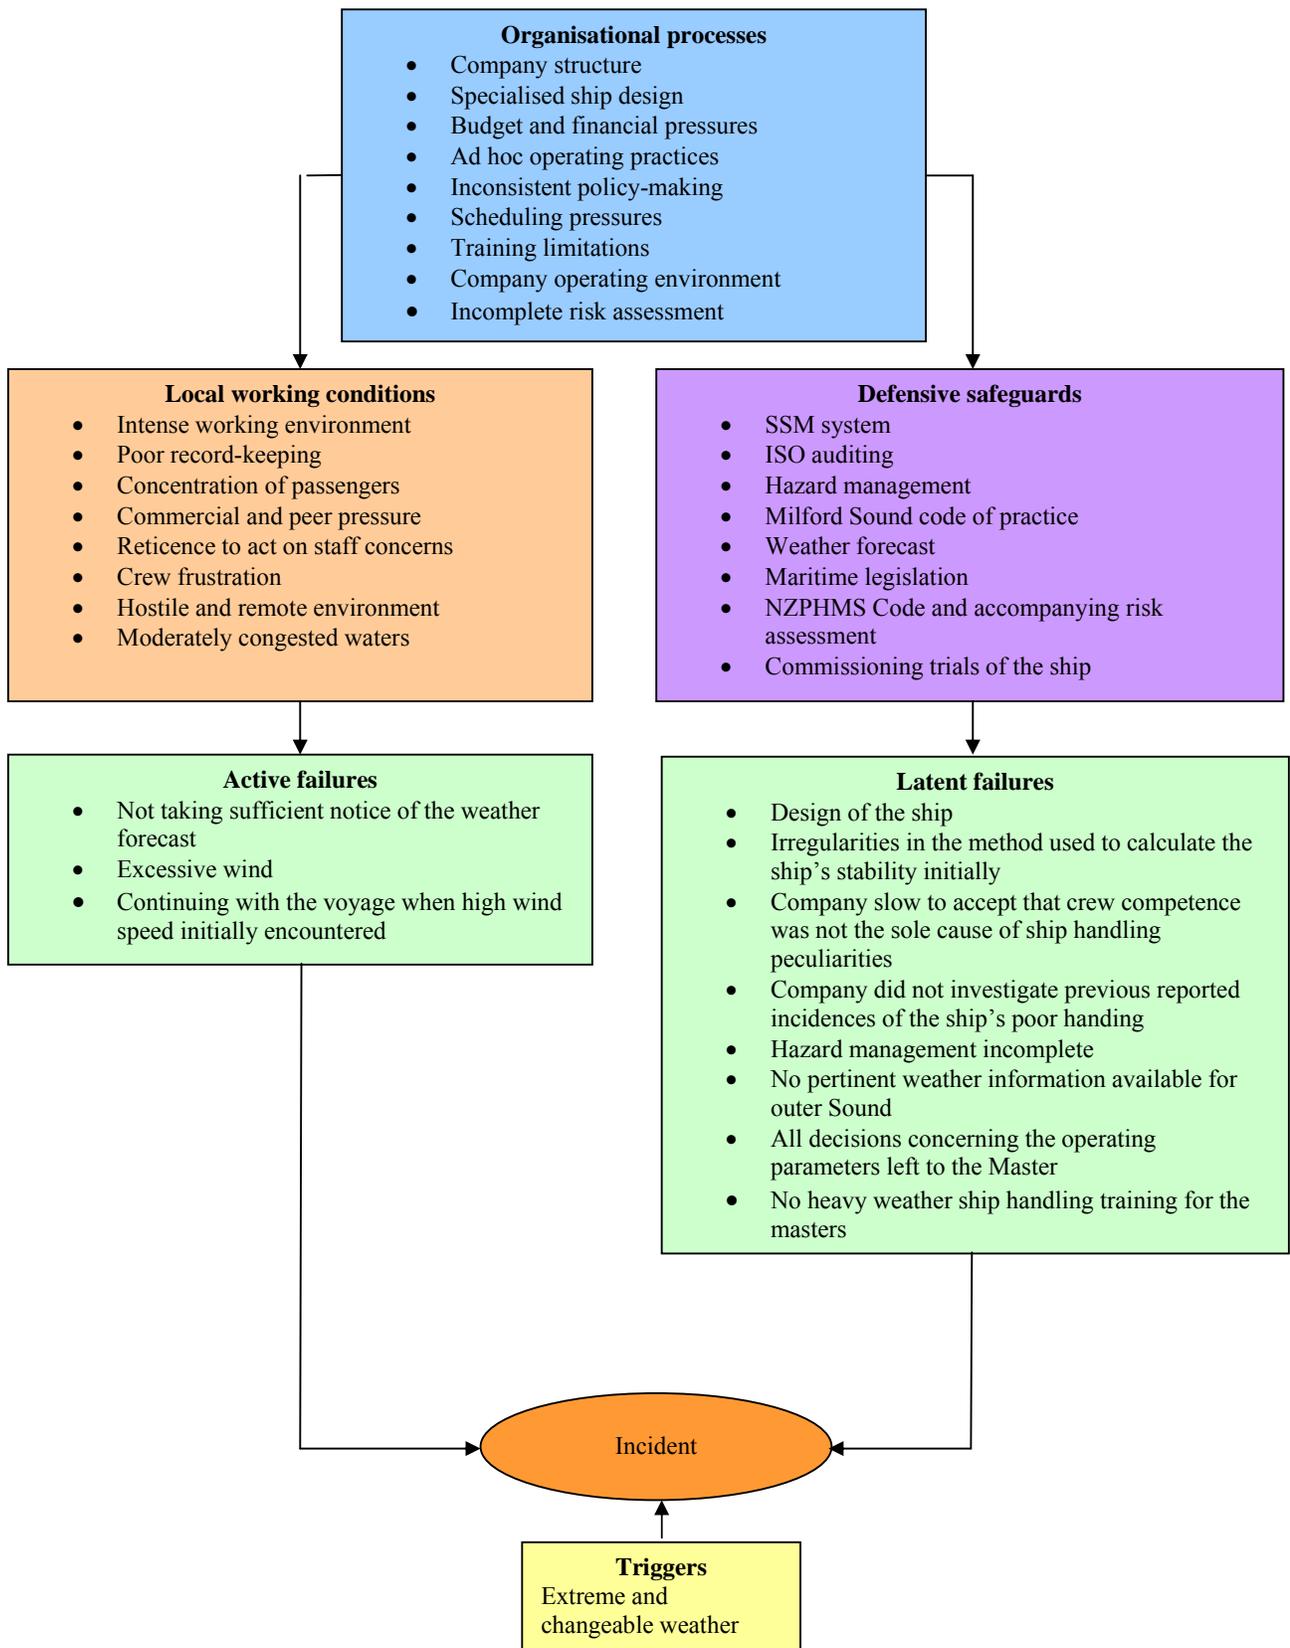
**Figure 6**  
**Causal pathways model**

- the difficulty of, and lack of training for, extreme weather conditions and also the lack of a system for reviewing a master's ability to handle such situations

- the unpredictable and extreme weather conditions
  - the process for assessing whether the *Milford Sovereign* and the *Fiordland Navigator* were fit for purpose, which did not require the specific intended operating area and prevailing environmental conditions to be taken into account.
