AVIATION OCCURRENCE REPORT

06-002

Piper PA 23-250 Aztec, ZK-FMU, wheels-up landing, Napier
Aerodrome

13 April 2006

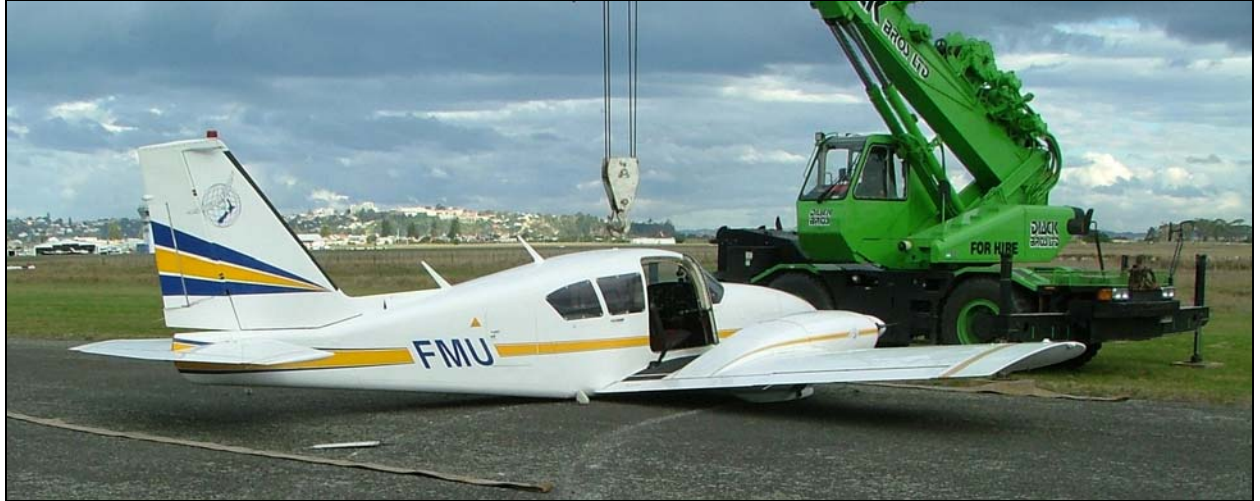
ZK-FMU after the wheels-up landing

- 1.3.1 The left propeller was bent, and the belly of the aeroplane was scraped and some external antennae were broken.

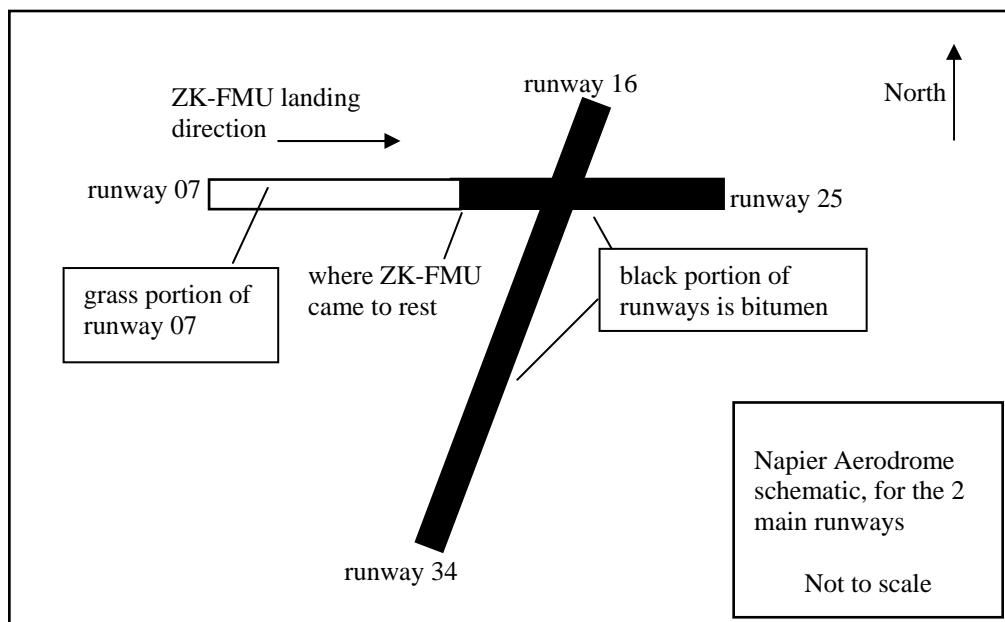
Figure 1
Napier Aerodrome schematic

- 1.1.9 After visually checking the aerodrome wind and surface conditions, and after the emergency services had checked runway 07 grass, the instructor decided to land ZK-FMU on the grass portion of runway 07 (see Figure 1).

- 1.1.14 ZK-FMU touched down smoothly about two thirds of the way down the grass portion of the runway. The aeroplane remained straight until it contacted the start of the sealed portion of the runway, where it slewed about 90° to the right and came to rest. No fire occurred, but the pilots later remarked that there was a smell like burning rubber that probably came from the sidewalls of the tyres rubbing on the runway surface.
