**Report 06-003 Boeing 737-319, ZK-NGJ, electrical malfunction and 12 September 2006  
subsequent ground evacuation, Auckland  
International Airport**

**Report 06-003**

**electrical malfunction and subsequent ground evacuation**

**Auckland International Airport**

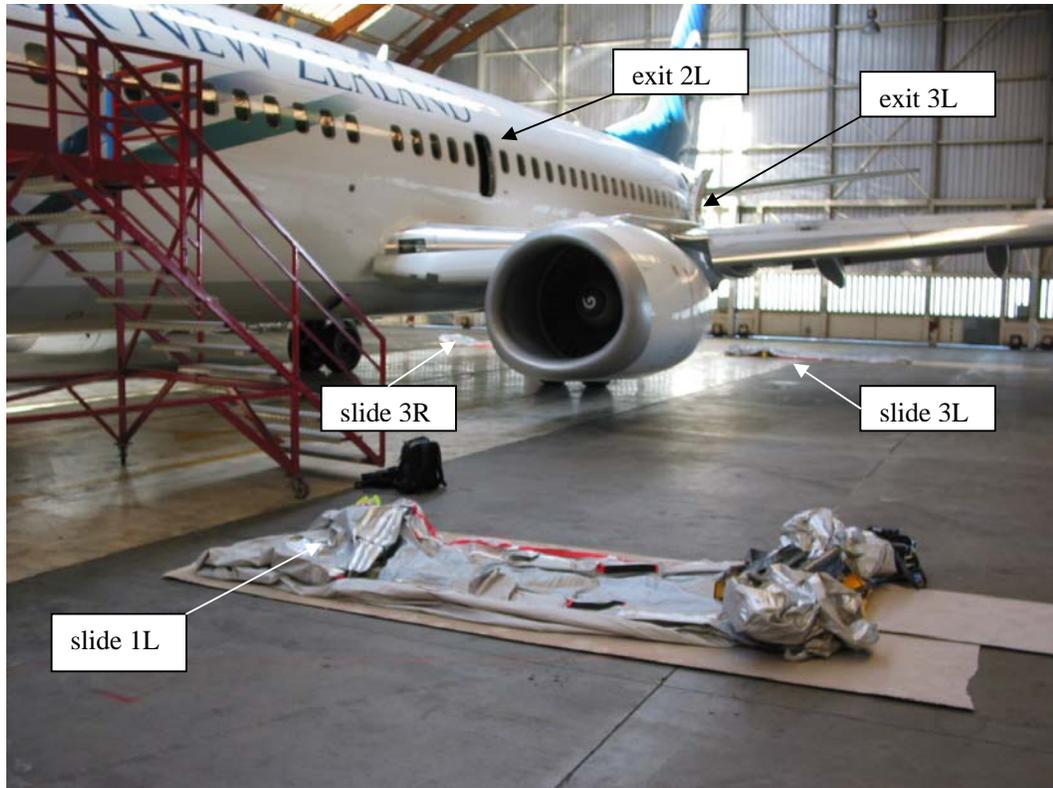
**Figure 1**  
**Boeing 737-319 ZK-NGJ**

- 1.1.18 The 2 FAs said they were initially a little hesitant to open their doors, but on hearing the forward slide deploy they opened doors 3L and 3R at the rear of the aircraft. All slides deployed successfully. The passengers were then instructed to move towards the exits and vacate the aircraft. At the same time, the 2 pilots located at the over-wing exits, 2L and 2R, observed that flaps had not fully deployed so directed passengers to move forward or aft towards the door slides. The pilot at 2L also removed the emergency window exit to help clear the smoke in the cabin. As the evacuation commenced, the purser at 1L noted that the smoke was dissipating (see Figure 1).

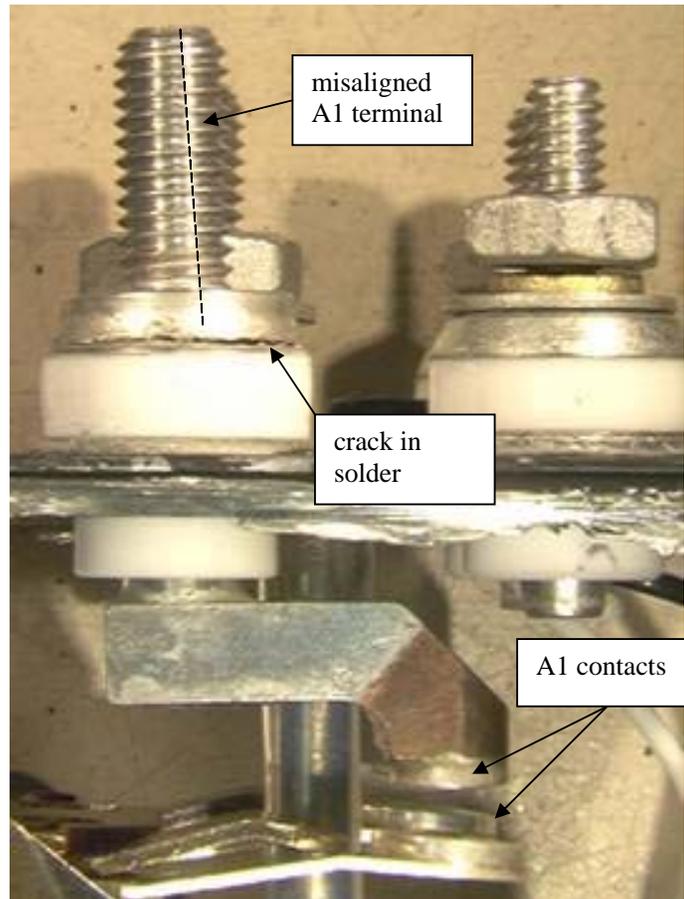
**Figure 4**  
**Side view of A1 terminal and contact assembly**  
(Courtesy of Boeing)

- 1.13.2 The R1 relay was examined to determine the mode of failure. The relay was identified as a Leach International H-X9A-101 relay, serial number 03320, manufactured in 1998 and fitted to ZK-NGJ at production. Visual, microscopic and X-ray examinations identified no defects other than that one of the terminal posts was misaligned and there was a partial circumferential fracture or crack in the solder junction at the base of the terminal where the post entered the relay case (see Figure 4).

- 1.13.4 The relay cover was removed and further load testing undertaken, resulting in arcing being observed on the A1 contact pair at both make and break.<sup>14</sup> Further examination identified a larger gap at open for the A1 contact pair than the A2 contact pair, at 0.072 inches and 0.042 inches (1.82 mm and 1.06 mm) respectively. Evidence of arcing and material transfer was also noted on the A1 contact pair. The B contacts were considered normal.

- 1.13.6 Boeing advised the Commission that "cracking of the solder junction in earlier manufactured relays has previously been documented". Boeing noted that voids in the solder reduced the ability of the junction to withstand torque being applied during repeated removal or installation of the wire lugs attached to the terminal. Further, the stress condition could be exacerbated by the attached wiring bending or vibrating.

Boeing believed that the failure in ZK-NGJ was unique in that the contact gap at A1 was so large in comparison with A2. Boeing reported that there was "no data or experience to suggest this discrepancy is the result of a batch or widespread problem". Boeing also noted that "this condition has not previously been witnessed during any previous analysis at Boeing". The relay manufacturer has been notified of these findings and the apparent manufacturing discrepancy.

than-normal gap between the A1 contact pair, probably resulting from the terminal post being misaligned during manufacture. Over time, the contacts overheated, causing arcing and fatigue. A fracture at the base of terminal stud A1 was initiated and propagated around the solder junction, increasing the gap, causing material transfer and further reducing the contact forces. Eventually there was sufficient vibration during the take-off roll to cause the contacts to release and stop current flow to the battery bus.
