AVIATION OCCURRENCE REPORT

06-004

Robinson R44 *Raven II*, ZK-HUC, wire strike, Motukutuku Point, near Punakaiki, Westland

9 November 2006

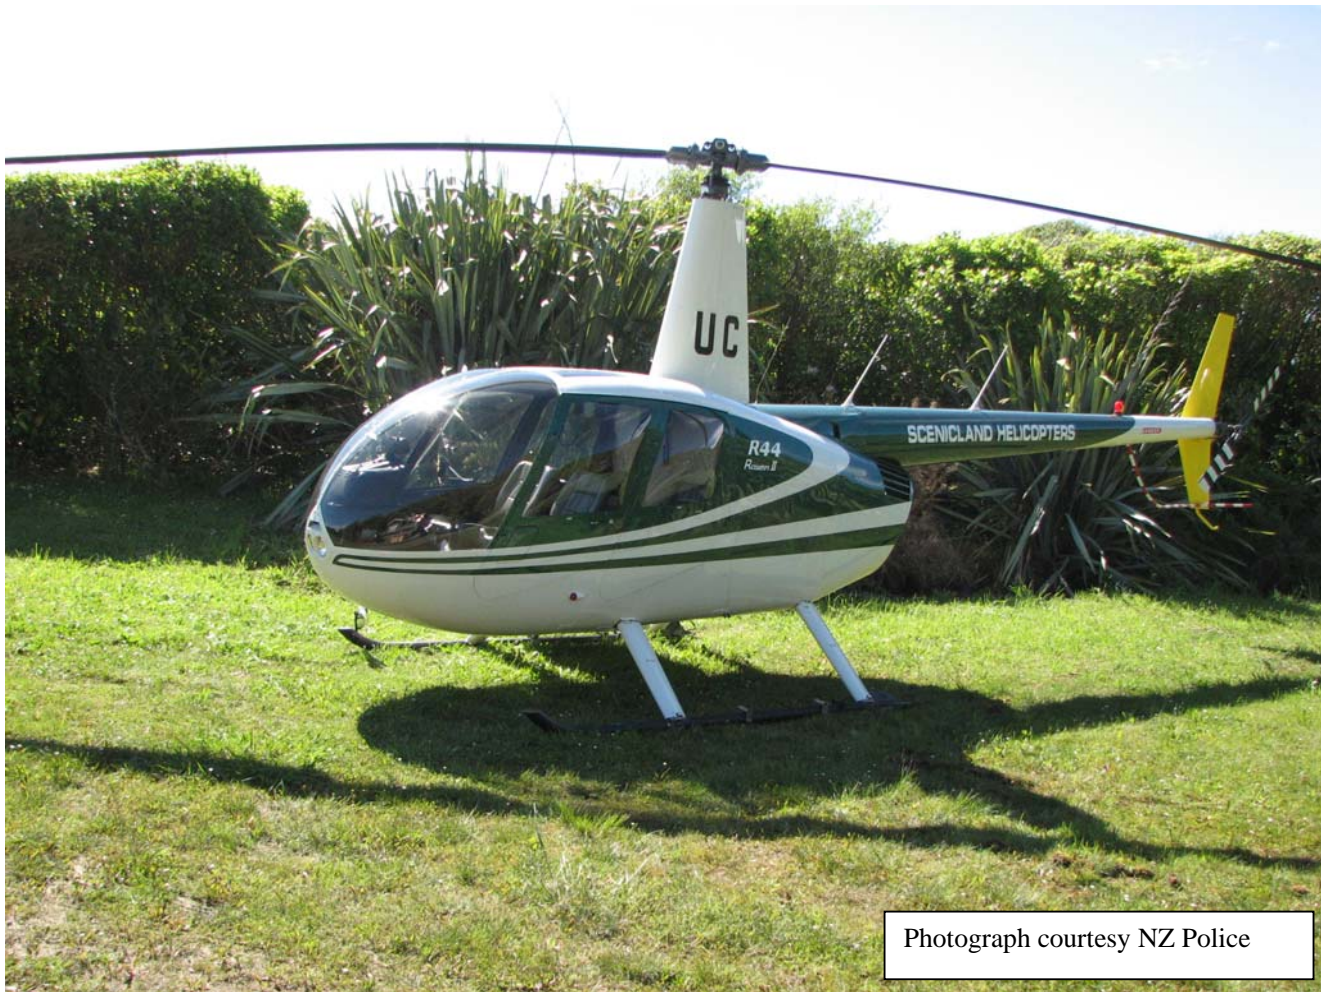
Robinson R44 helicopter, ZH-HUC, following the accident

- 1.3.1 The damage was confined to the front windscreens, the right-hand forward door and both main rotor blades.
- 1.3.2 The damage to one blade was assessed by the operator's maintenance provider as negligible wire grazing, but the skin on the other blade had delaminated. Both blades had to be replaced because of blade pairing requirements. The maintenance provider said that the blade damage found was probably not severe enough to have prevented a ferry flight after the accident.

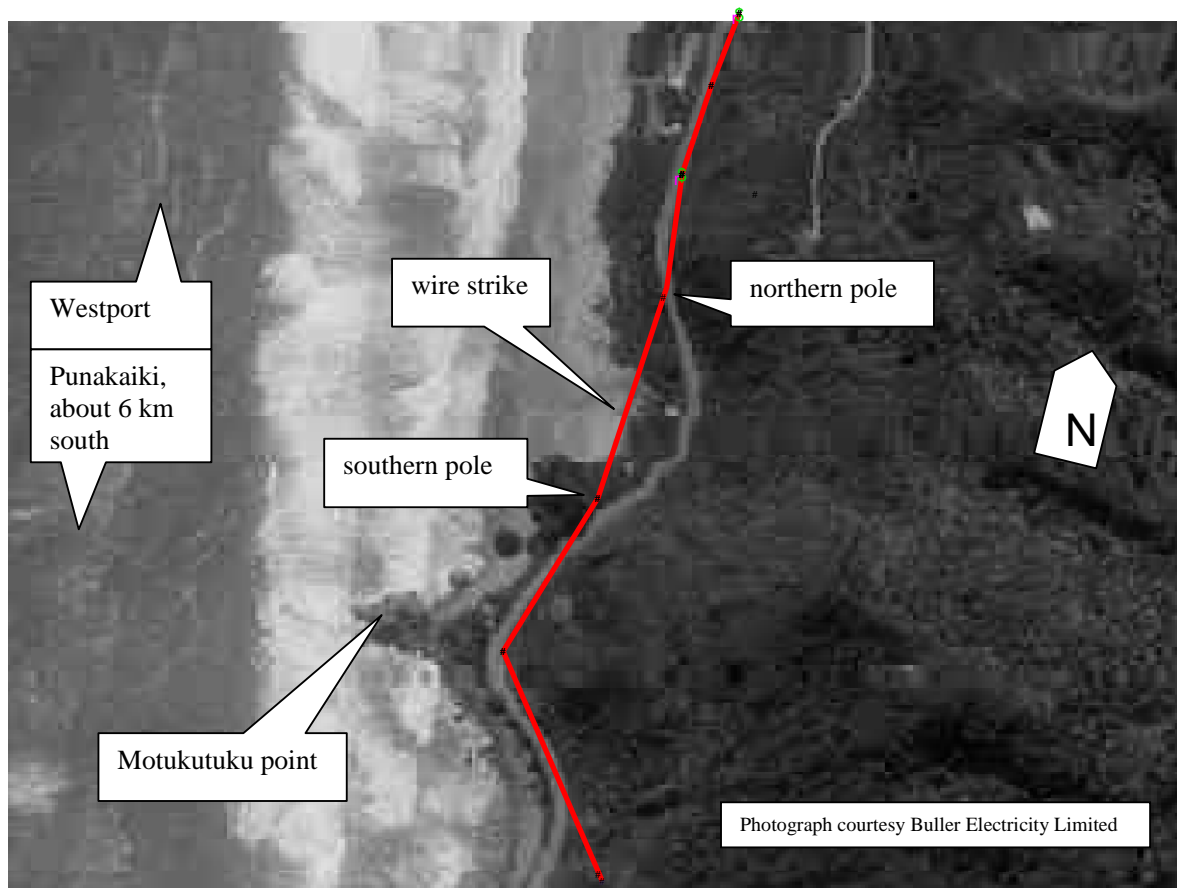
Figure 1
Aerial view of the accident site

- 1.1.11 At about 1356, after flying around Motukutuku Point, the pilot turned slightly to the right towards a small beach and creek. They were flying over the beach when there was a sudden “bang” and some windscreens shattered. The pilot immediately felt winded, but kept control and brought the helicopter to a high hover. He did not detect any unusual vibration.

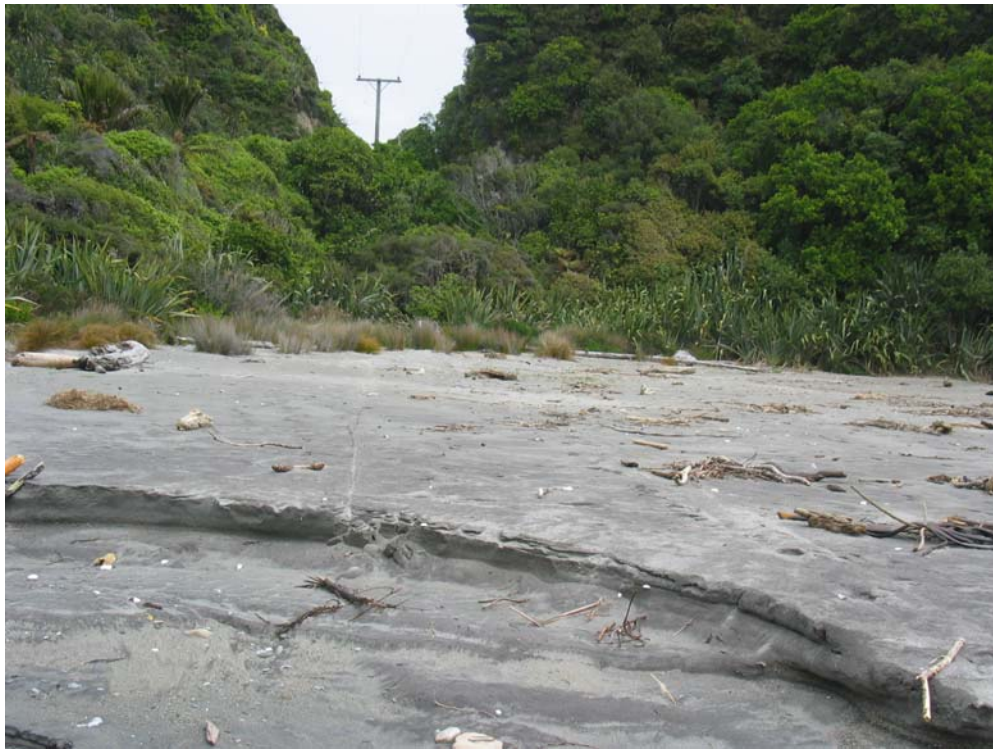
Figure 2
Southern pole in road cutting

- 1.10.4 Since 2000, the local body district plan had required poles, but not lines, in "scenic sensitive" areas such as the coast road to be inconspicuous. The transmission line was erected in 1987, so the environmental requirements of the district plan did not apply, but the line company had achieved the same goal by using poles and cross arms of treated timber that had a green hue, and anodised metal anti-possum bands with a bronze colour. The telephone line poles were also treated timber and often lower than roadside nikau palms. The combination of colour and low height caused the electricity and telephone lines to blend with the surrounding bush.
