06-006 ZK-MYF, Partenavia P68B, loss of engine 2 December 2006
power, Takapau

Report 06-006

**engine power loss and subsequent forced landing
during training flight**

2 December 2006

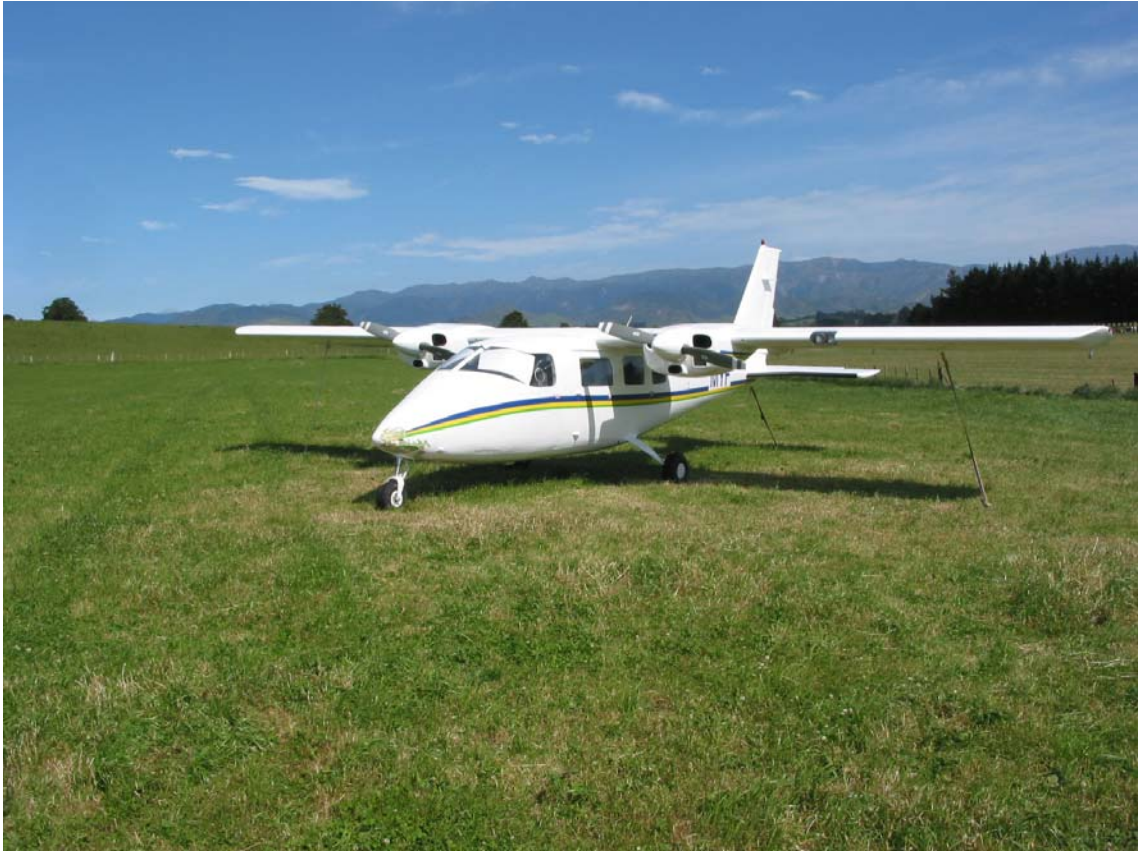
ZK-MYF after the forced landing

1.3.1 ZK-MYF sustained moderate damage, mainly to the nose fairing area and underside of the aircraft. A helicopter lifted the aircraft to a maintenance facility at Palmerston North for repair and return to service.

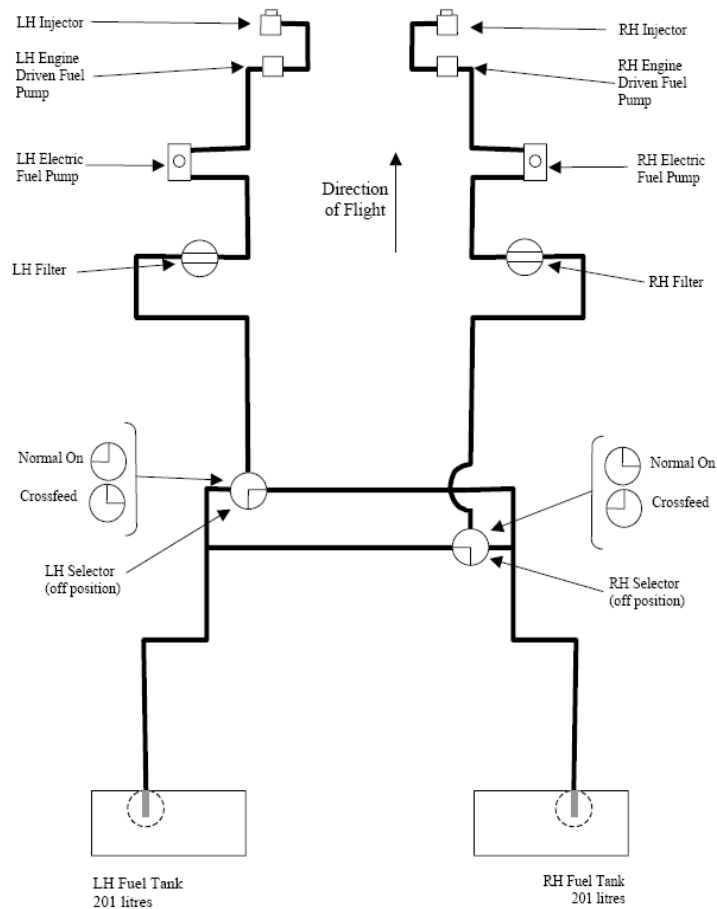
Figure 2
Fuel system schematic

- 1.6.5 ZK-MYF was fitted with 2 integral fuel tanks, one in each wing, with a total capacity of 410 litres. Of this, 18 litres were considered unusable, giving a useful fuel load of 196 litres per tank. Two 3-position fuel selector knobs, one for each engine, controlled the fuel flow. The selector knobs enabled a pilot to select which tank fed which engine. Normally the knobs would be selected for direct tank-to-engine flow; that is, the right engine fuel selector knob would be set to the right tank and the left engine selector knob to the left tank. Alternatively, crossfeed could be selected allowing for flow from a tank to the opposite engine, or if required from one tank to both engines. For example, if the left engine selector knob was rotated to its right tank setting, fuel from the right tank fed both engines. The left tank setting on the right engine selector allowed fuel from the left fuel tank to also feed both engines. The final position was for fuel shut-off (see Figures 2 and 3).

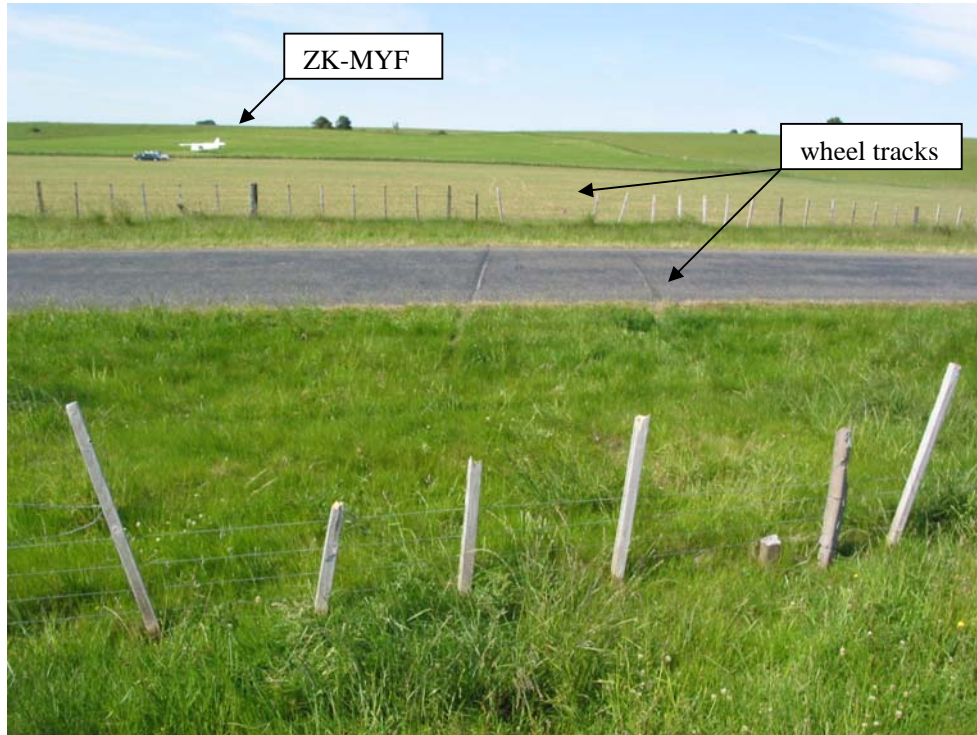
Figure 4
Landing Site

1.9.1 ZK-MYF was flying on a heading of about 200° magnetic (°M) when it struck the top of a fence located on the northern side of a sealed road. The road was about 15° off being perpendicular to the flight path of the aircraft. Tyre marks on the road matched the dimensions of the main undercarriage wheels (see Figure 4).

- 1.9.2 After crossing the road, ZK-MYF broke through a second fence before starting a turn to the left through about 70°. About 230 m from the first fence, ZK-MYF penetrated a third fence before coming to rest after a further 20 m on a heading of 125°M. The site was about 1100 feet above mean sea level.

- 1.9.3 The damage to the nose area and underside of the aircraft, including a broken right brake line, was consistent with the aircraft travelling through the 3 fences. Three strands of fence wire were found wrapped around the hub of the right engine and there were some associated marks on the propeller blades. The engines appeared to be otherwise undamaged.
