Report 06-201

passenger freight ferry *Aratere*

heavy weather incident resulting in cargo shift

3 March 2006

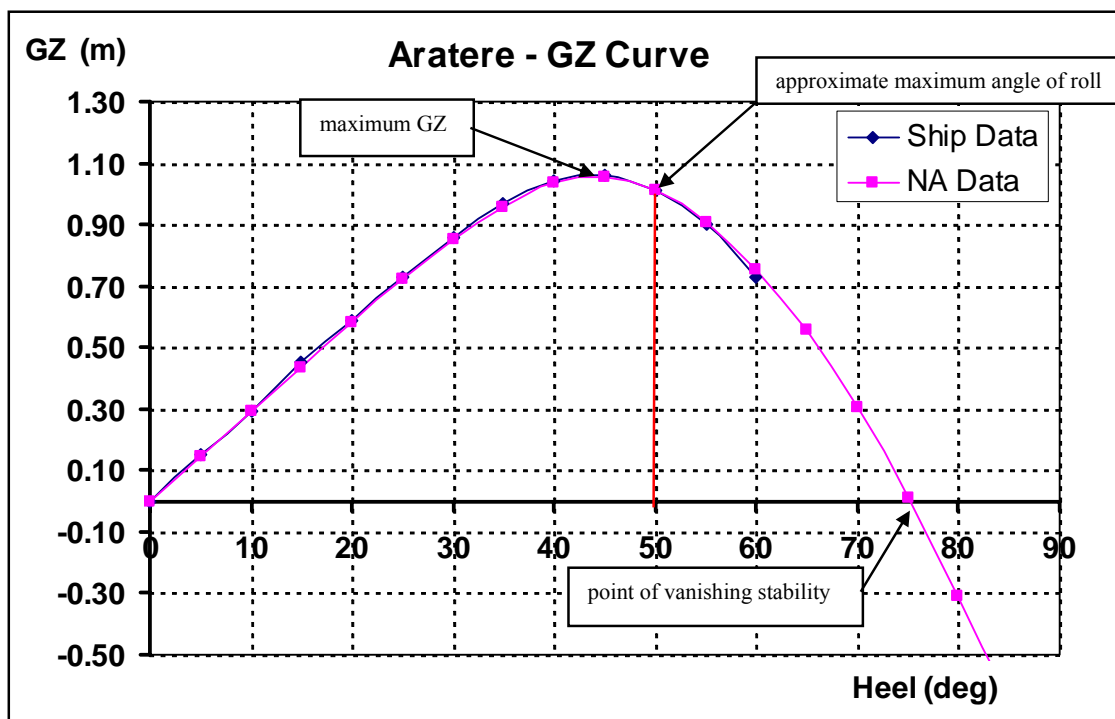
Figure 4
The *Aratere*'s GZ curve for 3 March 2006 sailing

It is not unusual for GZ curves to be conservative at higher angles of heel, and for the vessel to actually have more stability than may be indicated by the curves. This is usually due to items of watertight or semi-watertight structure high up in the vessel being ignored during the calculations, and the flooding of water onto decks (or downflooding) being much slower in practice than is assumed in the analysis.

As part of an earlier study for Toll Holdings Ltd I carried out an independent stability analysis for *Aratere*, using a completely different system, and can confirm that I was able to produce results that were almost identical to those in the stability book at all heel angles. For convenience this analysis ignored all structure above the vehicle deck and focsle decks, whereas there are in fact significant accommodation spaces and casings above these levels. I am therefore confident that the GZ curves in the stability book are a conservative representation of the actual stability of this vessel.

- 1.2.11 The GZ curve shows that the maximum GZ or righting lever occurs at about 45°, and the point of vanishing stability or where the vessel will capsize, was at about 75°. The GZ at the approximate maximum angle of roll on the day of the incidents was about 1.01m. From data contained in the *Aratere*'s stability documentation it was ascertained that the angle of deck edge immersion was about 33° and the openings' flooding line was at an angle of heel of about 49°.
- 1.2.12 To comply with the relevant IMO, SOLAS and Maritime rules the *Aratere* was required to meet certain conditions with regard to stability as detailed below:

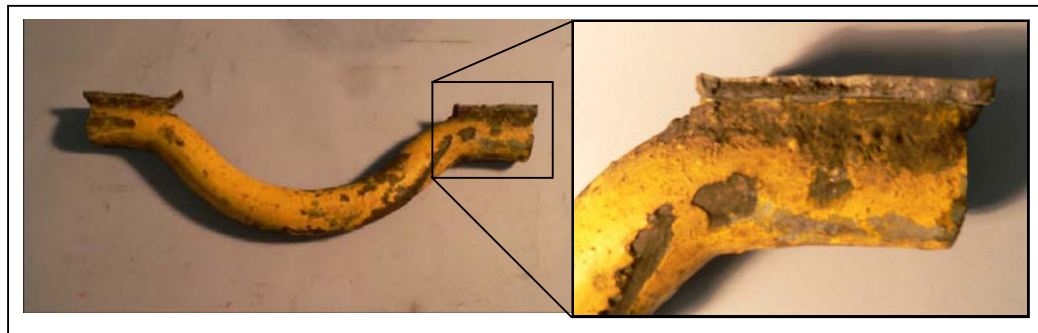
Figure 15
Truck lashing point, magnified end showing failure of base metal below the weld

The metal bracing has failed due to overload in the base material to which the bracing was attached.

One end of the bracing showed the failed base material below the weld. There were no signs of fatigue or defects within the welds at either end of the bracing. The weld between the bracing and the base material was sound and seems to be of a high quality as no failure has initiated in it.

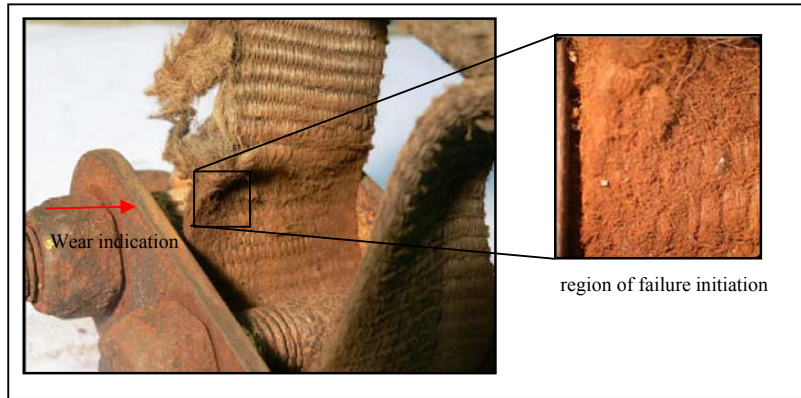
Figure 17
Region of failure initiation in brown intact strop (sample 1) and also wear located on deck attachment.

Failure of a portion of the webbing in the brown intact strop (sample 1) occurred at the bolt on the deck attachment, this is shown in Figure 17. Substantial wear had occurred to the webbing where it contacted the bolt. The length of the failed portion of webbing was consistent with the bolt thread which the webbing contacts with. Indications of wear were present on the top edge of the metal plate on the deck attachment, adjacent to the failed portion of webbing, caused by contact with the webbing as shown in Figure 17.

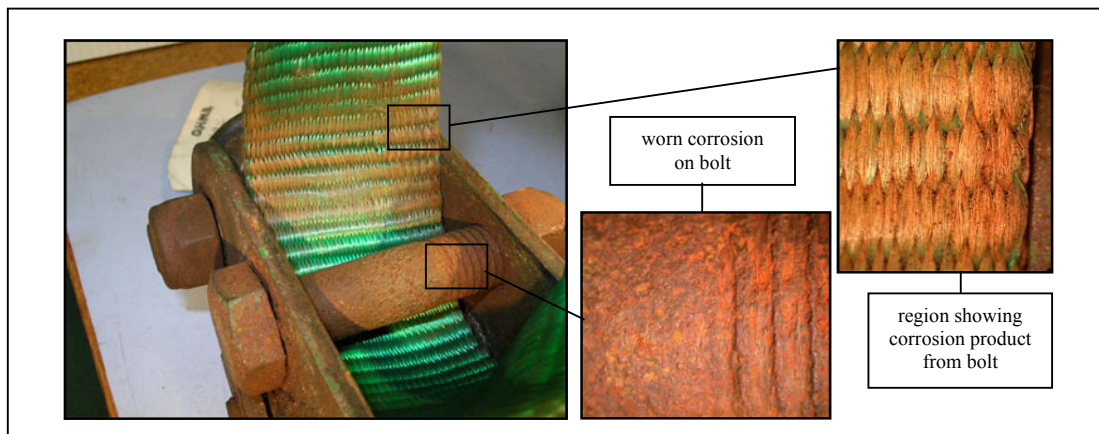
Figure 18
Region of wear around bolt, green intact strop (sample 4)

The green intact strop was in good condition and appeared relatively new. Signs of wear and of embedded corrosion product were present in the webbing around the bolt (see Figure 18).

The bolt was corroded but appears to be relatively new compared with the bolts examined in the other three samples. The surface of the bolt was rough and the thread of the bolt with this corrosion was very sharp. Wear damage was noted on the edges of the green strop where it had contacted the edge plates on the deck attachment.

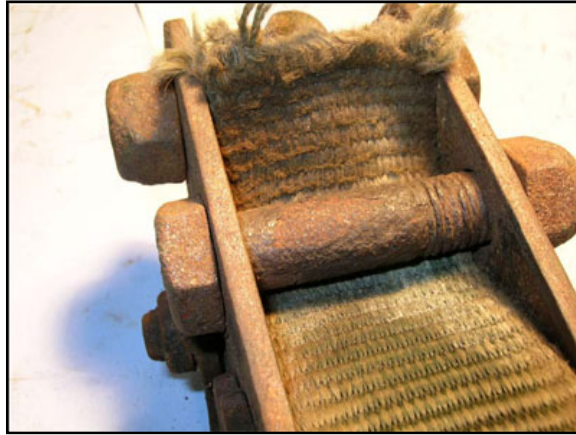
Figure 19
Location of failure in brown broken strop “A”

There was extensive corrosion product and failed fibres present within the webbing in the region of contact with the bolt.

Corrosion product and failed surface fibres are present in this representation and the overall condition of the webbing is well worn.

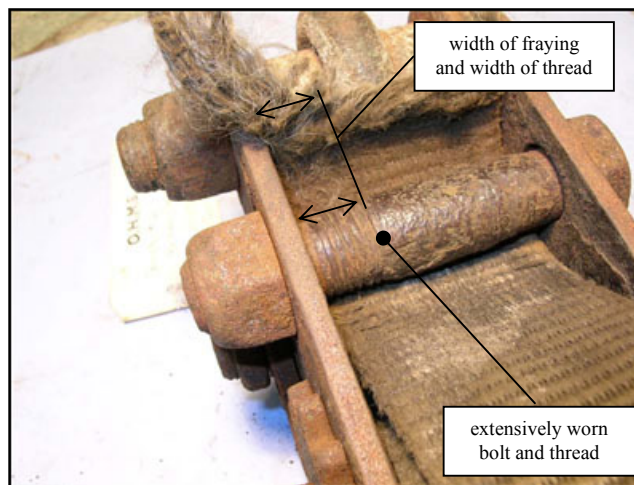
Figure 20
Location of failure in brown broken strop “B” and extensive wear on bolt and thread

The condition of the webbing overall is similar to the brown broken strop “A”, this being well worn. The bolt was heavily corroded and rough.
