**Report 06-204, fishing vessel, *Kotuku*, capsize and sinking, Foveaux Strait,
13 May 2006**

**fishing vessel
*Kotuku***

capsize and sinking

13 May 2006

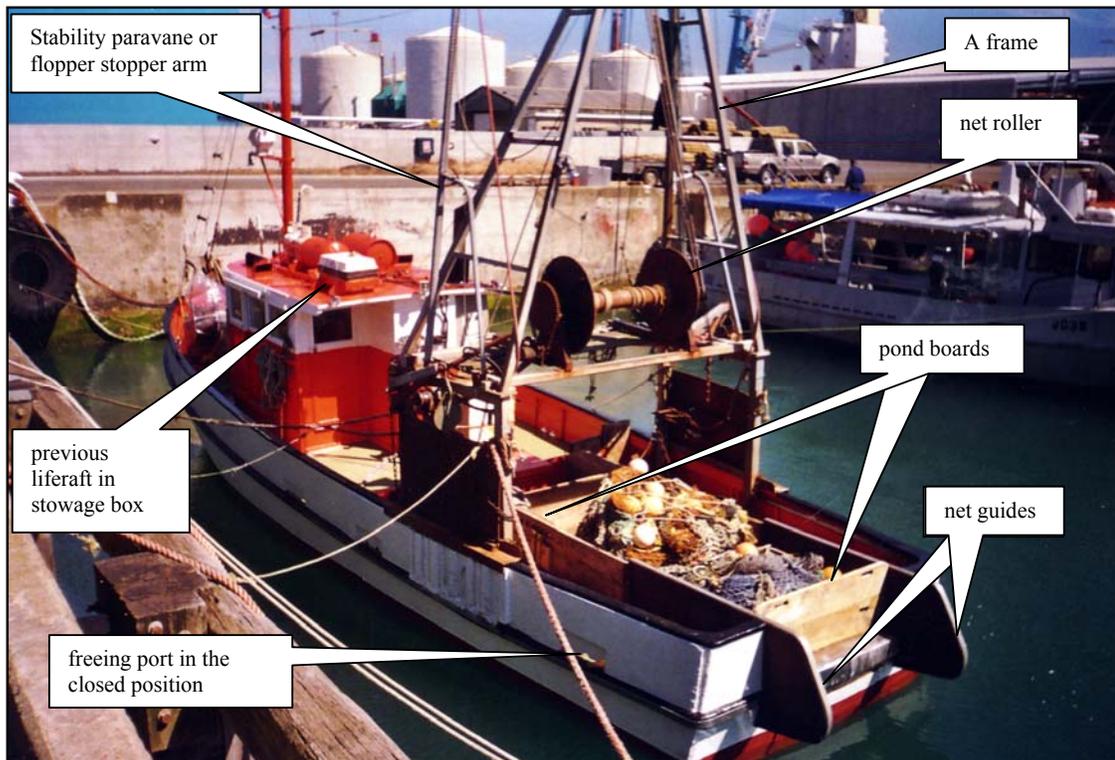
Figure 5
Afterdeck of the *Kotuku* in 2005

- 1.2.11 The net effect of the modifications over the years was to raise the centre of gravity of the vessel, increase its displacement and increase its trim by the stern. For example, the gantry that replaced the mast and derrick was of substantial construction and therefore added weight above the decks, and the net roller and accompanying net was additional weight, again well above the centre of gravity.

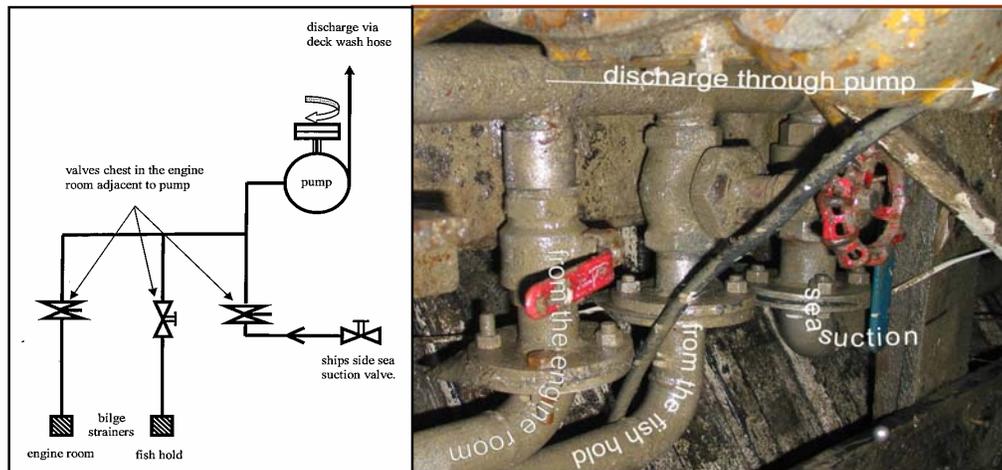
Figure 7
Bilge system diagram and photograph

- 1.2.20 The primary bilge and deck wash system was operated by a Renown main engine belt-driven pump that was rated at 25,000 litres per hour at 3250 rpm (see Figure 7). The pump was later tested and a flow of 18,000 litres per hour was achieved at 1400 rpm. The drive belt was connected directly to the main engine and so pumped continually when the engine was running. The system was generally set up to draw seawater through the sea suction and discharge it via the deck wash hose (see Figure 7). To pump the bilges the valves needed to be set to close the sea suction and to draw from the engine room or fish hold, the discharge being through the deck wash hose. The valves to the fish hold or engine room bilges were not of the non-return type and so would not prevent back flooding through the bilge system.

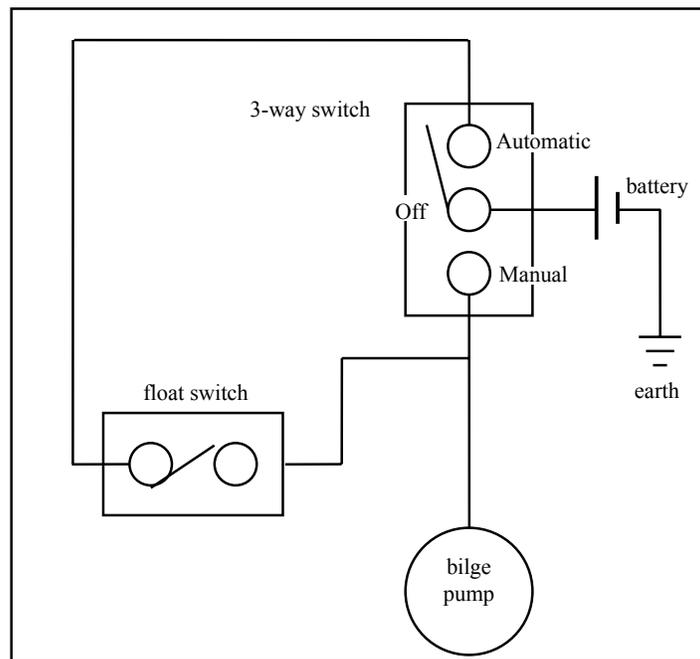
Figure 8
Circuit diagram of the 24-volt bilge pump and float switch

1.2.22 When the vessel was recovered, the wiring for the 24-volt submersible bilge pump and associated float switch was found to be in poor condition. The pump was controlled by a domestic 3-way electric switch, which was mounted low on the panel forward of the bench seat on the starboard side of the wheelhouse, next to the engine room entrance. The switch moved horizontally and its positions were:

After recovery of the vessel, the switch was found in the centre, or off, position. One of the wires from the switch was found disconnected; this was later identified to be the connection on the automatic side of the switch. The wiring between the pump, the float switch and the battery was joined by a non-weathertight connector in the propeller shaft recess.

The control switch had no continuity reading, the terminals were cleaned with a wire brush, but still no continuity. The switch was opened and severe corrosion, green fur probably from immersion in salt water and then exposure to air was found. The wiring to the switch was intact except for the return wire from the float switch, which was found clear of the terminal with the wire stiff with similarly stiff and broken insulation. There was a small piece of insulation tape attached to the end of the wire.

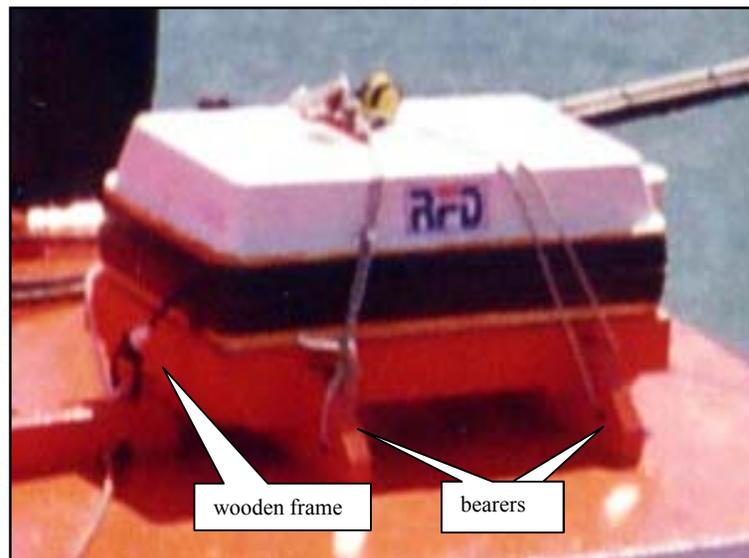
Figure 11
Surviva-6 RF liferaft in its cradle

- 1.10.11 When the *Kotuku* was recovered it was noticed that the liferaft was wedged into the cradle (see Figure 12), so tests were carried out to determine what force was required to free it (see Appendix 6). There was a slight difference in the test results between when the carpet strips between the cradle and the liferaft were wet or when they were dry. An overall force of about 60 kg was needed to lift the liferaft from the cradle. The dry weight of the case and liferaft was about 40 kg, so a holding force of 20 kg was being exerted on the liferaft. The vertical shoulders on the cradle indent prevented any sideways movement of the liferaft. The painter grommet was aligned with one of the cradle indents, further tightening the fit.

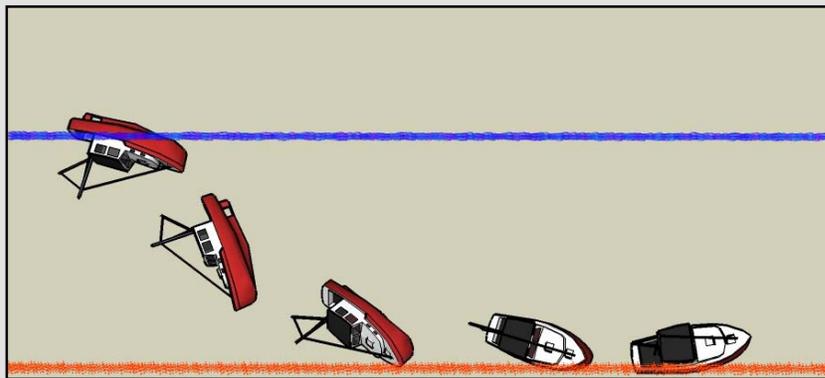
Figure 14
Probable sinking sequence

- 1.11.12 The survivors that remained with the vessel noted that it started to settle by the bow, a situation that could be expected due to the differences between the water plane shape of the bow and the stern. The damage to the forepart would suggest that the vessel was nearly vertical when the bow impacted the seabed (see Figure 14). The only other damage to the superstructure was a slight crack in the wooden mast forward of the wheelhouse, which was possibly due to the vessel pivoting on it as it settled towards the seabed.

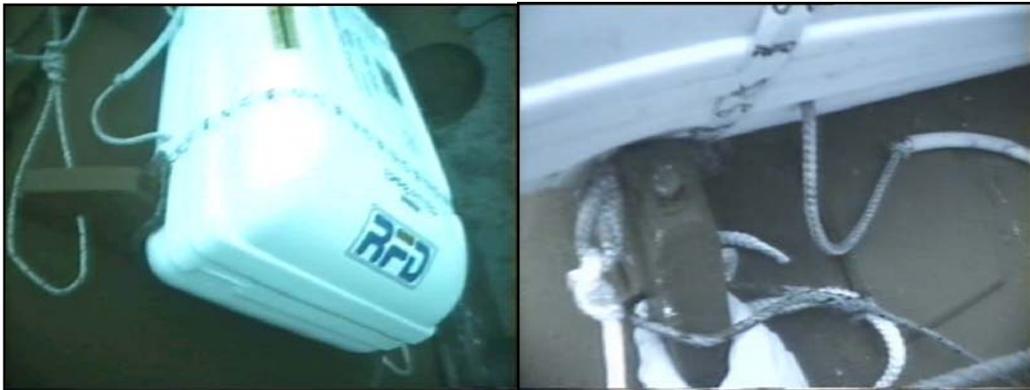
Figure A5.1
Still captures from the diver's underwater video

- the vessel was lying on its starboard side at an angle of about 70° from the upright
- the stabiliser paravanes were in the stowed position
- the fish hatch was missing (this was recovered as flotsam); there was no means of securing this hatch. The after stainless steel hatch was ajar but held in place by an athwartships lashing that was made fast to eyes on the hatch coaming
- the liferaft was in its cradle, with the lashings lying clear of it; the HRU was missing except for part of the weak link that was attached to the starboard lashing. There was carpet packing pieces between the liferaft and the cradle. The liferaft painter was intact and attached to the after cradle bearer (see Figure A5.1)

- the after wheelhouse door was closed but the bolt was not home. The glass from the window in the door was broken. All other wheelhouse windows were intact. The toilet/shower door was in place and closed. The port wheelhouse door was missing

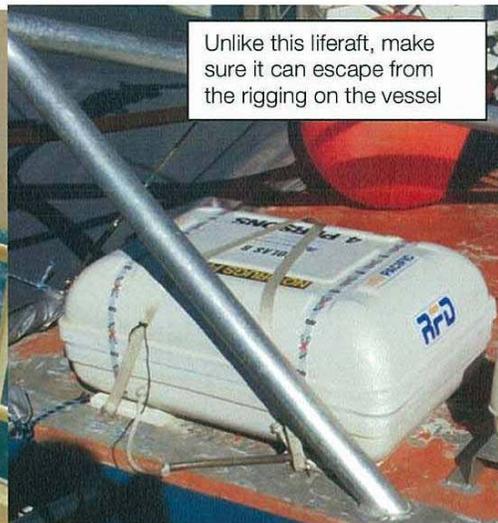
Unlike this liferaft, make sure it can escape from the rigging on the vessel

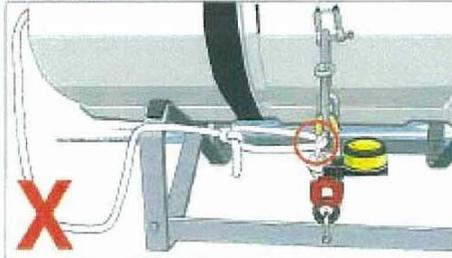
Painter secured to HRU
(not through weak link)

1. HRU will activate
2. Liferaft will be released but will **NOT** automatically inflate and will eventually drift away

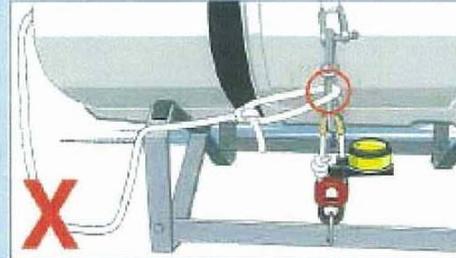
Painter secured to senhouse slip

1. HRU will activate
2. Liferaft will float free and eventually inflate
3. Because the painter is secured to the slip, the liferaft will **NOT** be released to the surface

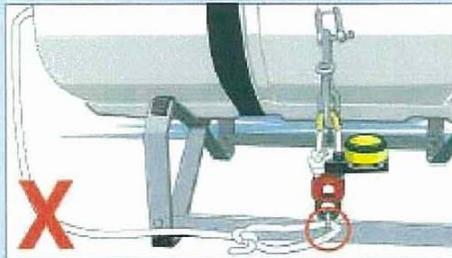
Painter secured directly to strong point

1. HRU will activate
2. Liferaft will float free and eventually inflate
3. Because the painter is secured directly to the strong point, the liferaft will **NOT** be released to the surface **EVEN IF** it is attached to the weak link as well

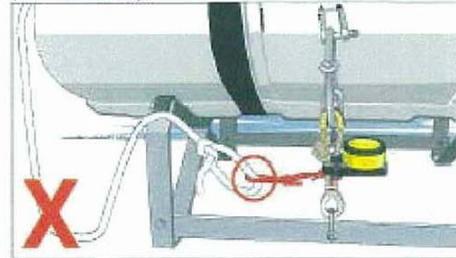
Painter secured only to weak link
(older version only)

1. Will work correctly for automatic release, but:
2. If liferaft is thrown overboard in an emergency (or comes adrift at sea) it may be lost

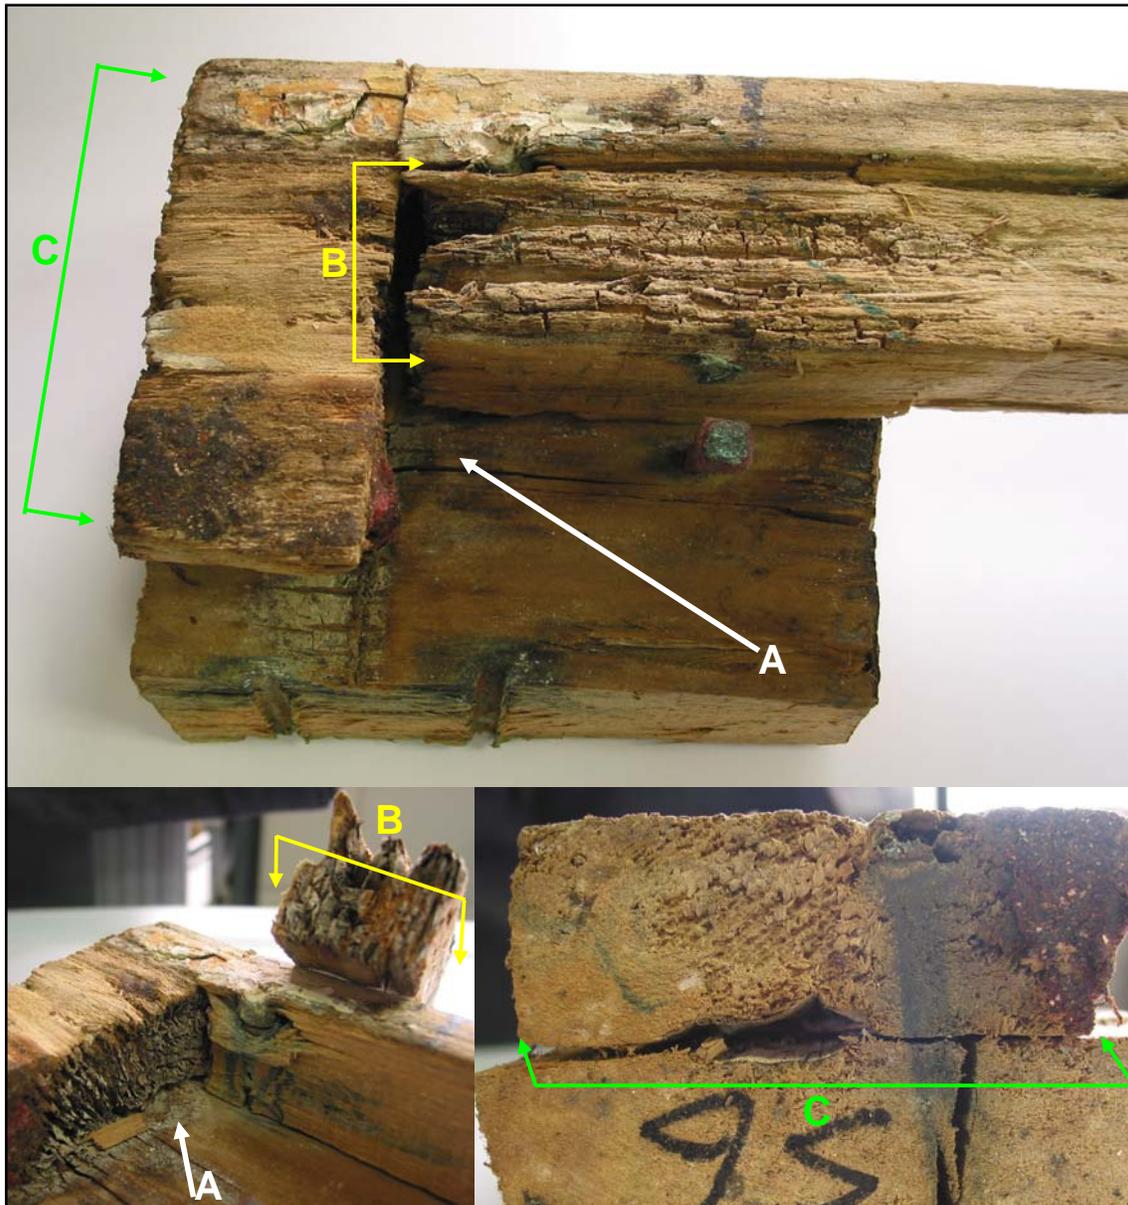
Figure A9.2
Sample of planking from the starboard side under the sheathing

A9.3 Prior to taking hull planking samples from the starboard side, the sheathing or “quarter badge” was removed. It was usual for tarred felt to be placed between the hull and the sheathing to provide protection from marine worm, but there was none present on the *Kotuku*. The hull planking beneath the sheathing showed extensive signs of decay, leaving the surface of the wood soft and divided across the grain into cubical sections. One butt joint of 2 hull planks that was removed revealed extensive decay in the end timber, the inside face of the hull planking and the butt block behind the joint (see Figure A9.2). Another sample of planking from the after starboard side revealed the onset of decay on the inboard side of the plank.
