M A R I N E O C C U R R E N C E R E P O R T

06-205

fishing vessel, *Lady Luck*, collision and subsequent foundering,
Motiti Island, Bay of Plenty

23 June 2006

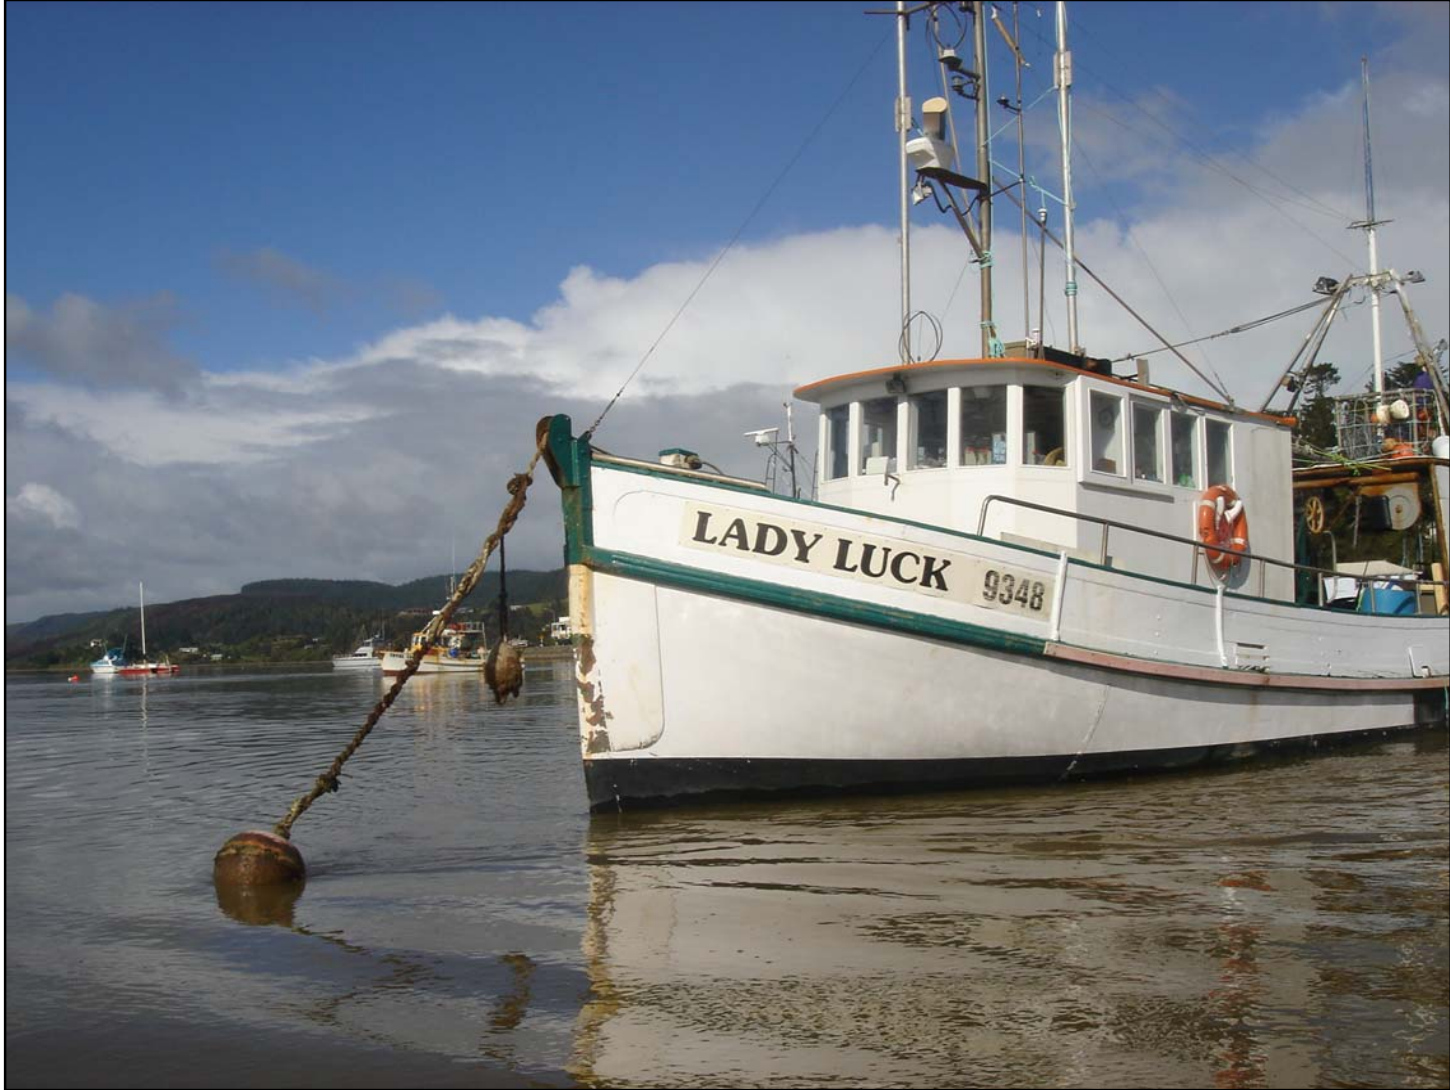
The Lady Luck
