**Report 06-207, restricted limit passenger vessel, *Milford Sovereign*,
engine failure and impact with rock wall, Milford Sound, 31 October 2006**

On 31 October 2006, the restricted limit passenger vessel *Milford Sovereign* was on a cruise of Milford Sound with a master, 9 crew and 181 passengers on board. Shortly after rounding Dale Point at about 1400, the master slowed the vessel in order that the passengers could view some penguins. As the master put the engines astern they both stalled, and before he was able to restart them the bow of the vessel struck the rock wall. The underwater hull was not penetrated so the master resumed the cruise.

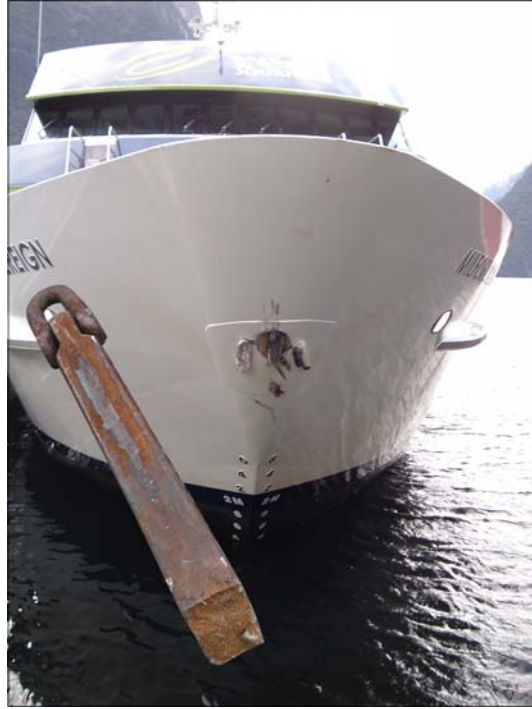
Figure 3
Bow of the *Milford Sovereign* with fractured anchor shank superimposed

- 1.2.1 The anchor located at the stem of the vessel took the brunt of the impact with the rock wall, causing the shank to fracture behind the head and the head to be lost in the water. There was slight indentation to the hull plating in way of the hawse pipe (see Figure 3).

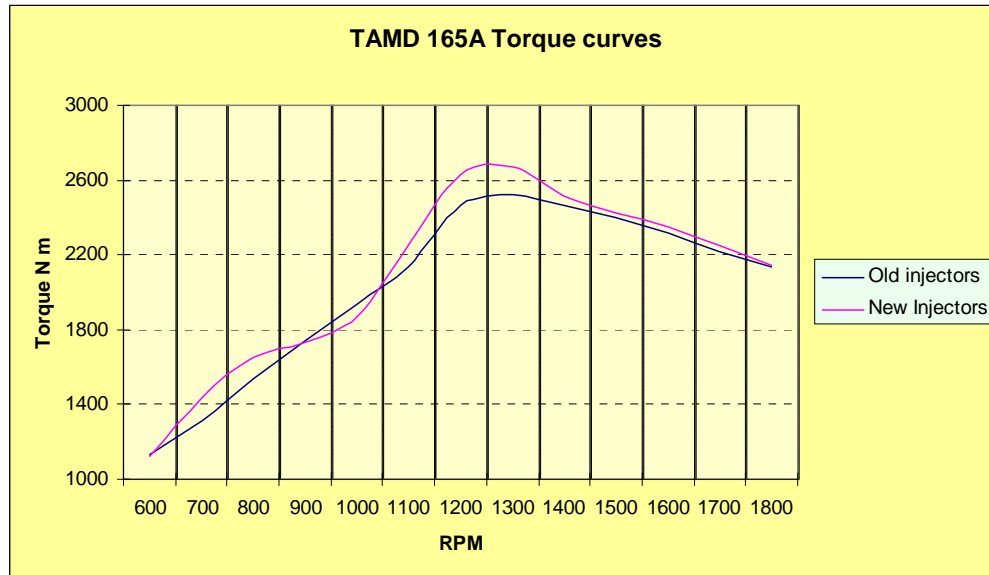
Figure 7
TAMD 165A torque curves

2.3 The single engine-and-transmission control lever was simple and convenient for an operator to use. However, when reverse engine power was used to slow a vessel, the reverse gear was engaged at idle speed, the instant when the torque load on the propeller shaft was at its highest. Load coming onto the engine caused a drop in engine speed, which could be sufficient to stall the engine.

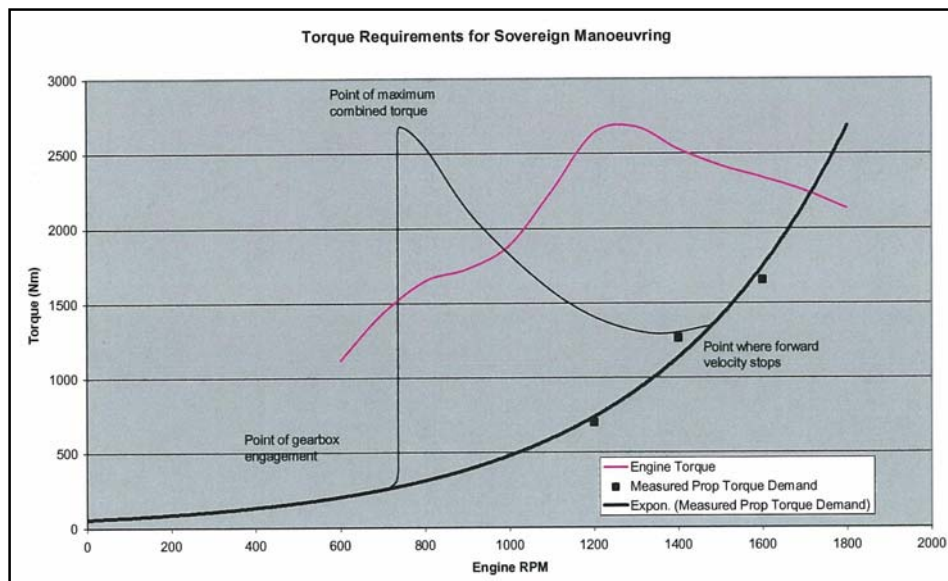
Figure 8
Design naval architect's diagram indicating calculated torque demand

- Torque demand – To bring a vessel to a stop using reverse power required that the engines produce a combined force equal to the forward resistance force of the vessel combined with the forward momentum of the vessel. Parameters for the performance of the vessel were selected, namely that the stopping time would be 10 seconds and there would be a delay of 5 seconds as the control passed through neutral. From this information the design naval architects calculated that the total torque required to stop the *Milford Sovereign* from 6 knots was 5059 Nm or 2529.5 Newton metres (Nm) per engine. When this requirement was superimposed on the propeller demand and engine torque curves it could be seen that the required torque exceeded the torque available at 750 RPM (see Figure 8). In discussions, they commented that the most significant variable in the required torque calculation was the time taken before reverse propulsion was engaged i.e. the longer the delay the more the momentum would erode and therefore the less torque required.

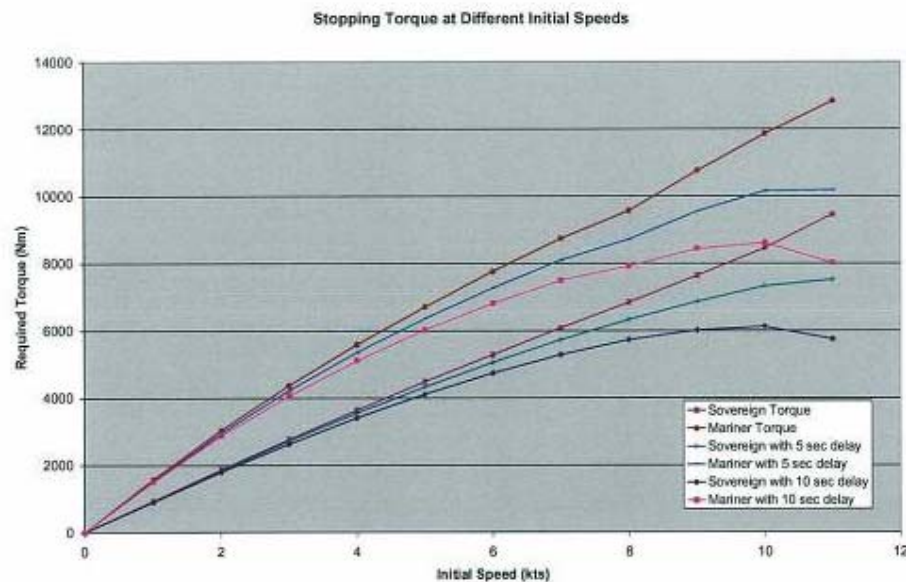
Figure 4, shows the difference a further 5 second delay on the torque required to stop the vessel. It can be seen that the more time that the vessel can slow before reverse thrust is applied the greater the reduction in the risk of stalling. Figure 4 also shows that if the vessel is in a situation that reverse thrust is required for stopping quickly the vessel should not have a forward speed greater than an average of 5 knots.

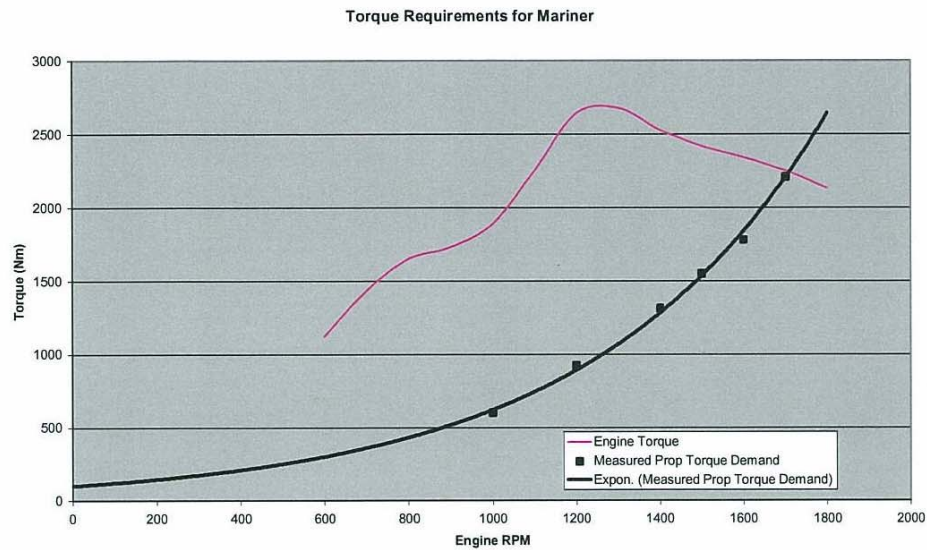
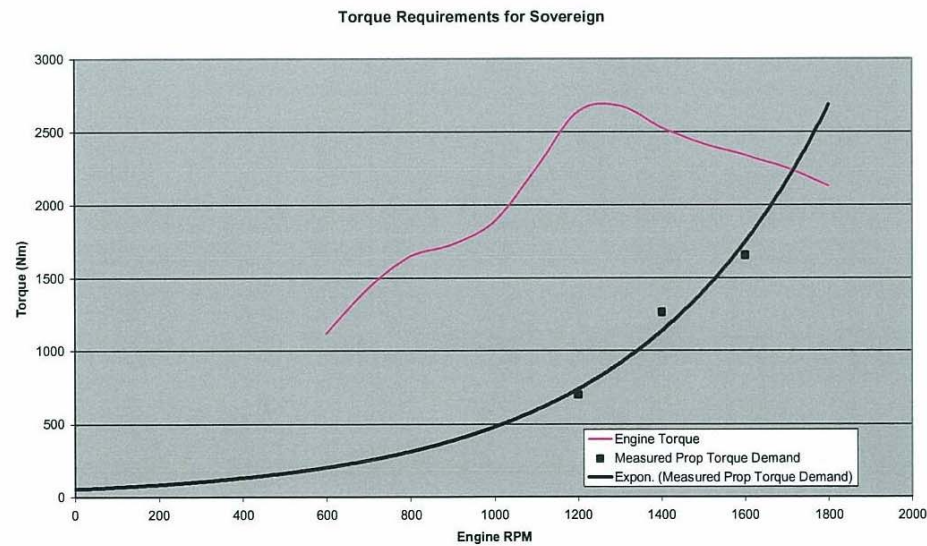
When looking at the engine torque required by the propeller throughout the rev range (Figures 5 and 6), it can be seen that the engine has sufficient torque for forward motion up until 1700rpm on both vessels. The reason that the propeller demand is greater than the torque that can be supplied by the engine is due to the propellers being pitched for a cruising speed of 1600rpm.

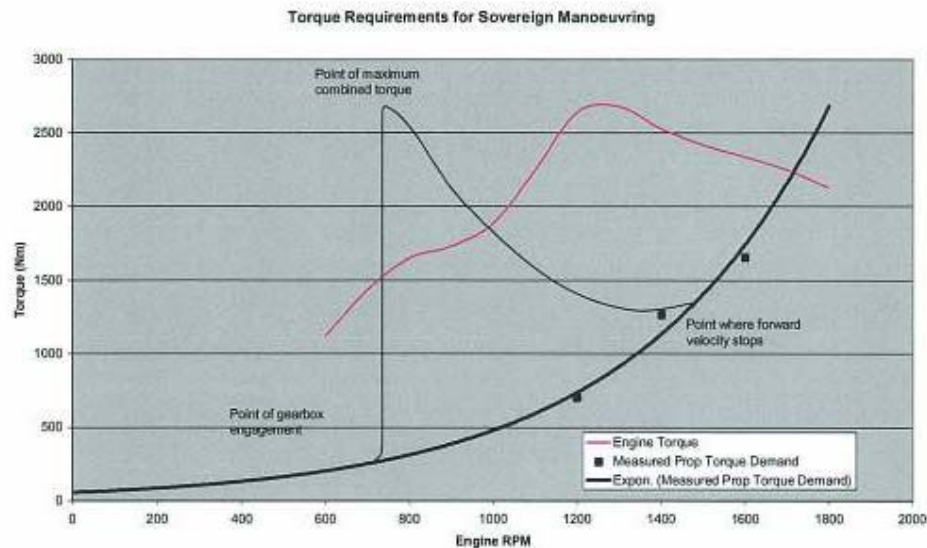
The Sovereign is travelling at 6 knots ahead and is put in reverse to slow the vessel. The selector on the gearbox is set to engage the clutch at 750rpm. The stopping time will be 10 seconds with a 5 second delay to take into account deceleration and a small rest in the neutral position before engaging reverse. Using Figure 4, the torque required to stop the vessel in these conditions is 5059Nm for both engines or 2529.5Nm if each engine is loaded equally. This

additional torque load when superimposed onto the propeller demand curve exceeds the available torque from the engine as shown in Figure 7.

As can be seen from Figure 7 the torque required exceeds the torque the engine can produce at the instant the gearbox engages. As the vessel slows due to the reverse thrust the torque requirement reduces to the level that is required by the propeller to travel in the reverse direction.

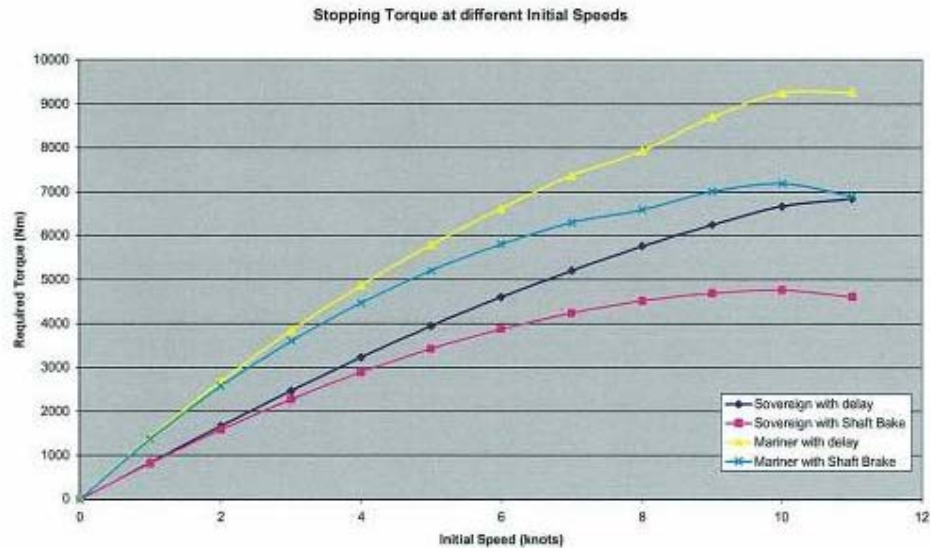
Figure 8

Overall, the shaft brake decreases stopping time by 20-30% as shown below, but will be less effective if the operator does not allow the vessel to slow before engaging astern.
