## **Report 06-208**

**fishing vessel  
*Santa Maria II***

**engine room fire**

**105 nautical miles west-southwest, L'Esperance Rock,  
Kermadec Islands**

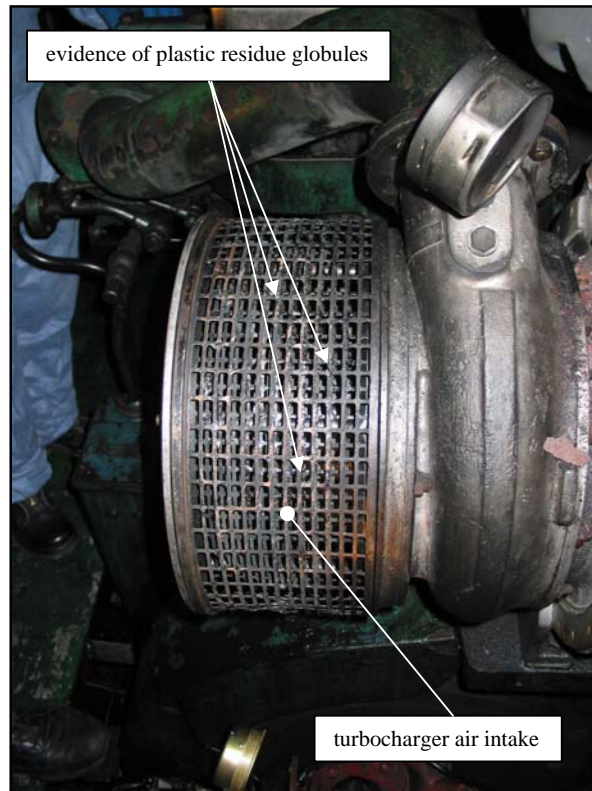
**Figure 2**  
**Turbocharger air intake showing melted plastic globules**

- 1.2.12 Inspection of the area around the turbocharger revealed:
- small globules of plastic on the air intake
  - a small pool of plastic directly below the turbocharger

- a melted plastic container wedged between the engine and the tank top walkway forward of the turbocharger
  - the plastic diffuser on the fluorescent light above the engine forward of the turbocharger was missing

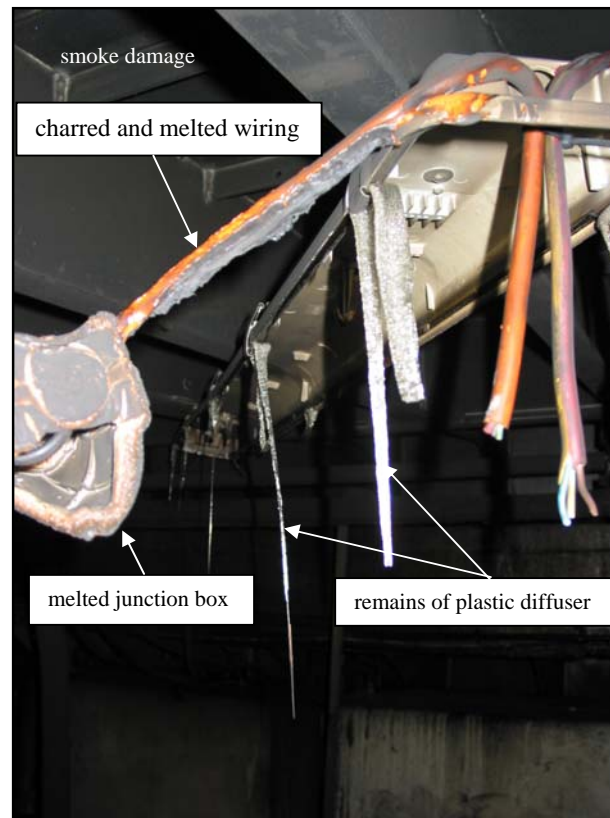
- the plastic diffuser on the fluorescent light above the turbocharger aft of the engine had melted and dripped onto the deck below (see Figure 3)
  - the plastic filter “glass” on the fuel line, from the day tank to the fuel pump, on the bulkhead adjacent to the turbocharger had deformed under the heat and had ruptured, discharging about 650 litres of diesel into the bilges.

**Figure 3**  
**Light fitting aft of the main engine showing melted diffuser and burnt wiring**

- 2.2 From the evidence available it was not possible to establish conclusively where the fire started, but the most likely cause was either one of the plastic diffusers from the fluorescent strip lights dislodging and falling onto the turbocharger casing next to the air intake, or a plastic container of some description falling from a level above the turbocharger onto the turbocharger casing next to the air intake. The turbocharger casing reaches temperatures well above the ignition points of many substances, especially the plastics found in the engine room. The temperature can be near to that found in the combustion cylinders.

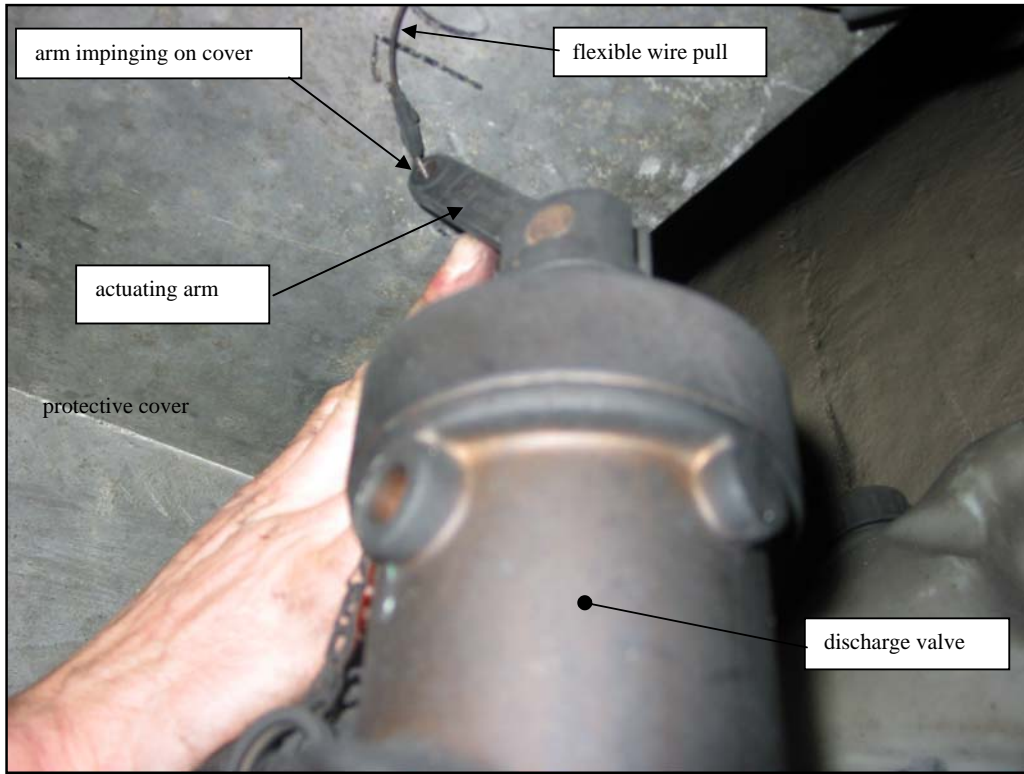
- 1.2.6 The NAF-S-III gas cylinder and valve assembly were protected from damage by a cover fabricated from aluminium checker plate fixed to the solid GRP frames with self-tapping screws. Since the installation of the cylinder and valve assembly, the cover had been fixed at varying heights relative to the cylinder and valve, as evidenced by the plethora of screw holes in the adjacent frames.

**Figure 4**  
**Fire-suppressant gas actuator arm impinging on protective case**

- 2.10 The slight movement of the protective cover as it was removed allowed the actuating valve to travel far enough to allow the gas to escape. The protective cover had been replaced at some time at a height too low to allow free movement of the actuating lever.

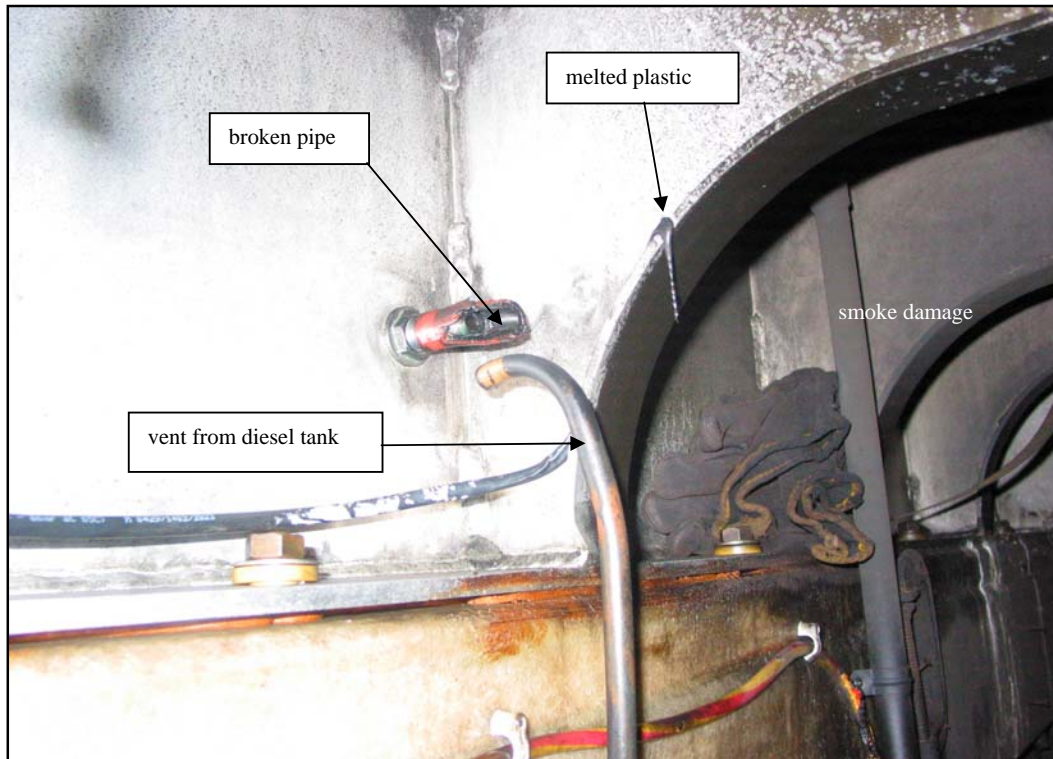
**Figure 5**  
**Broken vent connection between diesel oil tank and deck penetration**

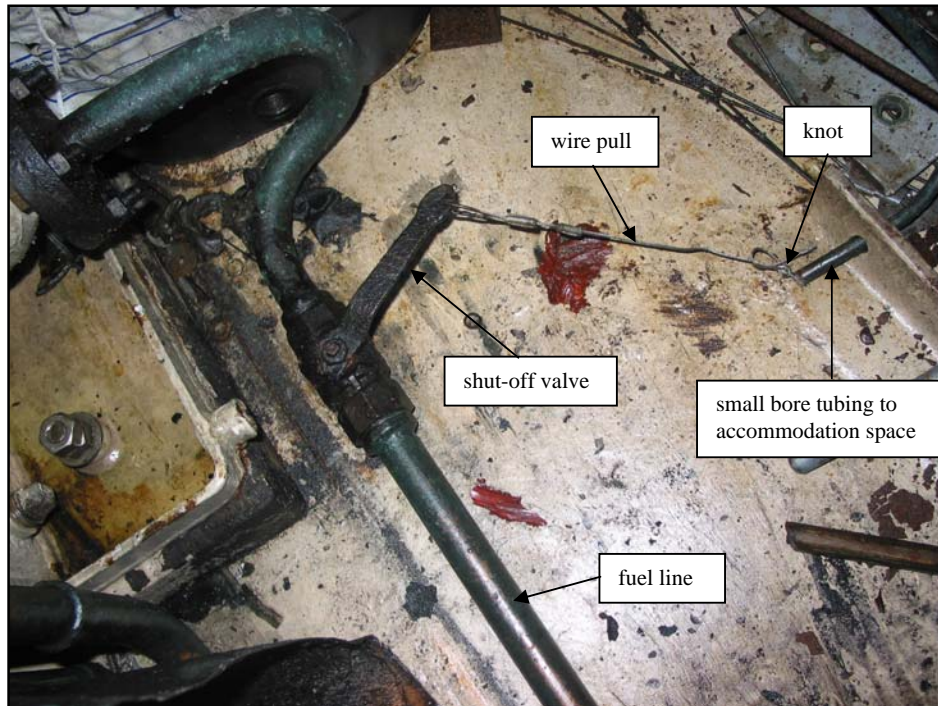
- the fuel line linking the daily use tank to the fuel filter and main engine was fitted with a stop valve before the filter; this was able to be closed remotely from a cupboard located in the accommodation by means of a flexible wire pull to the valve. The wire ran at a height of about 50millimetres across the deck in the engine room. Where the wire passed

through the bulkhead to the accommodation it passed through a small-diameter tube. This wire had, at some time in the past, broken and had been repaired by knotting (see Figure 6). The knot was unable to pass through this tube, so the valve could not fully shut remotely. At the time of the inspection a steel rod about 40mm diameter and 600mm in length was lying across the wire further hindering movement

**Figure 6**  
**Emergency diesel fuel shut-off valve showing knotted wire pull**

- 2.8 The diesel fuel filter ruptured as a result of the fire and the diesel fuel from the day tank drained into the engine room bilges where it could have been ignited by the fire. Normally the engineer could under these circumstances have attempted to close the valve between the tank and the filter using the remote pull, but the knot joining the broken ends of the wire would have jammed in the small bore tube before the valve was completely closed. It was not established how long the remote pull wire had been in that state. The wire should have been replaced when it broke. Whoever tied the knot in it instead did not fully understand or recognise its function. The quick closing of the valve remotely had obviously not been tested by ship staff or surveyor since the wire had parted.
