**Report 07-004 Boeing 737-319, ZK-NGK, electrical burning and fumes in 3 May 2007  
the cockpit leading to a precautionary landing at RNZAF  
Base Ohakea**

**Report 07-004**

**Boeing 737-319**

**electrical burning and fumes in the cockpit leading to a  
precautionary landing**

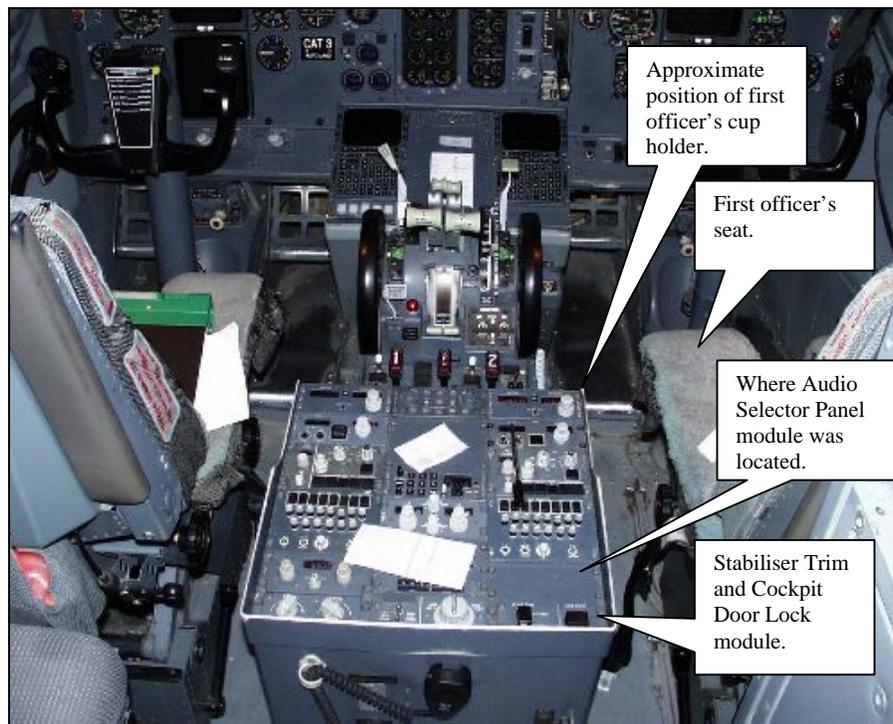
- 1.3.4 The first officer seated himself in his seat (the right seat) and with his left hand picked up his cup of coffee. As he did so the lid came off the cup, and some of its contents landed on the first officer and the floor beside him. In addition, some coffee spilt onto the right rear corner of the centre control pedestal (see Figure 1). The captain immediately got some paper towels and began to mop up the spilt coffee, before advising an aircraft engineer who was on board at the time.

**Figure 1**  
**A Boeing 737-300 cockpit avionics control pedestal**

- 1.3.5 The engineer had an avionics authority, and after the pilots had mopped up the coffee he assessed the extent of the spill and its possible implications. Located in the right corner of the control pedestal were the first officer's Audio Selector Panel module, and the Stabiliser Trim and Cockpit Door Lock module. The avionics control modules in the pedestal were fluid splash resistant. There was evidence of fluid around the audio selector panel so he removed it and examined the area around and under it. He saw no evidence that the fluid had affected other areas, including the other modules. He mopped the panel and swapped it with the observer's audio selector panel located in the overhead pedestal. A functional check of the various modules and other electrical systems showed that they were operating normally.

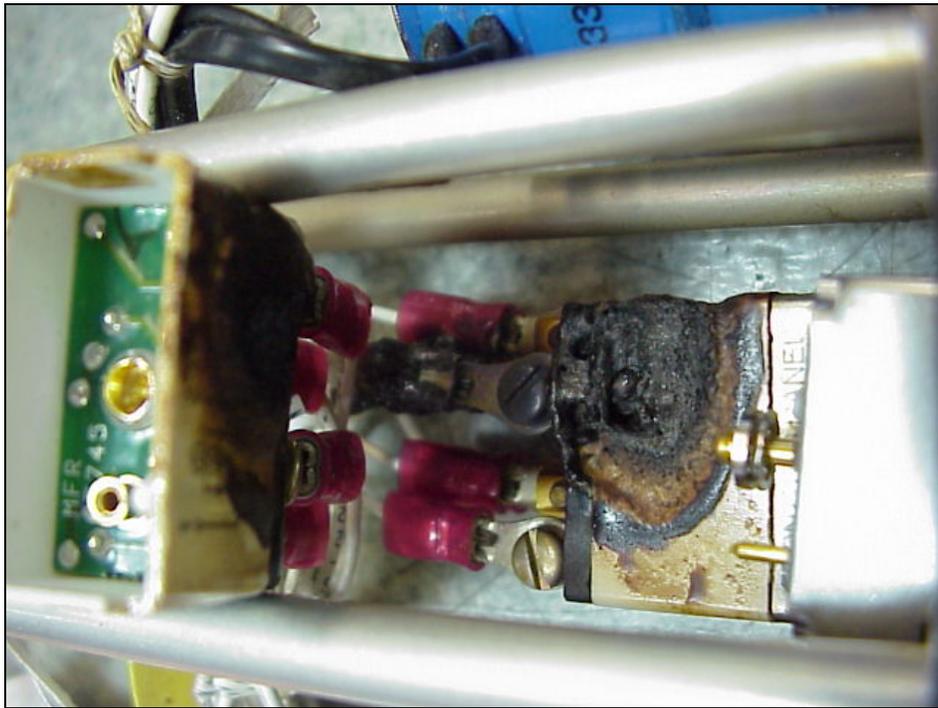
- 1.7.2 Examination of the module showed burning and melting of 2 warning light push-to-test switch assembly components (see Figures 2 and 3). The module was in the same electrical system as the various electrical lights that had displayed spuriously in the cockpit, including the landing gear indicator lights.

- 1.7.3 Specialist examination of the module found a sticky residue present around the lights test switch contacts and diodes, which suggested some form of fluid ingress. The fluid ingress had occurred around the edge of the module and had run down the outside of the light assembly. There was evidence of a slow electrical breakdown and gradual heat build-up and an eventual short circuit. The examination determined this was because of the partially conductive nature of the fluid, which contained sugar. Heat build-up had led to water evaporation and the eventual burning and carbonising of the sugar. The carbonised sugar was a better conductor than liquid coffee, and current flow subsequently increased and generated more heat. The heat build-up caused thermal damage to the light assembly components, until an electrical short occurred and the protection circuit breaker tripped.

**Figure 2**  
**External burning of light switch assembly component**

- 2.10 Some spilled coffee had probably entered the Stabiliser Trim and Cockpit Door Lock module light assembly and gone undetected by the engineer. However, aircraft attitude changes during the subsequent 2 sectors may have caused some liquid coffee to migrate to the module. The heat generated by the lights in the module and the surrounding area slowly evaporated the water in the spilled liquid, leaving a sticky residue of carbonised sugar that was a better conductor than liquid coffee. Consequently, the electrical current flow gradually increased and generated more heat, resulting in the slow electrical breakdown and subsequent melting and burning of the light assembly components in the module. This culminated in the electrical indication problems encountered on the incident flight, because of the common circuitry, until a short circuit occurred and the protection circuit breaker eventually tripped, protecting the components from further damage.

A Maintenance Highlight is to be produced highlighting to all engineers the hazard fluid poses on the flight deck and the need to complete an accurate assessment and clean-up process before releasing the aircraft back into service.

The Boeing [737] standard operating procedures will be amended so that any time a fluid spillage occurs in the flight deck during flight, or on the ground, an operational occurrence report will be filled out, in addition to the information currently being put into the aircraft technical log.

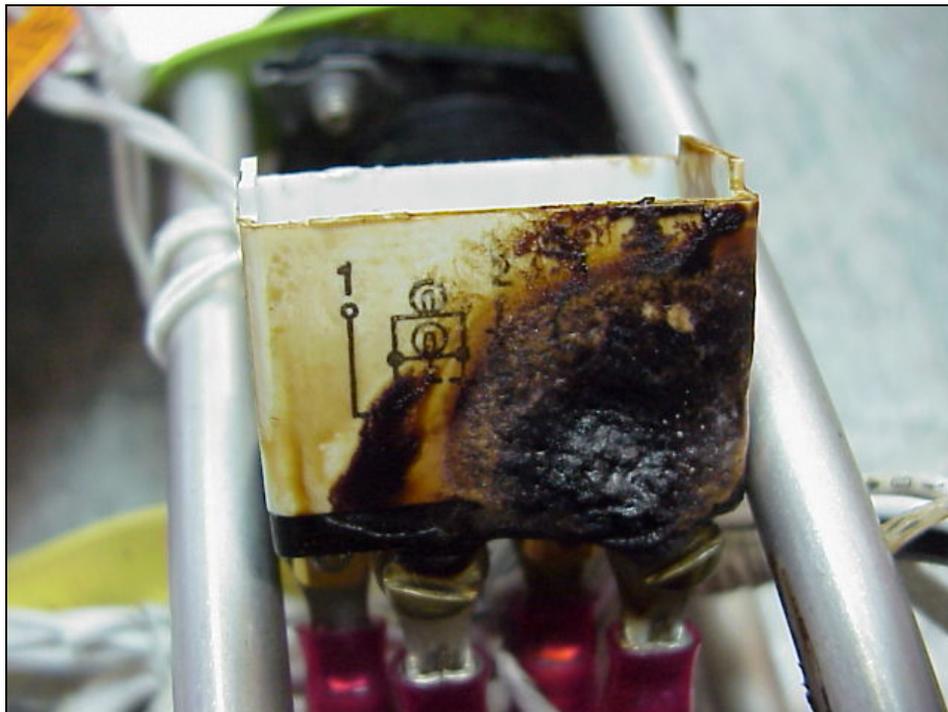
**Figure 3**  
**External burning of adjacent light switch assembly component**
