Report 07-115, express freight Train 533, derailment, 103.848 kilometres, near Tokirima, Stratford – Okahukura Line, 7 November 2007

Report 07-115

express freight Train 533

derailment

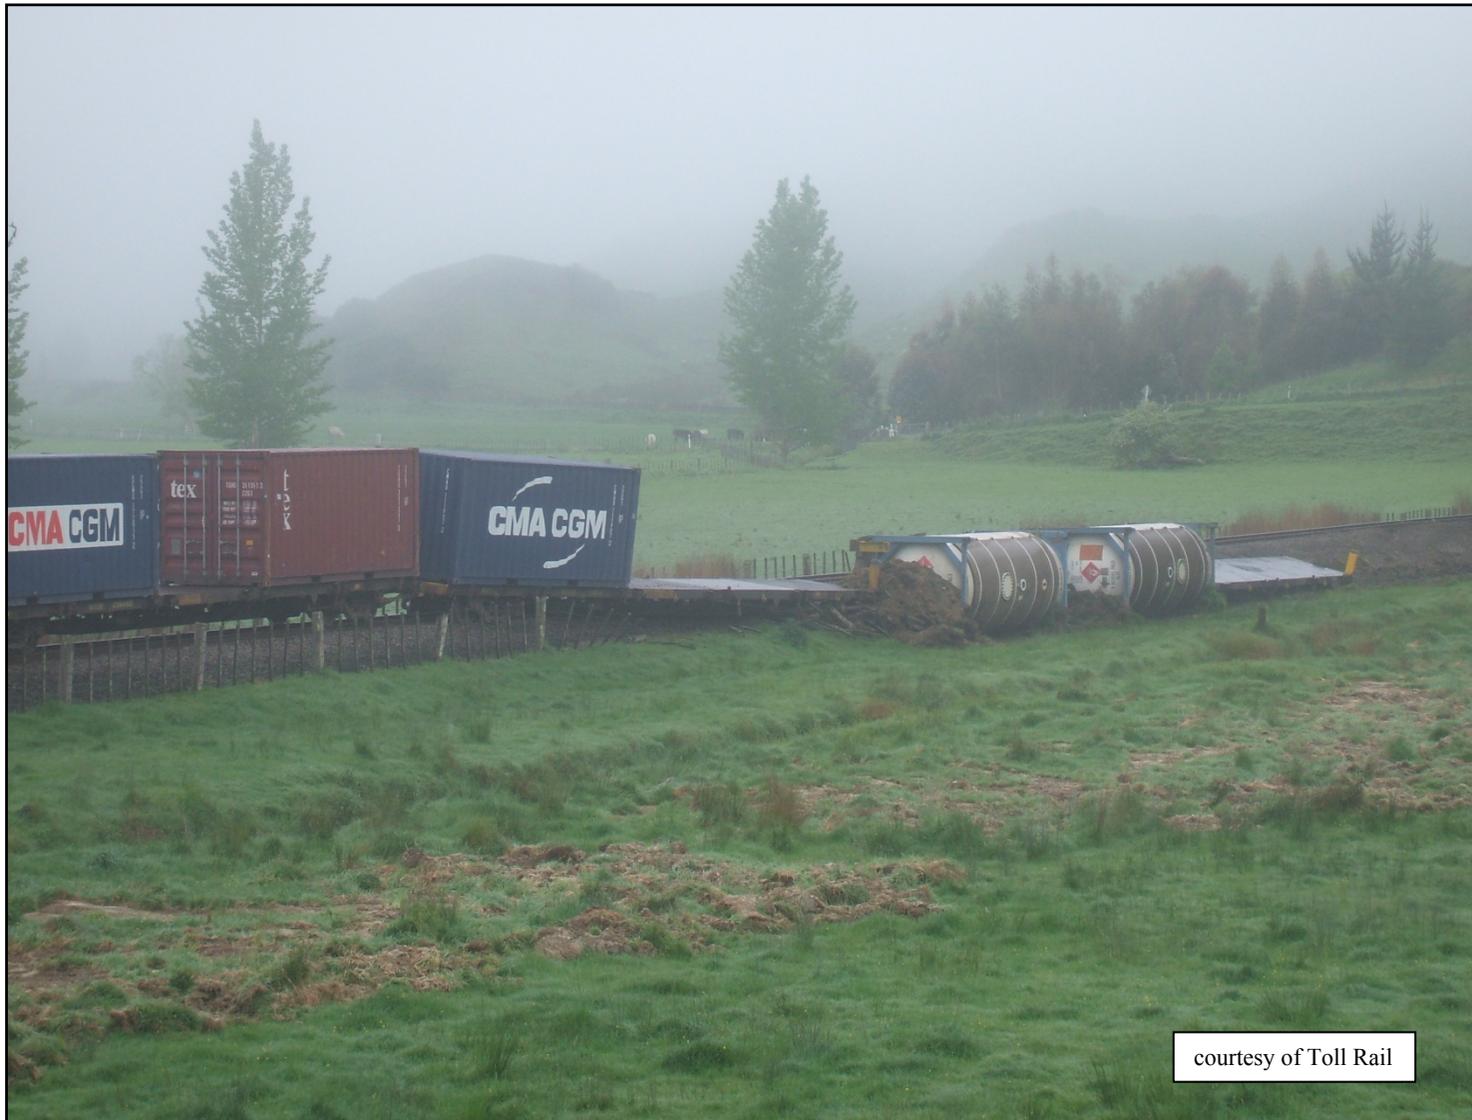
Derailed site

On Wednesday 7 November 2007, at about 0140, the trailing bogie of wagon UK10696, on Auckland to New Plymouth express freight Train 533, derailed at 103.848 kilometres (km) on the Stratford – Okahukura Line. The derailed wagon was dragged a further 2.75 km until the leading bogie also derailed. The wagon tipped on its side, derailing the wagon immediately in front and behind it.

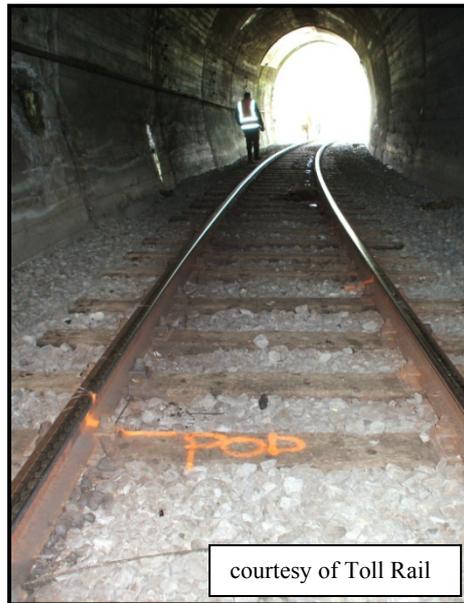
Figure 2
Track formation at the point of derailment

- 1.3.1 The point of derailment was confirmed as 103.848 km by a wheel flange mark on the left-hand rail in the direction of travel. The point of derailment was on a 250 m long, 180 m radius right-hand curve, in the direction of travel, including through Tunnel 16 (see Figure 2).

- 1.3.2 Train 533 approached the point of derailment on a 900 m long descending grade of 1 in 50.
- 1.3.3 The track leading up to the point of derailment consisted of 75 pounds per yard continuous welded rail manufactured in 1952, fastened to mixed-age treated *Pinus radiata* sleepers with R-type fastenings. The sleepers and the fastenings were in fair condition.

- 1.3.4 The cribs and ballast shoulders were full with 200 millimetres (mm) of ballast under the sleepers.
- 1.3.5 The witness mark indicated that the leading axle of the trailing bogie of UK10696, the second to last wagon of the train, derailed with its left wheel riding up onto high-leg rail in the direction of travel. The mark indicated that the flange travelled along the railhead for a distance of about 5 m before dropping off to the outside of the high-leg rail.

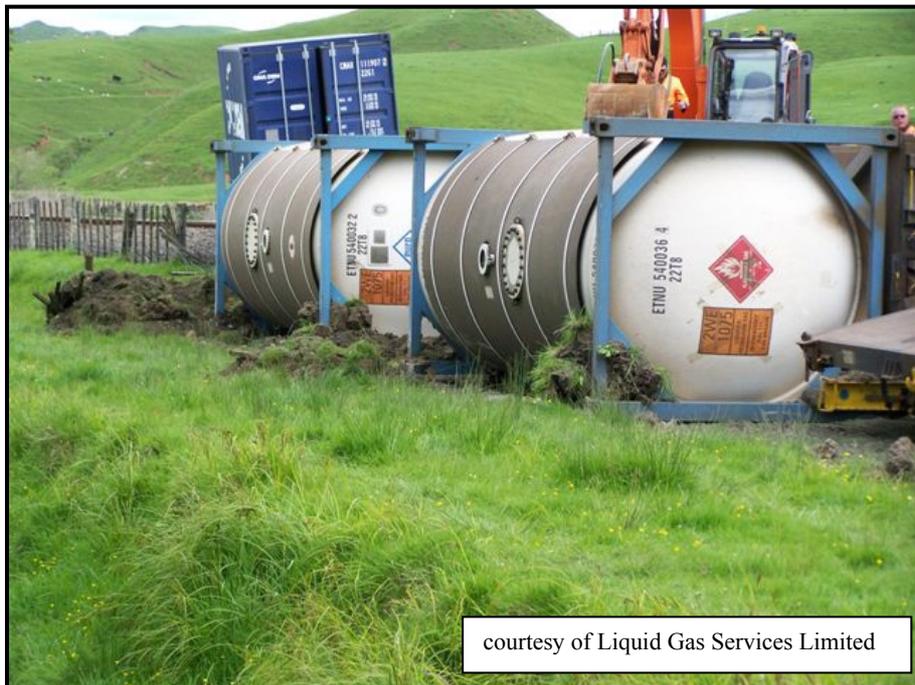
Figure 3
The ISO liquid petroleum gas tanks

- 1.3.6 Train 533 continued in this condition for a further 2.75 km to 101.100 km where the trailing axle of the same bogie also derailed. The resultant disruption tipped the wagon on its side, causing wagon UK6638 in front and wagon PK821 behind to derail as well, but these 2 wagons remained upright (see Figure 3). All wagons on the train remained coupled when the train stopped.

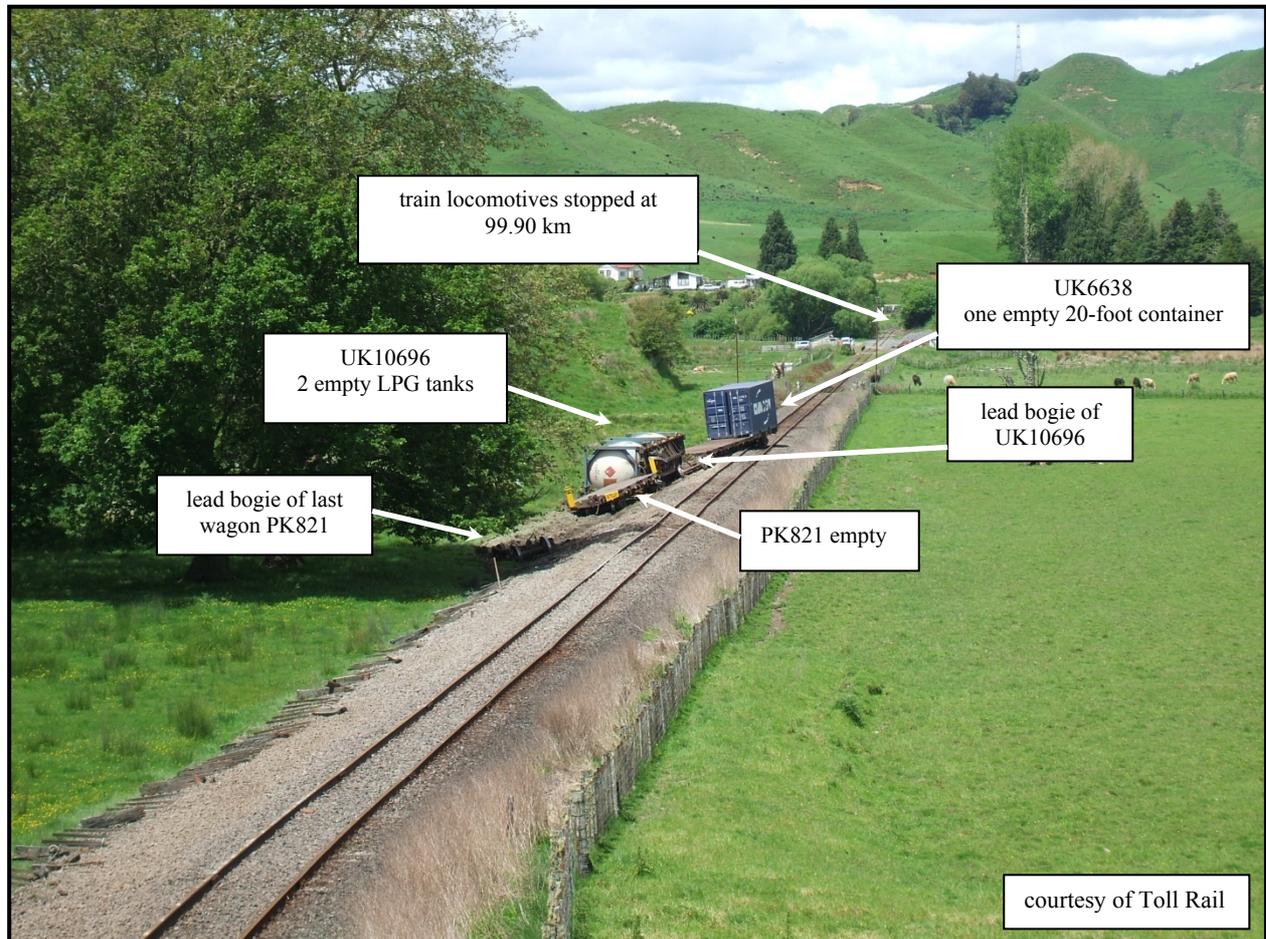
Figure 4
Derailment site detail

- 1.3.7 The lead bogie of wagon PK821 became detached and was 3.7 m from the rear of the train (see Figure 4). The lead bogie of wagon UK10696 also detached but was adjacent to where the wagon came to rest.

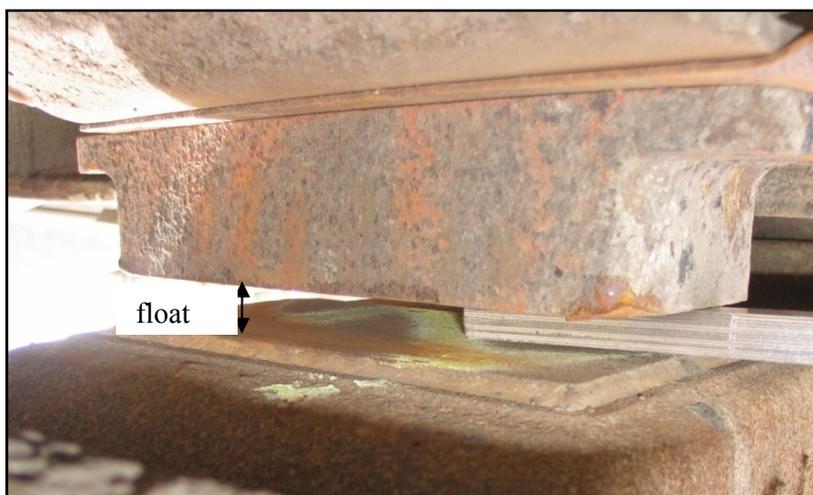
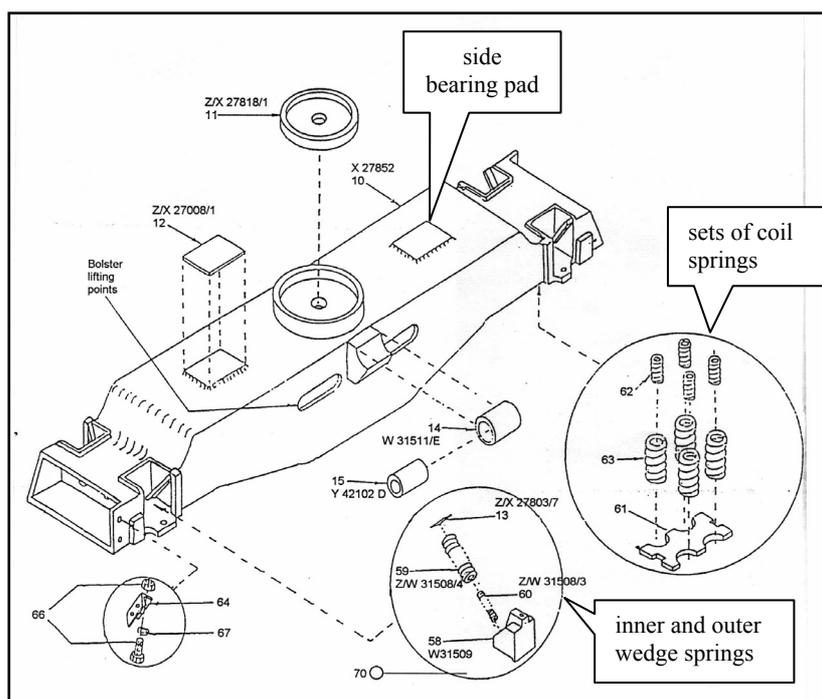
- 1.7.3 The under-frame of UK10696 was twisted as a result of the derailment. It was not possible to determine the float clearance⁷ measurements because the damage and disturbance sustained by the wedges and float blocks would have resulted in inaccurate measurements (see Figures 5 and 6).
