**07-201** passenger vessel, *Cruise Cat*, collision with navigational light beacon, Waikato River entrance Lake Taupo 22 February 2007

## **Report 07-201**

**passenger vessel  
*Cruise Cat***

**collision with navigational light beacon**

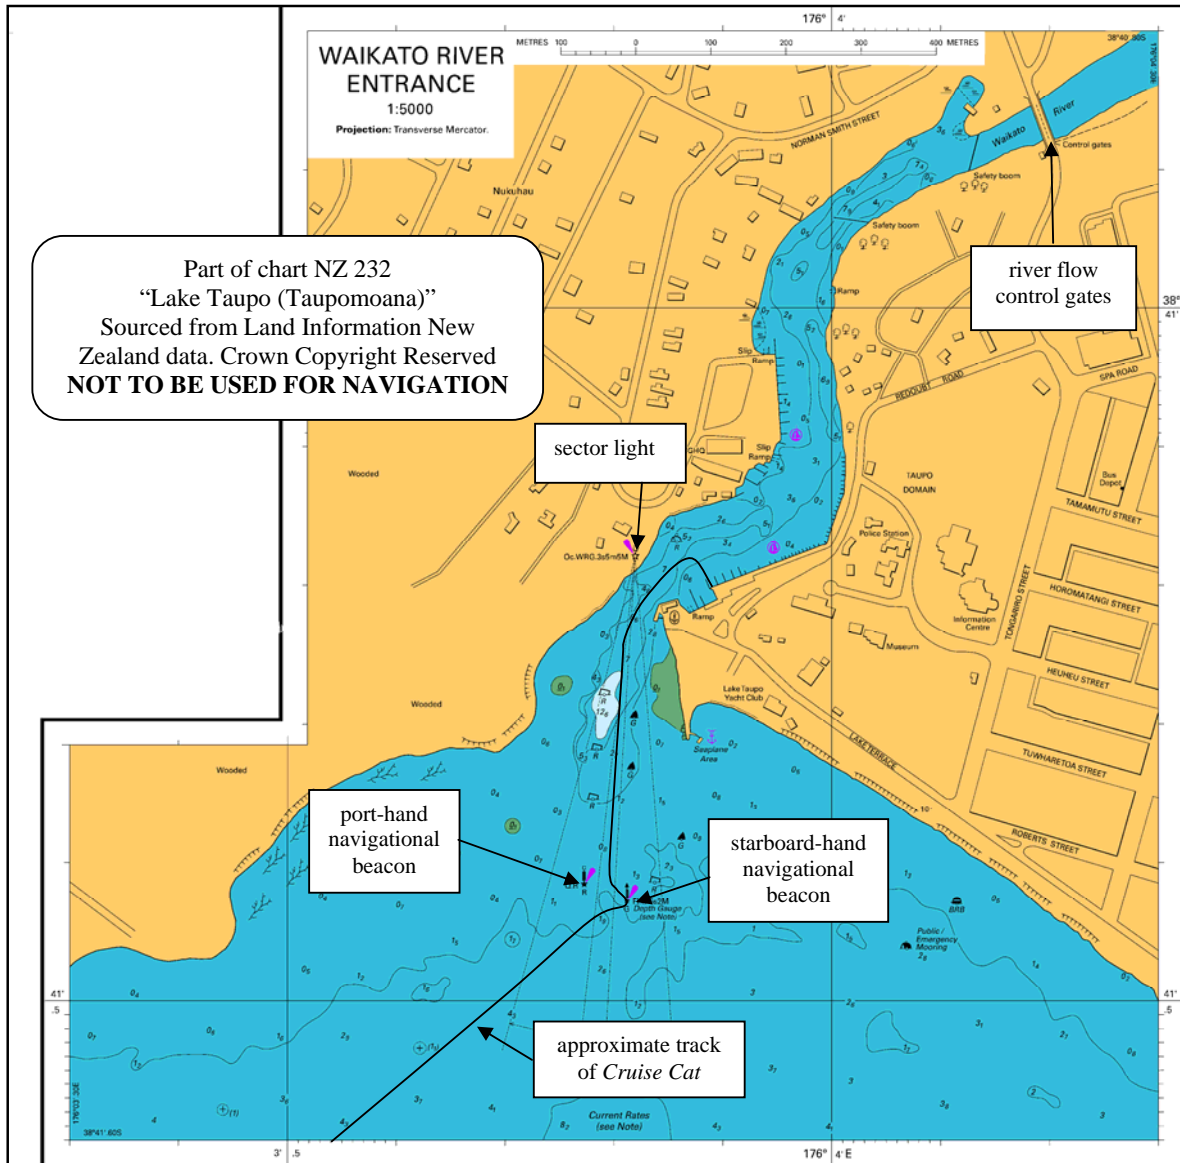
**Figure 2**  
**Waikato River entrance and entrance channel**

- 1.1.7 The *Cruise Cat* approached the entrance channel at an oblique angle with the port-hand beacon fine to port rather than lining up with the channel from a point further out in the lake. As the *Cruise Cat* neared the beacons the relief skipper reduced the vessel's speed, then turned to starboard across the channel and waited until he could see the white sector of the sector approach light before turning the vessel to port into the channel (see Figure 2). The relief skipper said later that he made the initial turn to starboard to get to the starboard side of the channel where he knew there was more water available.

- 1.1.8 As the *Cruise Cat* turned to port the relief skipper realised that the vessel was not turning swiftly enough to prevent a collision with the starboard-hand beacon so, he put both engines to astern, but before the engines had time to stop the vessel, the bow of the *Cruise Cat* collided with the starboard-hand beacon. The starboard-hand beacon snapped off at the lake bed.

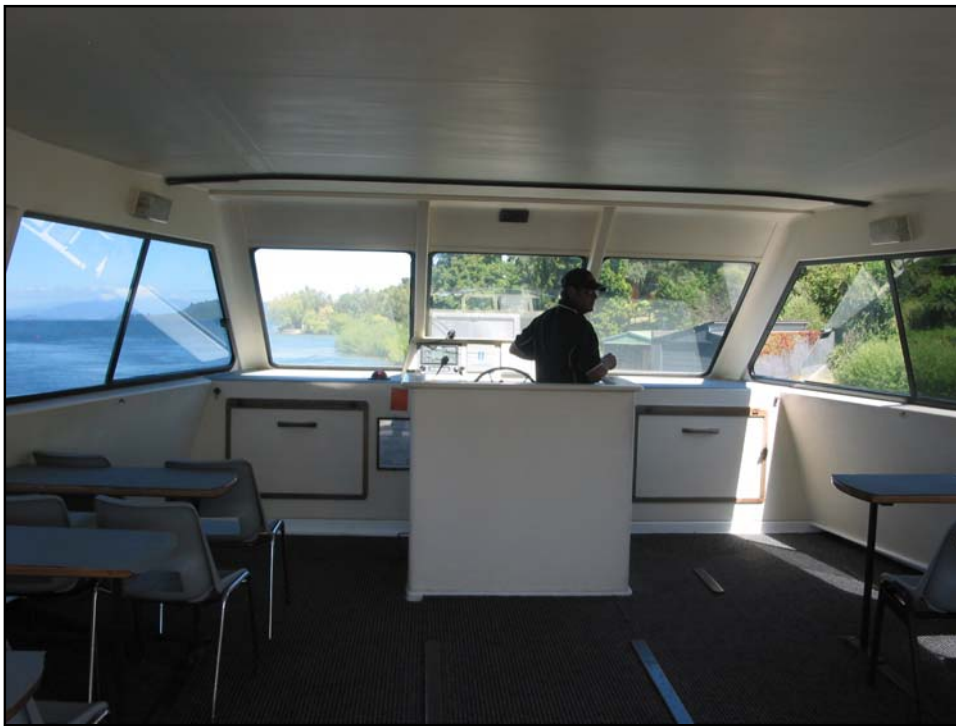
**Figure 3**  
**The *Cruise Cat*'s helm station**

- 1.2.1 The *Cruise Cat* was a wooden 16m passenger-carrying catamaran. It was built in 1995 by Robertson Brothers Boat Company Limited of Warkworth, New Zealand. It had a beam of 6.2m and a displacement of 27 tonnes.
- 1.2.2 The *Cruise Cat* was owned by Lake Taupo Cruising Company Limited and operated by Chris Jolly Boats Limited.
- 1.2.3 The *Cruise Cat* was powered by 2 Iveco C78 ENT M50 diesel engines each producing 331 kW at 2600 rpm. Each engine drove a fixed pitch propeller through a reversing Twin Disc gearbox. The *Cruise Cat* had a cruising speed of about 17 to 18 knots and a maximum speed of about 22 knots.
- 1.2.4 The *Cruise Cat*'s helm station was located at the forward end of the upper deck. The position was not isolated from the remainder of the deck allowing free access for passengers to the forward windows (see Figure 3).

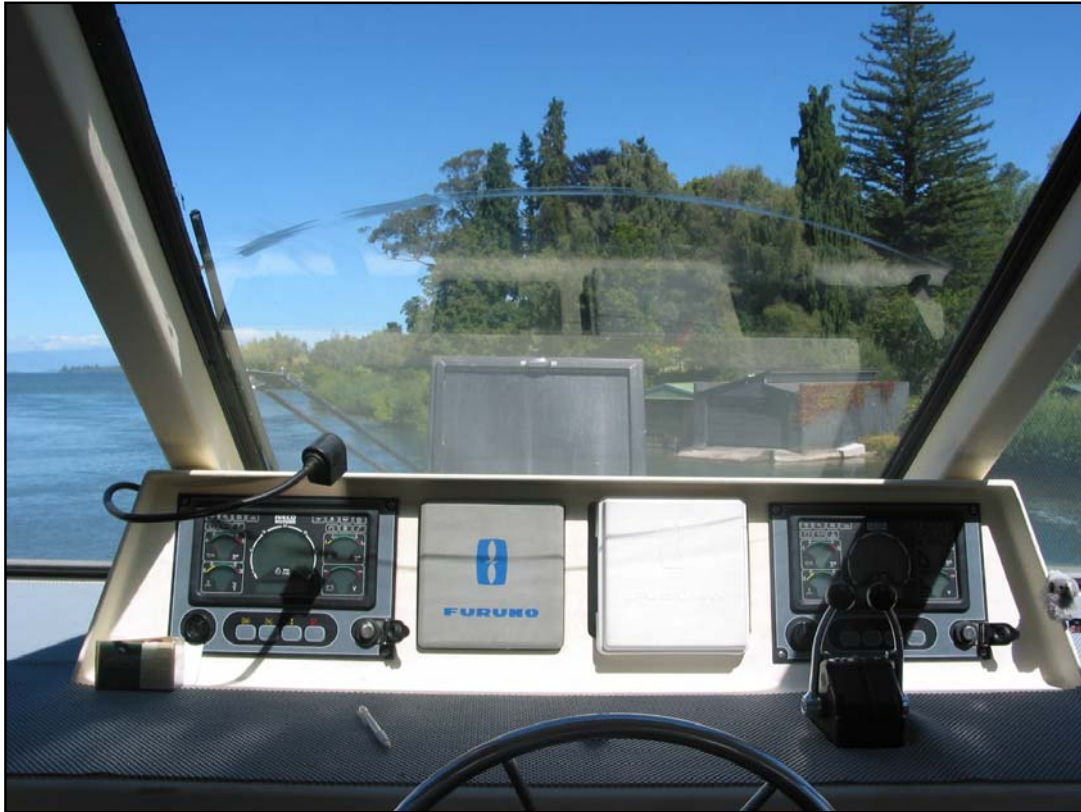
**Figure 4**  
**View from the helmsman's seat with the forward access hatch open**

- 1.2.7 When the foredeck hatch was open, the hatch lid partially obscured the helmsman's view directly ahead and below (see Figure 4).

- the onset of fatigue due to the relief skipper nearing the end of his third consecutive 14-hour day
- the raised foredeck hatch partially obscuring his view of the light beacon
- distraction by passengers close to the conning position

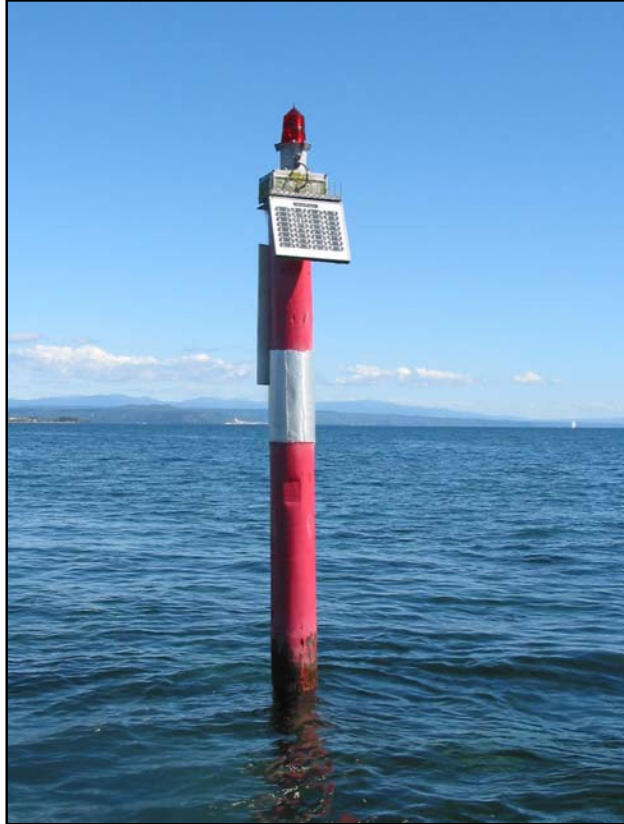
**Figure 5**  
**Port-hand entrance channel beacon**

- 1.3.2 The port-hand red beacon (see Figure 5) consisted of a single wooden pile of about 0.3 m diameter set into the lake bed; the pile was painted red above the normal lake water level. The pile extended about 3 m above lake level with a quick-flashing red light on the top. The focal plane of the light was about 0.5 m above the top of the pile.

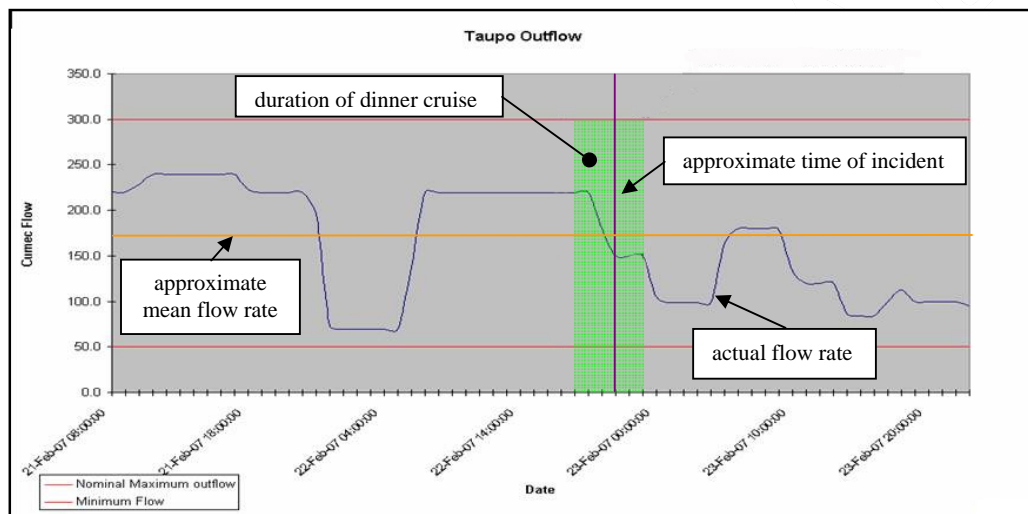
**Figure 6**  
**Graph of water outflow through the Taupo control gates**

The relief skipper said later he thought that he had possibly been caught out by the current flow. The skipper of the *Cruise Cat* stated that there was no distinguishable current flow at the channel entrance by the navigational beacons, but the current was distinguishable from about the second marker buoy onwards. This information was corroborated by the Harbourmaster's office.

- 1.5.4 The control gate settings and lake level were controlled by Mighty River Power which used the Waikato River, among other sources, to generate electricity from hydroelectric power stations along the river. Mighty River Power controlled the flow of water from Lake Taupo to suit its generation needs; this control was by the control gates located about 800 m downriver from the *Cruise Cat*'s berth. The amount of water being allowed through the gates would directly affect the strength of the current in the Waikato River.
- 1.5.5 Information on the flow of water through the control gates and by inference the amount that they were open was available from the Mighty River Power free information line.
