Report 07-202, fishing vessel, *Walara-K* flooding and sinking, 195 nautical miles off Cape Egmont, 7 March 2007

**fishing vessel
*Walara-K***

flooding and sinking

7 March 2007

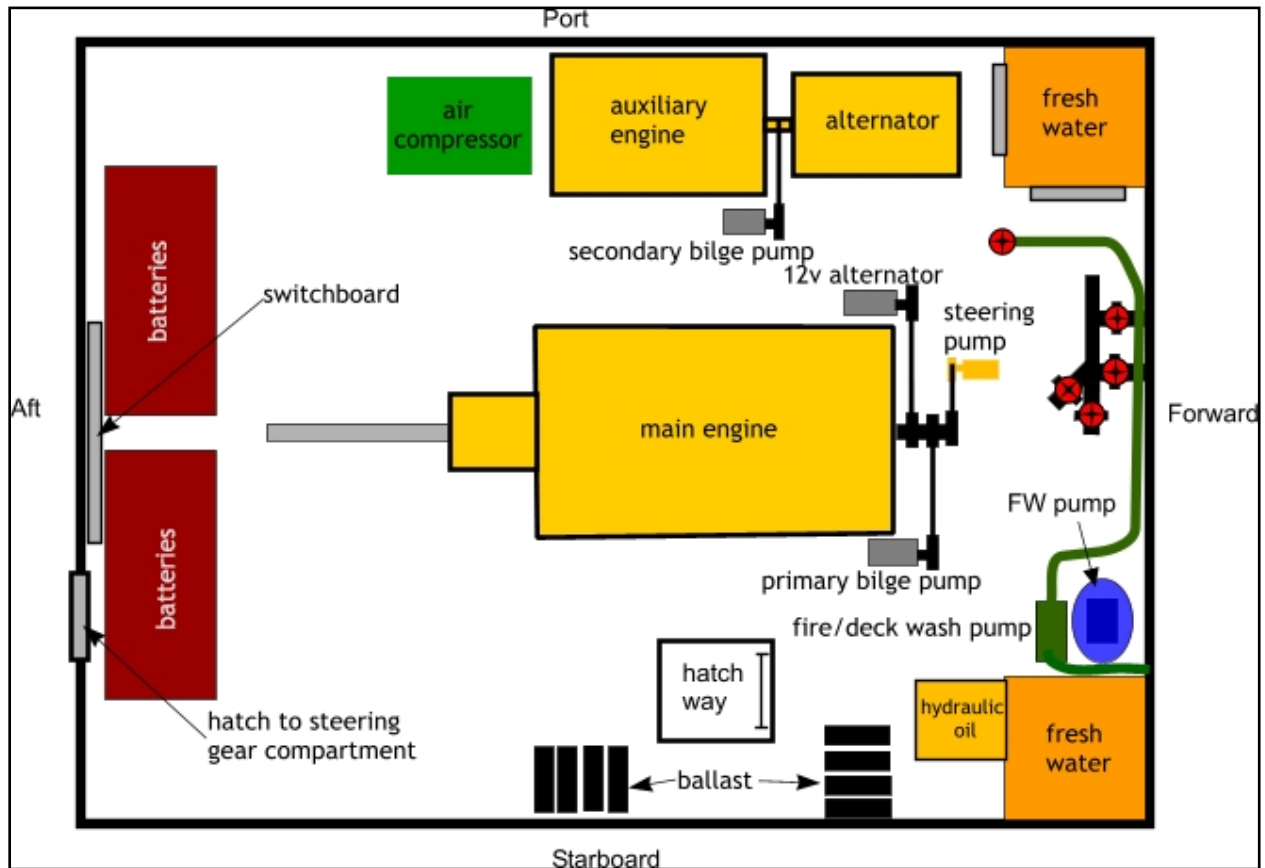
Figure 2
Schematic of the engine room

- 1.2.8 The deep "V" of the hull beneath the main engine had been filled with concrete to ease cleaning and to prevent tools and debris falling into it. The forward extent of the concrete was the frame aft of the forward bulkhead, so leaving that forward section as a well for the bilge suction. This was the area in which the skipper saw water welling up.

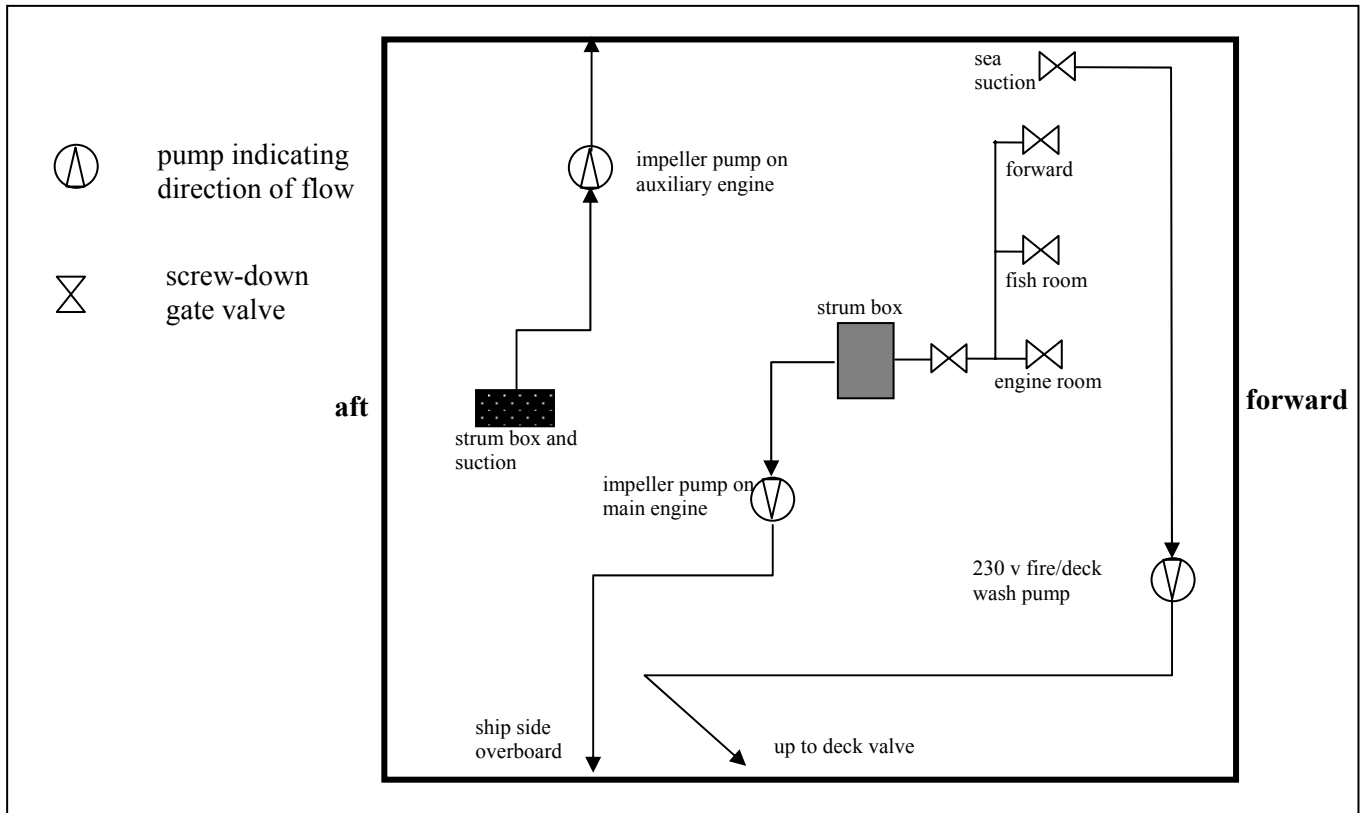
Figure 3
Pumping diagram pre-modification

- 1.3.1 Originally, the bilge system consisted of 2 completely separate pumping systems (see Figure 3):
- The first system used a Johnson 1.5-inch [38.1 mm] self-priming pump, that had a rubber impeller and an electromagnetic clutch, and was belt-driven directly off the main engine. The primary bilge system serviced the engine room, fish hold and forepeak, discharging the water through the ship's side above the water line on the starboard side of the engine room. A strum box was fitted between the bilge suctions and the pump to prevent foreign objects being drawn into the system and damaging the pump. This system had no sea connection so prevented the accidental flooding of the vessel.

- The second system was dedicated to the engine room, drawing from a single bilge suction situated below the main engine. It used a similar Johnson 1.5-inch pump that was belt-driven directly off the auxiliary engine and discharged the water through a ship's side valve on the port side above the water line. This system also had no sea connection.

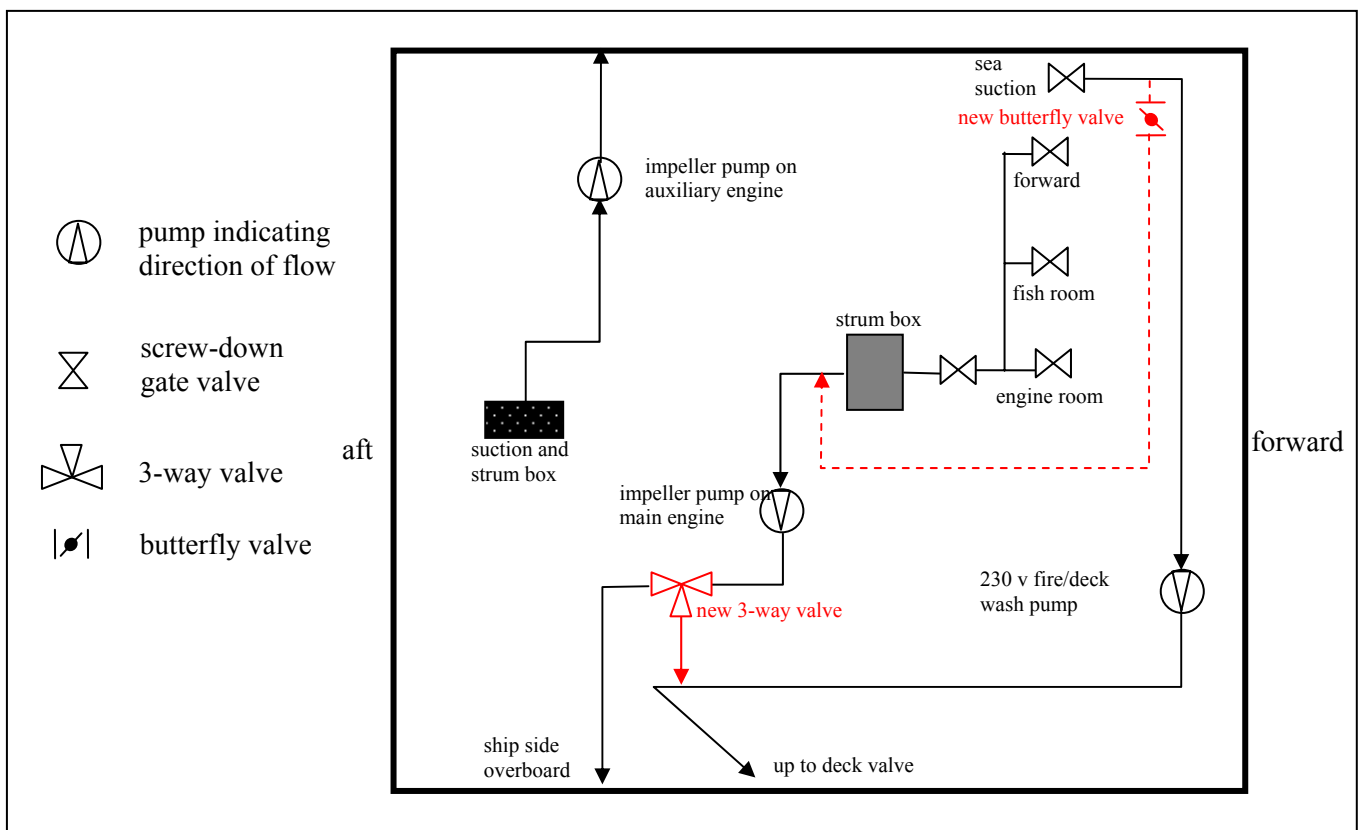
Figure 4
Pumping diagram post modification

- 1.3.5 In September and October 2006, before the vessel was put into service, Tasman Tuna made a number of modifications. It added a new bottom longline reel to the deck, moved the existing surface longline reel and added fishing float storage cages to the afterdeck. In the engine room, the pumping arrangements were modified so that the primary bilge pumping system could be used to provide water to the deck (see Figure 4). In order to achieve this, a pipe was connected between the sea suction for the fire main and deck wash water system and the pipeline between the strum box and the primary bilge pump. On the discharge side of that pump a 3-way valve was installed to allow the discharge to be directed either through the starboard ship side valve or through the fire and deck wash water line. With the correct valve settings, this modification

also enabled the bilges to be pumped using the 230-v electric pump. The modifications were carried out by a Nelson engineering company to the specification of the owner and his engineering advisor. No drawings or plans were made of the modifications to the piping and there was uncertainty about which, if any, of the new valves were non-return. The engineers that made the modifications did have a copy of the invoice for materials and were able to draw a rough sketch of the bilge and deck wash water piping on the vessel, showing the approximate placement of the new butterfly valve and 3-way valve as shown on Figure 4. They had no recollection of any non-return valves being fitted.

The modifications to the vessel’s piping system did impact on the conditions of assignment of load line because they had the potential to affect the watertight integrity of the vessel. The modifications had not been notified to the SSM company.

- 2.5 The number of non-return valves, if any, and the condition of any strum boxes or strainers in the modified bilge system were unknown. It is not uncommon for gate valves or non-return valves to become fouled and allow water to back-flow into the vessel. Pre-modification, such an event would have been impossible as the bilge systems had no sea suction, but by connecting the bilge and the fire and deck wash systems the defence against the possibility of back-flowing was lost.

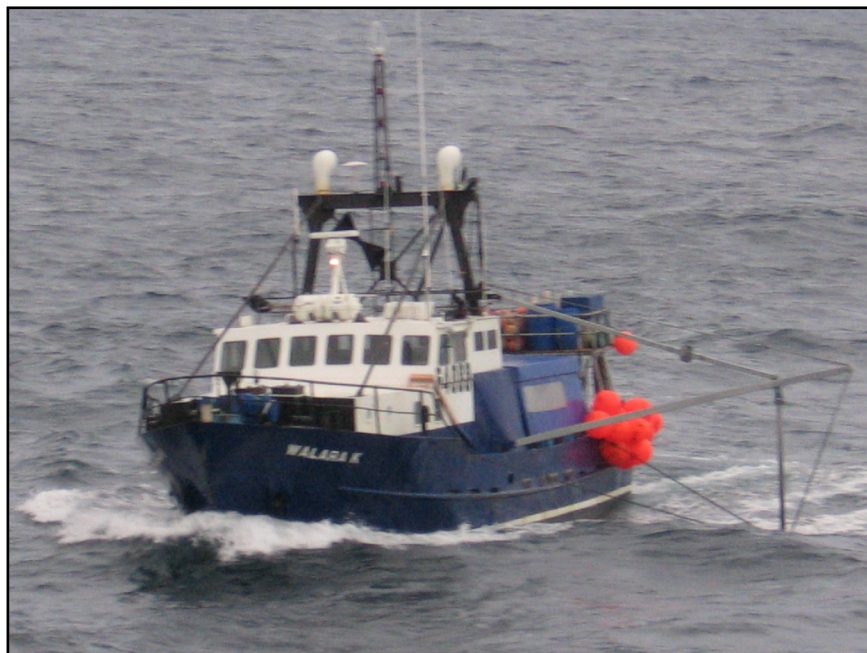
Figure 5
The *Walara-K* with stabiliser arm deployed

1.4.1 In late 2005, the owner from Gisborne modified the vessel by fitting a rigid stabiliser arm on the port side of the vessel just aft of the wheelhouse, which was level with the forward part of the engine room. The stabiliser arm consisted of 3 main tubular steel members: a horizontal arm, a vertical arm and a hinged diagonal stay (see Figures 5, 6 and 7):

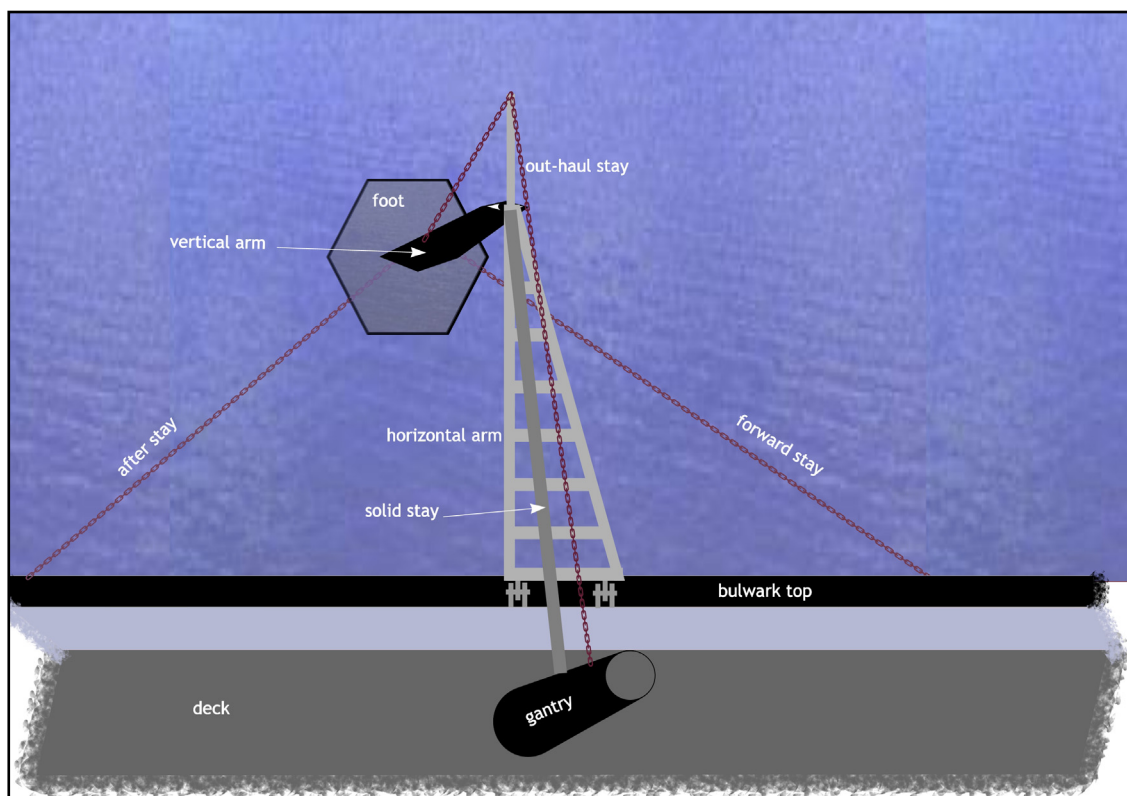
Figure 6
Diagram of the solid stabiliser arm

- 1.4.3 The designer of the stabiliser arm indicated that it weighed less than 500 kilograms. The installation of the arm had not been approved by a surveyor in accordance with Maritime Rule 40.D.7(c), nor had the effect of the arm on the stability of the vessel been considered.

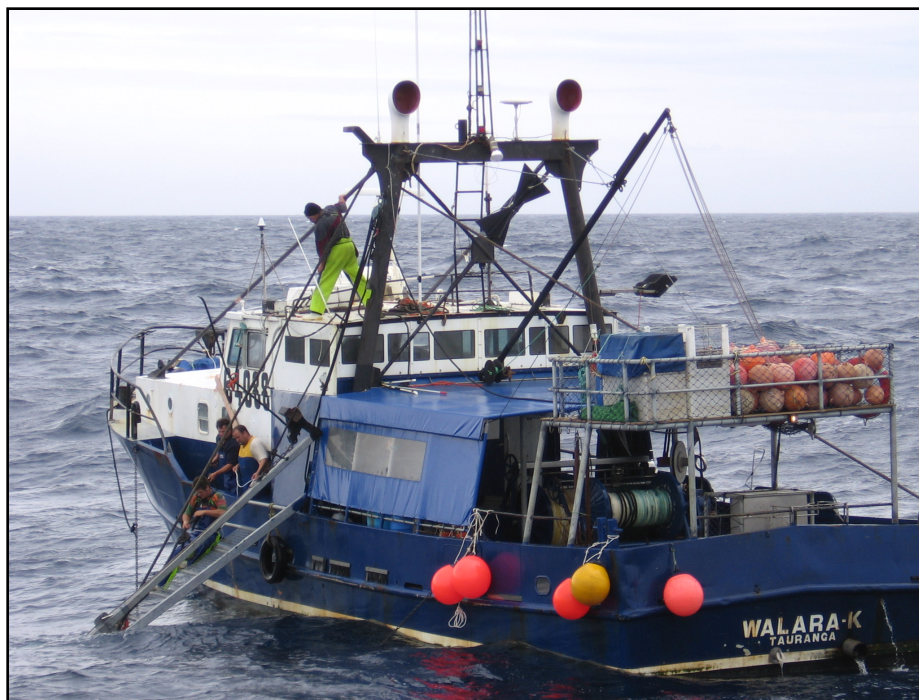
Figure 8
The *Walara-K* with broken stabiliser arm

- 1.4.4 In late January 2007 while hauling the longline, the plate on which the diagonal solid stay and the out-haul stay were mounted came away from the gantry, causing the stabiliser arm to drop. The hinge on the bulwark where the horizontal arm was attached was such that it prevented the arm falling completely, but it did allow it to fall to about 35° below the horizontal (see Figures 8 and 9). The crew were able to recover the arm and return to Nelson, where an engineering company repaired and reinforced the gantry, and reconnected the solid stay and out-haul stay. The owner did not consider it likely that the arm had contacted the hull, so did not carry out an inspection of the underwater hull.

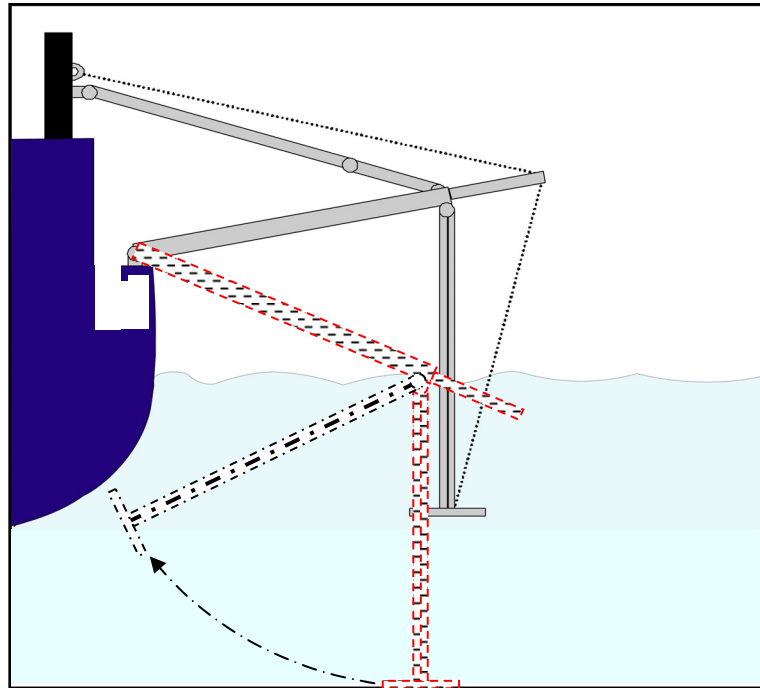
Figure 9
Elevated view of the stabiliser arm showing position when it dropped

- 2.10 In February 2006 the stabiliser arm broke as the vessel was rolling to starboard, causing the arm, which was under load, to drop violently. The haul-out stay was attached to the plate that parted from the gantry and became slack, while the fore and aft stays remained in place, attached between the main deck and the head of the vertical arm. When the arm dropped, the effect would have been for the head to be drawn inwards towards the vessel's hull. Measurement suggests (see Figure 9) that it was possible for the foot to make contact with the hull. However, the dynamic nature of the vessel and arm motion meant that contact between the

2 could not be positively established. Had there been contact, the edge of the plate foot could have cut into the hull in way of the forward part of the engine room, possibly in the area where concrete was lining the inside of the hull. The concrete might have initially prevented any major ingress of water, but could have failed later, allowing water to flood the hull. Unfortunately, damage to the hull was not considered at that time so no underwater inspection was conducted. Consequently, the opportunity to eliminate hull damage as the source of the ingress was lost.

- 3.6 Contingent hull damage following the breakage of the stabiliser arm could not be ruled out as a possible cause of the flooding because no hull inspection had been conducted.
