**Report 07-206, tug *Nautilus III* and barge *Kimihia*, barge capsized while under tow,
Wellington Harbour entrance, 14 April 2007**

Report 07-206

tug *Nautilus III* and barge *Kimihia*

barge capsized while under tow

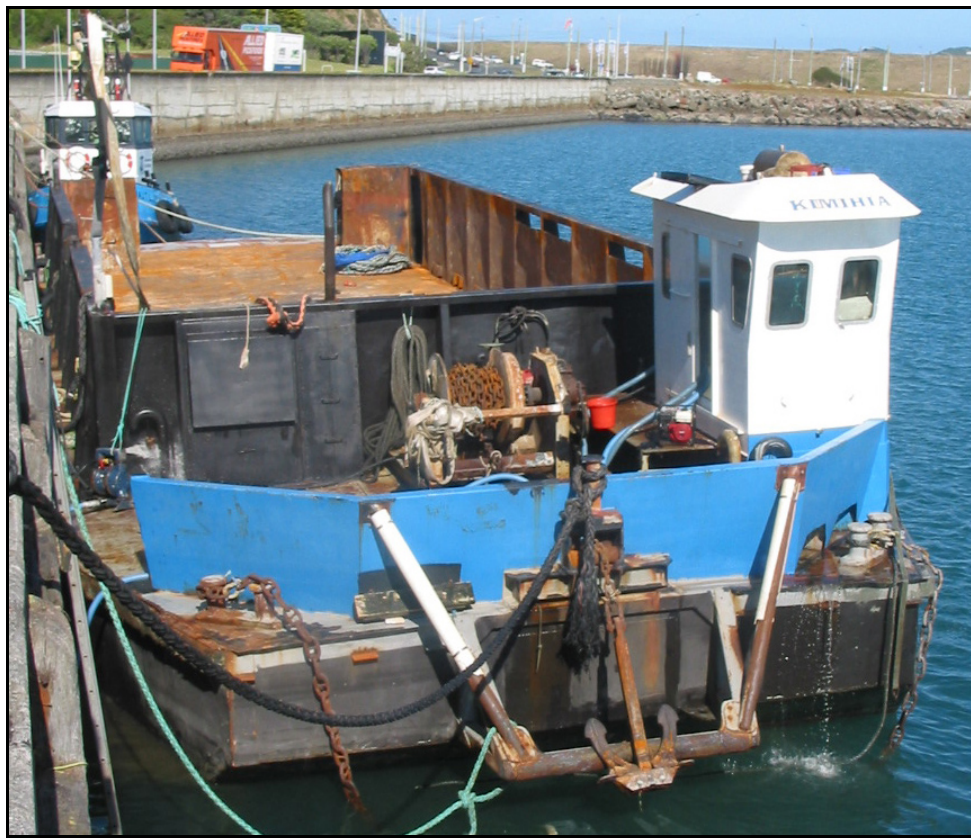
The barge *Kimihia* after righting at Wellington

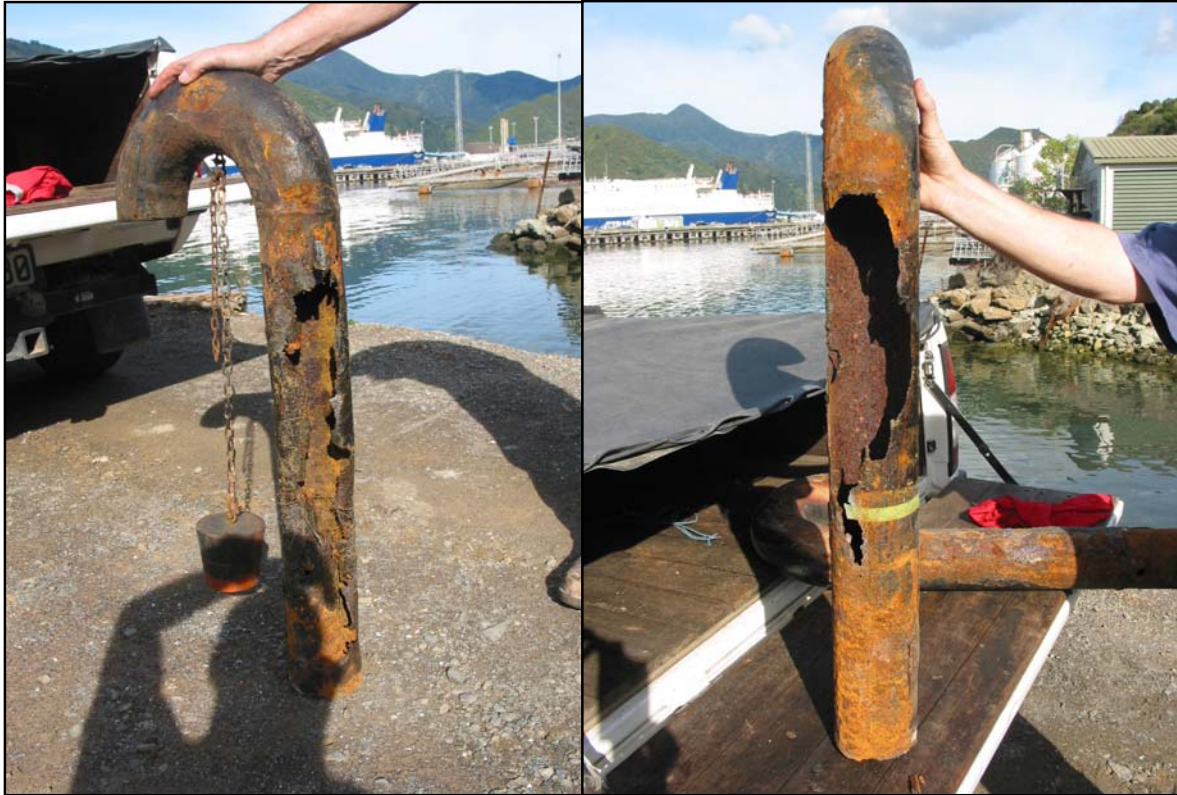
Figure 3
2 of the 3 wasted air pipes

- 1.2.9 During the post-accident investigation 3 of the metal air vent pipes on the port side were found to have corroded to the extent that 2 were severely holed. About 2 weeks after the occurrence the air pipes were removed by the owner and put into storage. The air pipes were further examined and photographed by the Commission 3 weeks after the occurrence, which was about 6 weeks after the survey was carried out in Nelson (see Figure 3). The holes were on the back of the air pipes close to and obscured by other parts of the barge's structure.

- 2.23 Although the position of the holes formed by corrosion wastage of the metal of the air pipes was hidden from view, this is a typical place for such wastage to occur and should be carefully examined during any survey concerned with the watertight integrity of a vessel by a surveyor.

- 2.24 The wastage due to corrosion on the air pipes was of such an extent that this wastage would have been present when the load line survey should have been conducted by Nortel, thus an opportunity was missed for discovery and remedial repairs to be made to the air pipes. A further opportunity was missed during the out-of-water survey conducted by the new owner's SSM company when the surveyor deemed it unsafe to use a ladder to inspect the air pipes.

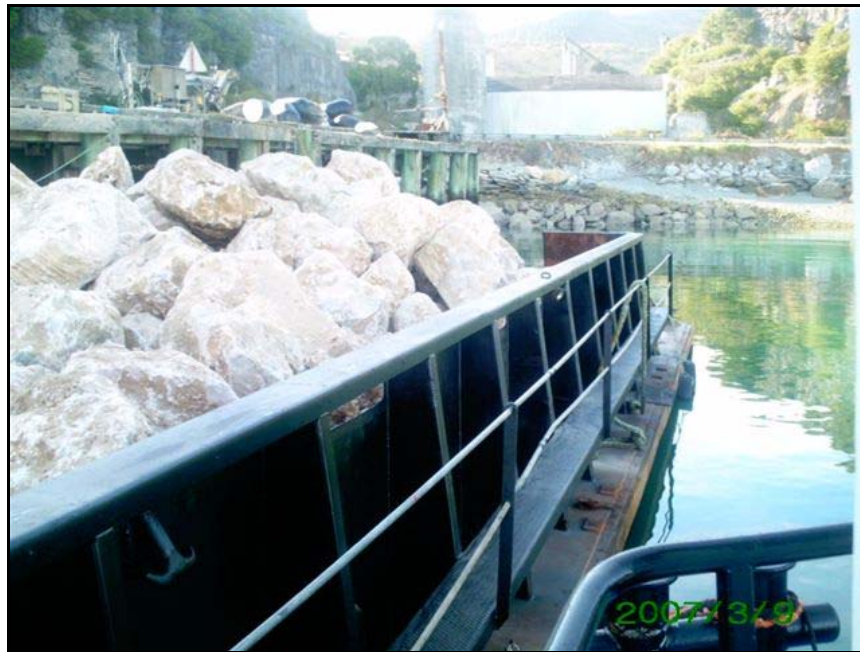
Figure 4
Kimihia loaded with rock at Tarakohe

The barge was slightly overloaded prior to the capsizing event, when considered with respect to the Barge Stability Guidelines.

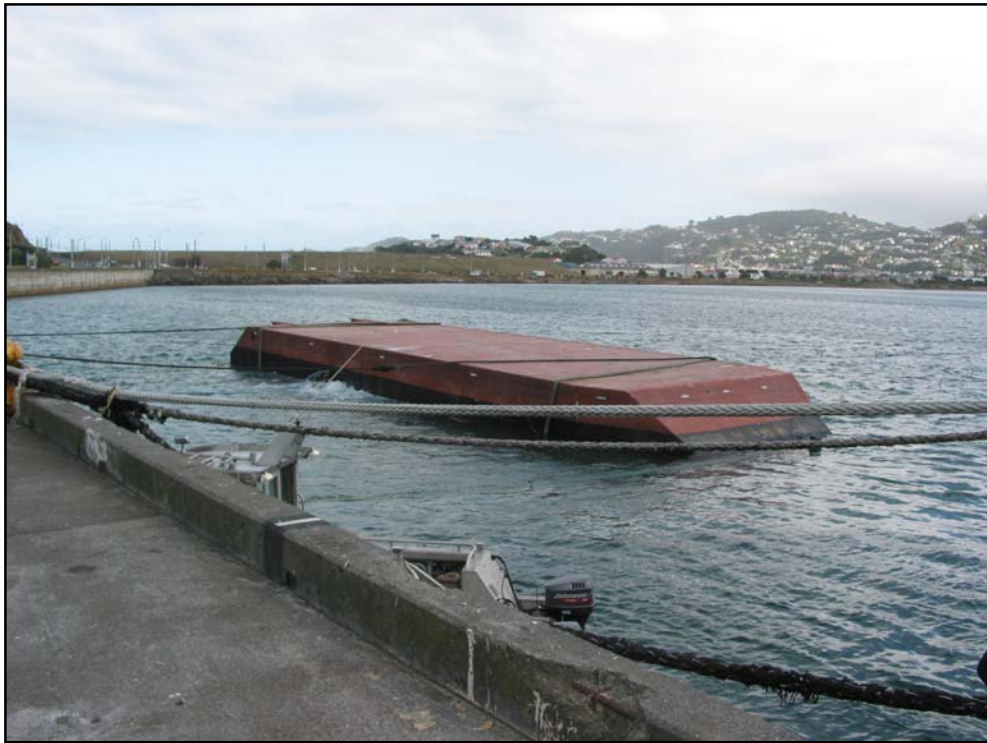
Figure 7
The *Kimihia* at Miramar wharf at commencement of righting

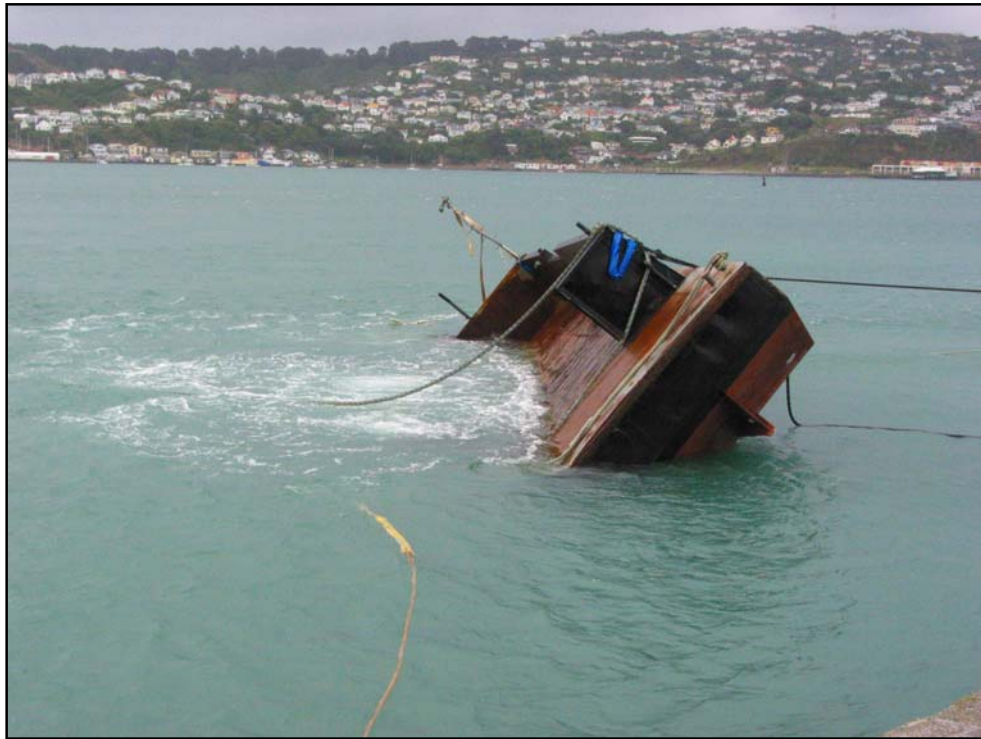
Figure 8
The *Kimihia* in the process of being righted

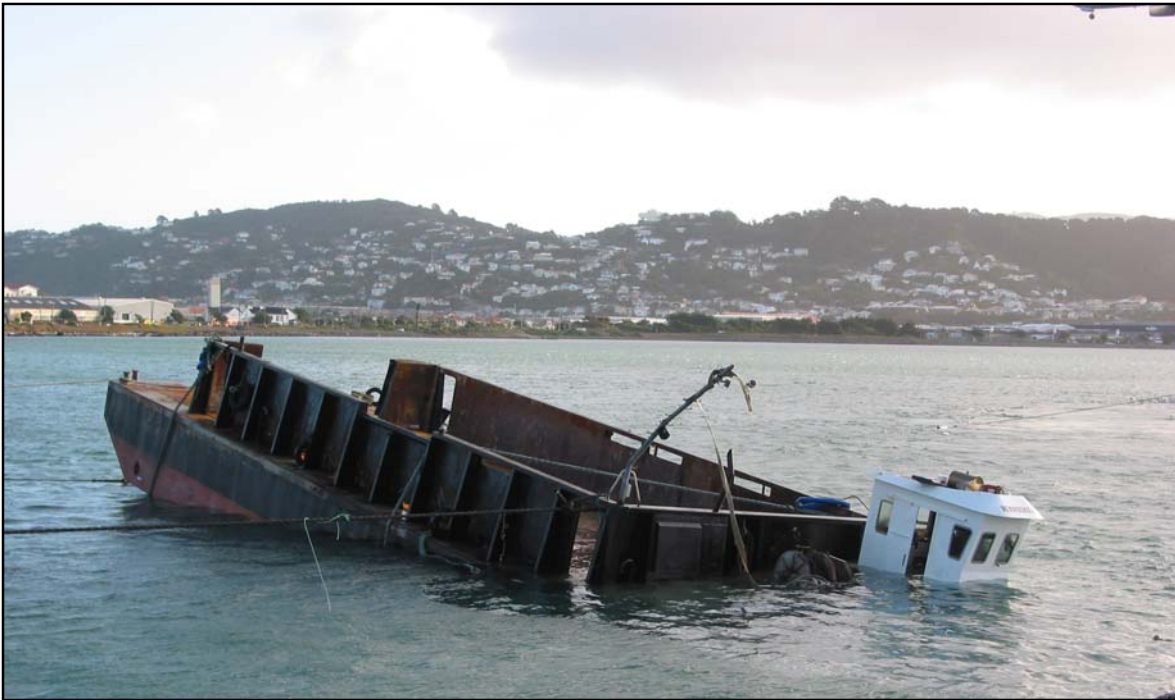
Figure 9
The *Kimihia* after righting

The capsizing was most probably initiated by the barge taking on a progressive list due to compartment flooding via defective air escapes in the prevailing swell conditions. With about 18 t of water on board the deck edge would be immersed, leading to a rapid increase in the flooding rate.
