**Report 08-201, fishing charter vessel, grounding, Murimotu Island,
North Cape (Otu), 13 April 2008**

Report 08-201

fishing charter vessel *Pursuit*

grounding

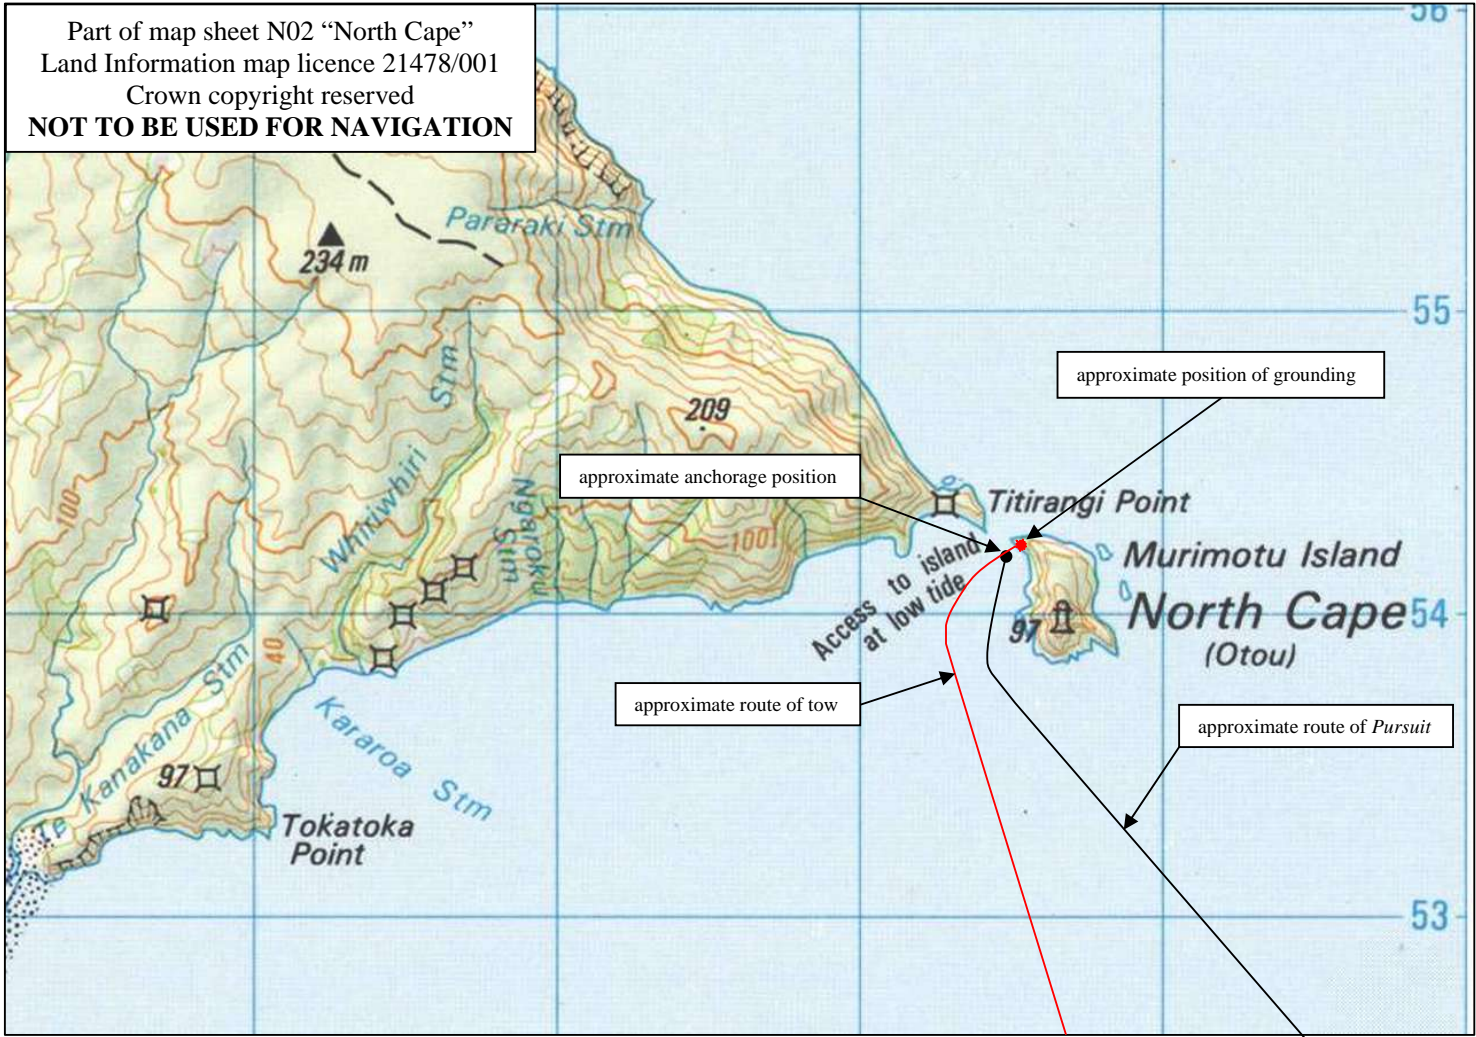
Figure 2
Map showing anchorage and grounding position

- 3.1 The *Pursuit* ran aground on rocks when it overran its anchor cable, most likely tripping the anchor free from its holding ground when the wind increased sufficiently to form a wake eddy; on the lee side of Murimotu Island, with sufficient force to cause the *Pursuit* to be pushed onto the rocks.

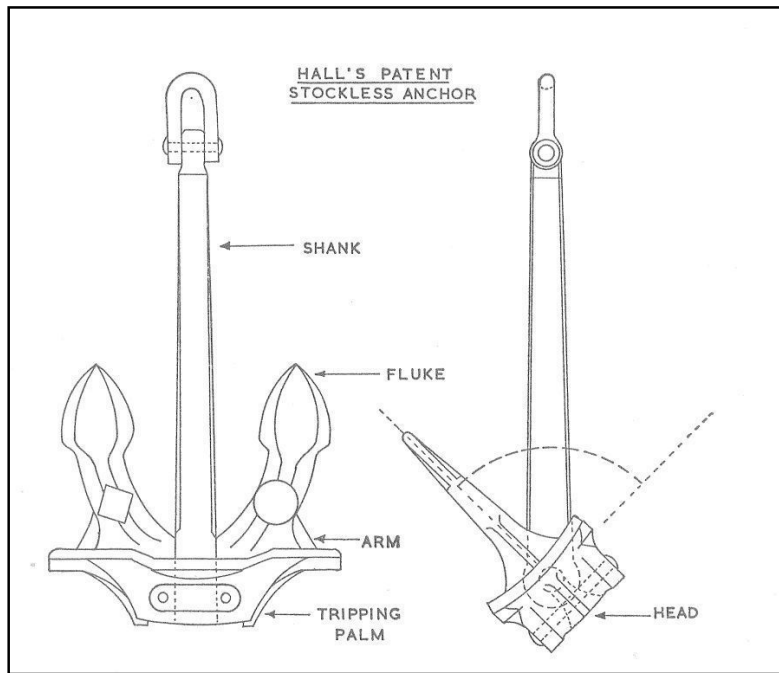
Figure 3
Diagram of a stockless anchor

- 1.3.2 In stockless anchors similar to those carried by the *Pursuit*, there are 2 digging blades set on opposite sides of the shank, and hinged to it by a horizontal hinge, which allows them to set themselves at the correct digging angle which ever way up the anchor may fall on the ground (see Figure 3). There is no difficulty in making them begin to bite as soon as the pull comes on the chain. However, the simple design, consisting of 2 blades set on opposite sides of a shank, is essentially unstable in the ground.

- 1.3.3 The stockless anchor has a holding power, in the region of 3 to 4 times its weight in efficient holding ground, but has a moving part that can become choked with sea-bed material. This can cause the flukes to fail to re-trip should the anchor be broken out of its holding position. The stockless anchor is useful on rocky, foul bottoms as it is relatively heavy and robust and if the anchor becomes fouled it can usually be wrenched clear; conversely the stockless anchor is less useful on shale, shell or mud and sand over a sandstone base. The seabed in the vicinity of where the *Pursuit* anchored was charted as being of fine sand and broken shell. Other more modern designs of anchors such as the plough, claw, delta and Rocna anchors have a greater holding power than the stockless in the bottom conditions in which the skipper anchored.

- 2.2 A second possibility is that the anchor was not set well and broken free from the bottom when the vessel overrode it or swung around and exerted a pull from another direction. There are a number of reasons why a stockless anchor might not set well; uneven holding ground, a twist or loop in the chain or debris jamming the moving parts to name a few.

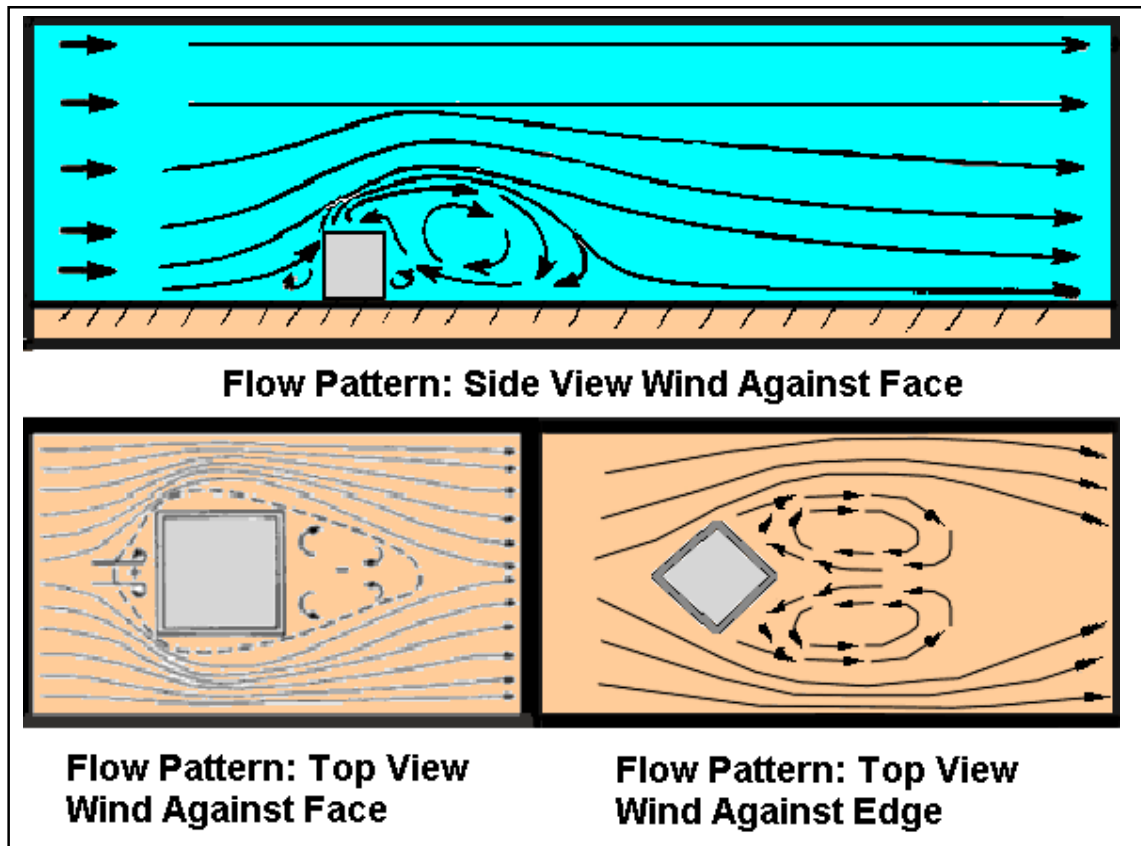
Figure 4
Air flow pattern around a cube

- 1.4.8 Research shows that when wind hits the face of an island, the flow splits and is diverted into several streams, the orientation and number depending on the angle of wind incidence relative to the island's edges and the "flatness" of the upwind island surface. For the simplest situation - a cube or rectangular solid - one flow path rises over the island and 2 go around it.(see Figure 4) The fourth diverts downward along the upwind face, eventually meeting the ground then travelling back upstream to form a reverse eddy in the flow. When the main point of flow separation is high on the island or when the winds are strong, the downward stream can be strong enough to cause hazards.

- 1.4.9 The side streams produce zones of accelerated flow near the island edges and vortices (areas of rotating flow like stationary dust devils) off the back, downwind edges of the island. Just behind it, a dead air zone of light and chaotic flow usually forms. The stream that moves over the island top accelerates along the top upwind edge, then descends some distance downwind from the island to combine with the side vortices to produce a wake eddy. In these vortex zones, and at the points where the flow direction is diverted from the original flow, the turbulence, i.e. the gustiness, is greatly enhanced.

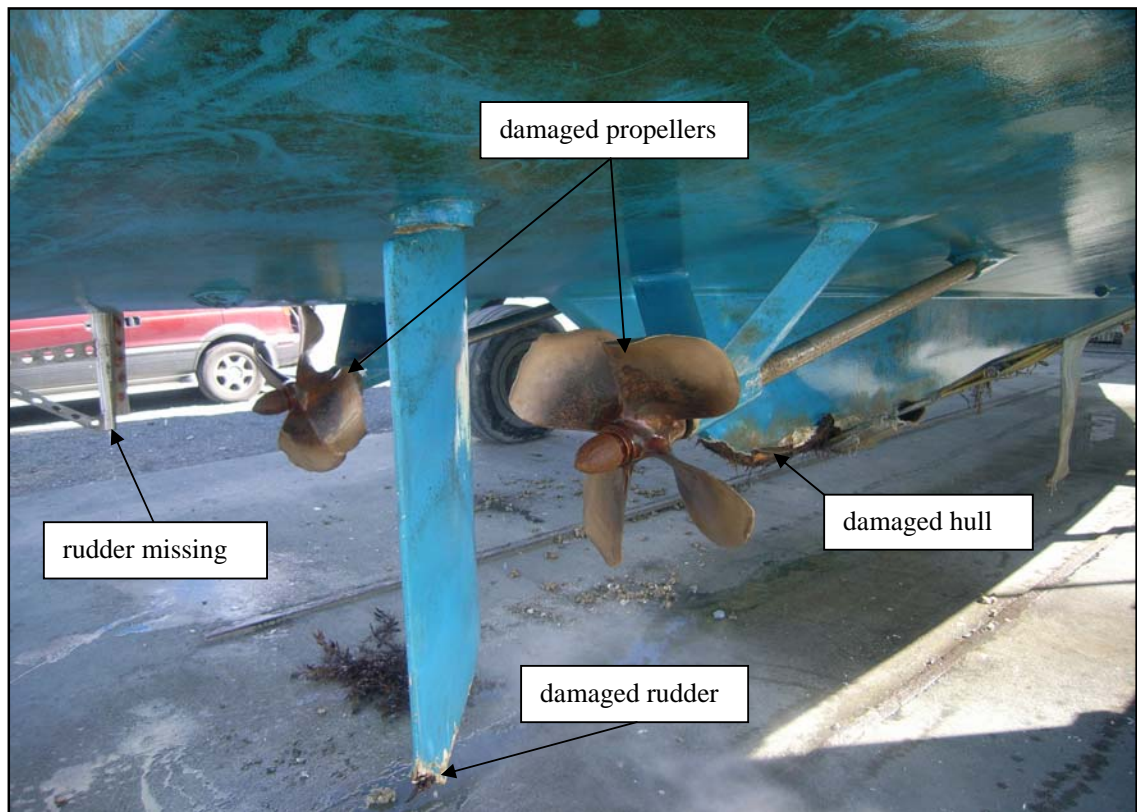
Figure 5
Damage sustained to the drive train and steering of the *Pursuit*

- 1.5.1 The *Pursuit* sustained damage to the underwater hull and fittings where they grounded on the rocky shoreline (see Figure 5). The major items of damage were:
- one rudder was lost
 - one rudder was damaged on its blade
 - both propellers were damaged beyond repair
 - both propeller shafts and drive train required alignment checks and crack testing
 - substantial damage to the hull throughout the length but more extensively toward the stern.
