**Report 08-206: passenger ferry *Monte Stello*, collisions with wharves,
Picton and Wellington, 8 and 9 August 2008**

Report 08-206

**passenger ferry
*Monte Stello***

collisions with wharves

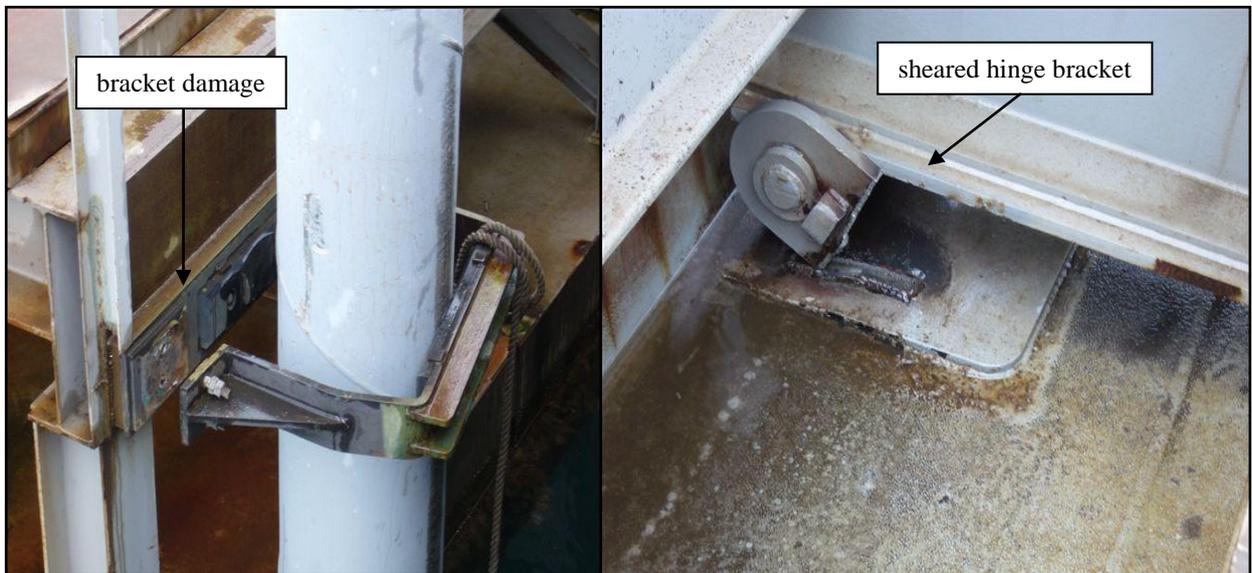
Figure 4
Damage to hinges and brackets on link-span

- 1.2.2 When the *Monte Stello* hit the floating pontoon, 5 hinges that linked the floating pontoon to the link-span sheared off and 2 of the brackets that secured the floating pontoon to the adjacent piles also sheared (Figure 4). There was also superficial damage to the pontoon plating. The pontoon was out of commission for about 2 days while repairs were made.

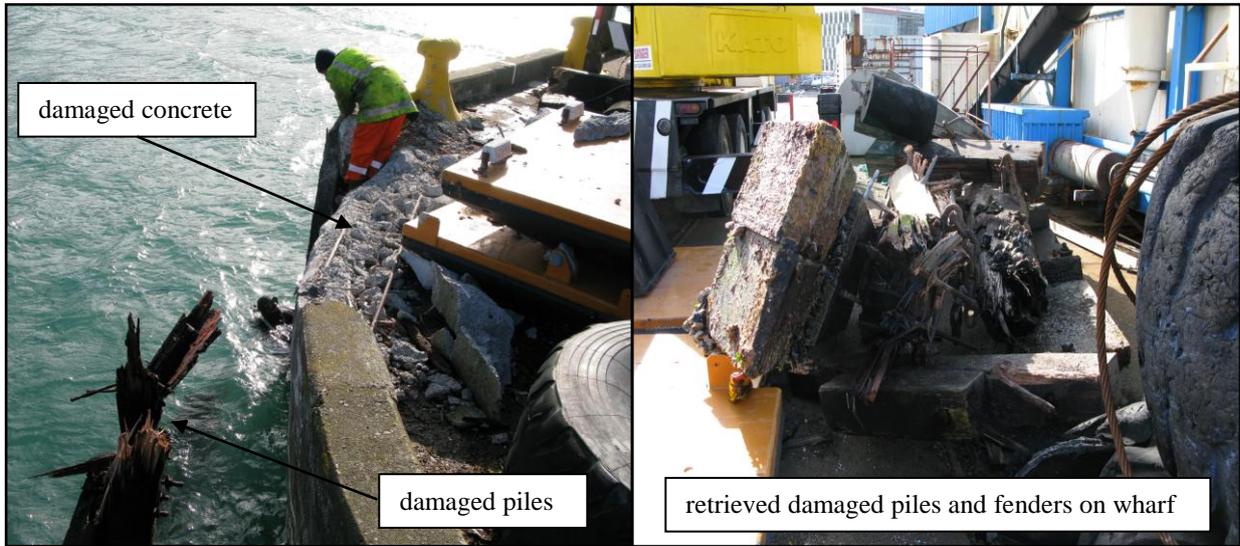
Figure 5
Damage to end of Glasgow Wharf

- 1.2.3 The stern of the ship was damaged slightly by the impact and required some remedial welding repairs when the ship arrived back in Wellington.
- 1.2.4 The port aft quarter of the *Monte Stello* contacted the knuckle of Glasgow Wharf, and in the impact the wooden fenders and the wharf were damaged (Figure 5). The damaged piles and fenders that had fallen into the water were removed by a diving contractor and the wharf repaired.

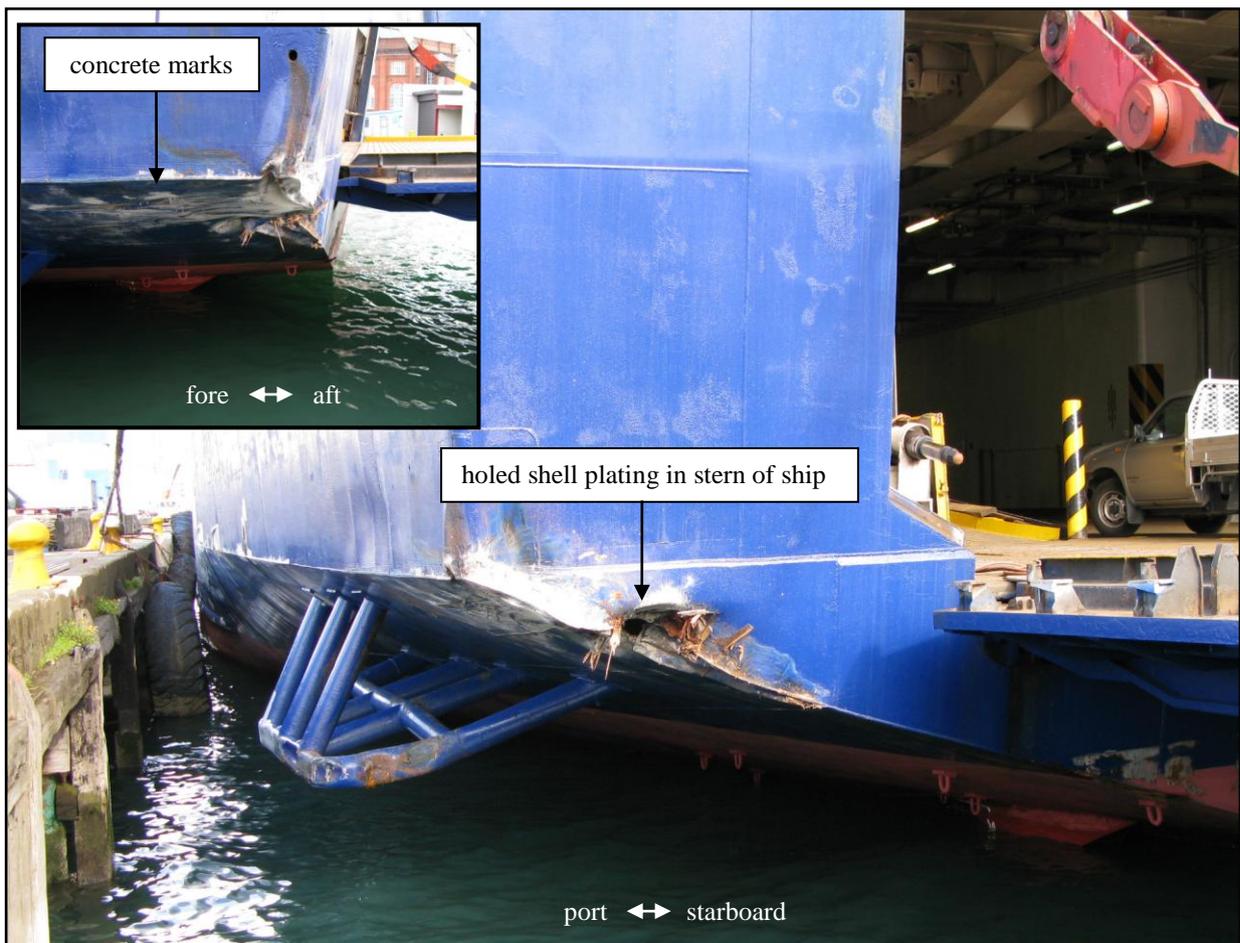
Figure 6
Damage to *Monte Stello* stern after Wellington collision

- 1.2.5 The collision punctured a hole in the shell plating of the ship above the water line (Figure 6).
- 1.2.6 The *Monte Stello* returned to service 8 days later after repairs had been made to the ship's hull plating.

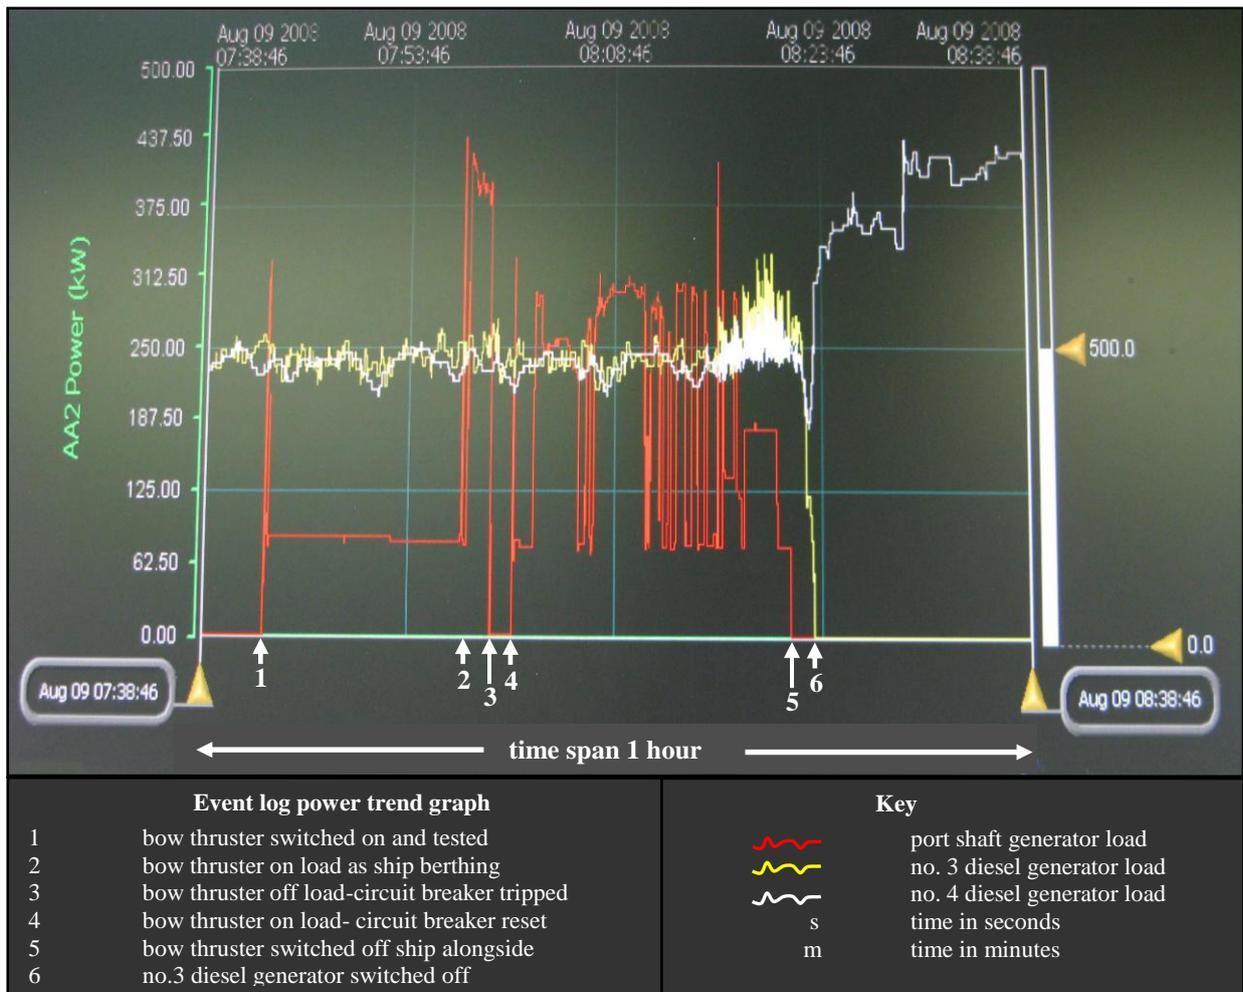
Figure 12
Electrical load data during berthing in Wellington

- 2.4.6 Figure 12 shows that the ship's 2 diesel generators were on load when the ship arrived at the entrance to Wellington Harbour. The bow thruster was the only load on the port shaft generator, so the load on the generator reflects the load on the bow thruster. The bow thruster was switched on and tested (spike in power at point 1). The bow thruster was not used on load until about 15 minutes later. The bow thruster was then on load (in use) for just under 2 minutes until it tripped at point 2. This supports the master's recollection that he was using the bow thruster as the ship backed towards the wharf after the turn was complete. The length of time that the bow thruster was in use coincided with the time taken for the ship to move astern and collide with the wharf.

- 2.4.7 A comparison with frequency trend data in the same time period showed that on the bus-bars supplied by the port shaft generator, the frequency fell to zero about 7 seconds after the load on them fell to zero. This shows that the bow thruster's circuit breaker tripped about 7 seconds before the port shaft generator circuit breaker tripped. The port shaft generator was reset in about 30 seconds and the bow thruster reset and on load again about 60 seconds after that, meaning the bow thruster was off for about 90 seconds in total. This supports the chief engineer's recollection of resetting the circuit breaker for the port shaft generator and advising the bridge that the bow thruster could be switched on again. Neither the second officer nor the additional master saw the bow thruster trip.

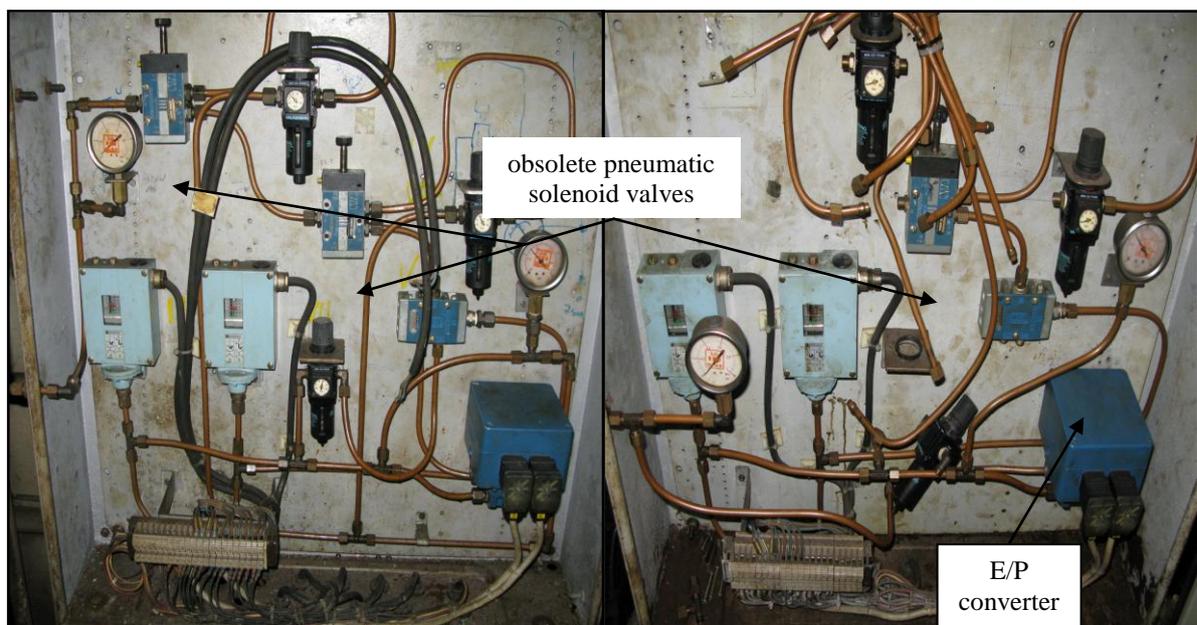
Figure 13
Modifications to electro/pneumatic control boxes

- 2.5.13 When the CPP systems were modified the changes made to the CPP system pneumatic control boxes in the engine room were not identical, although they achieved the same result. The original solenoid-operated pneumatic valves were left in one system, although electrically disconnected (Figure 12). The components of the system then no longer matched what was in the drawings and description of the system. This might cause confusion when personnel are trying to fault find or understand the system in future.

- 2.5.14 In general, leaving redundant pneumatic components in a system is not good practice; under normal circumstances it would be reasonable to assume such components were overhauled or inspected periodically. Since these obsolete components were not considered part of the new system, it was possible for the degradation of internal components over time to go undetected and contamination of the pneumatic system to result with potential to affect performance.

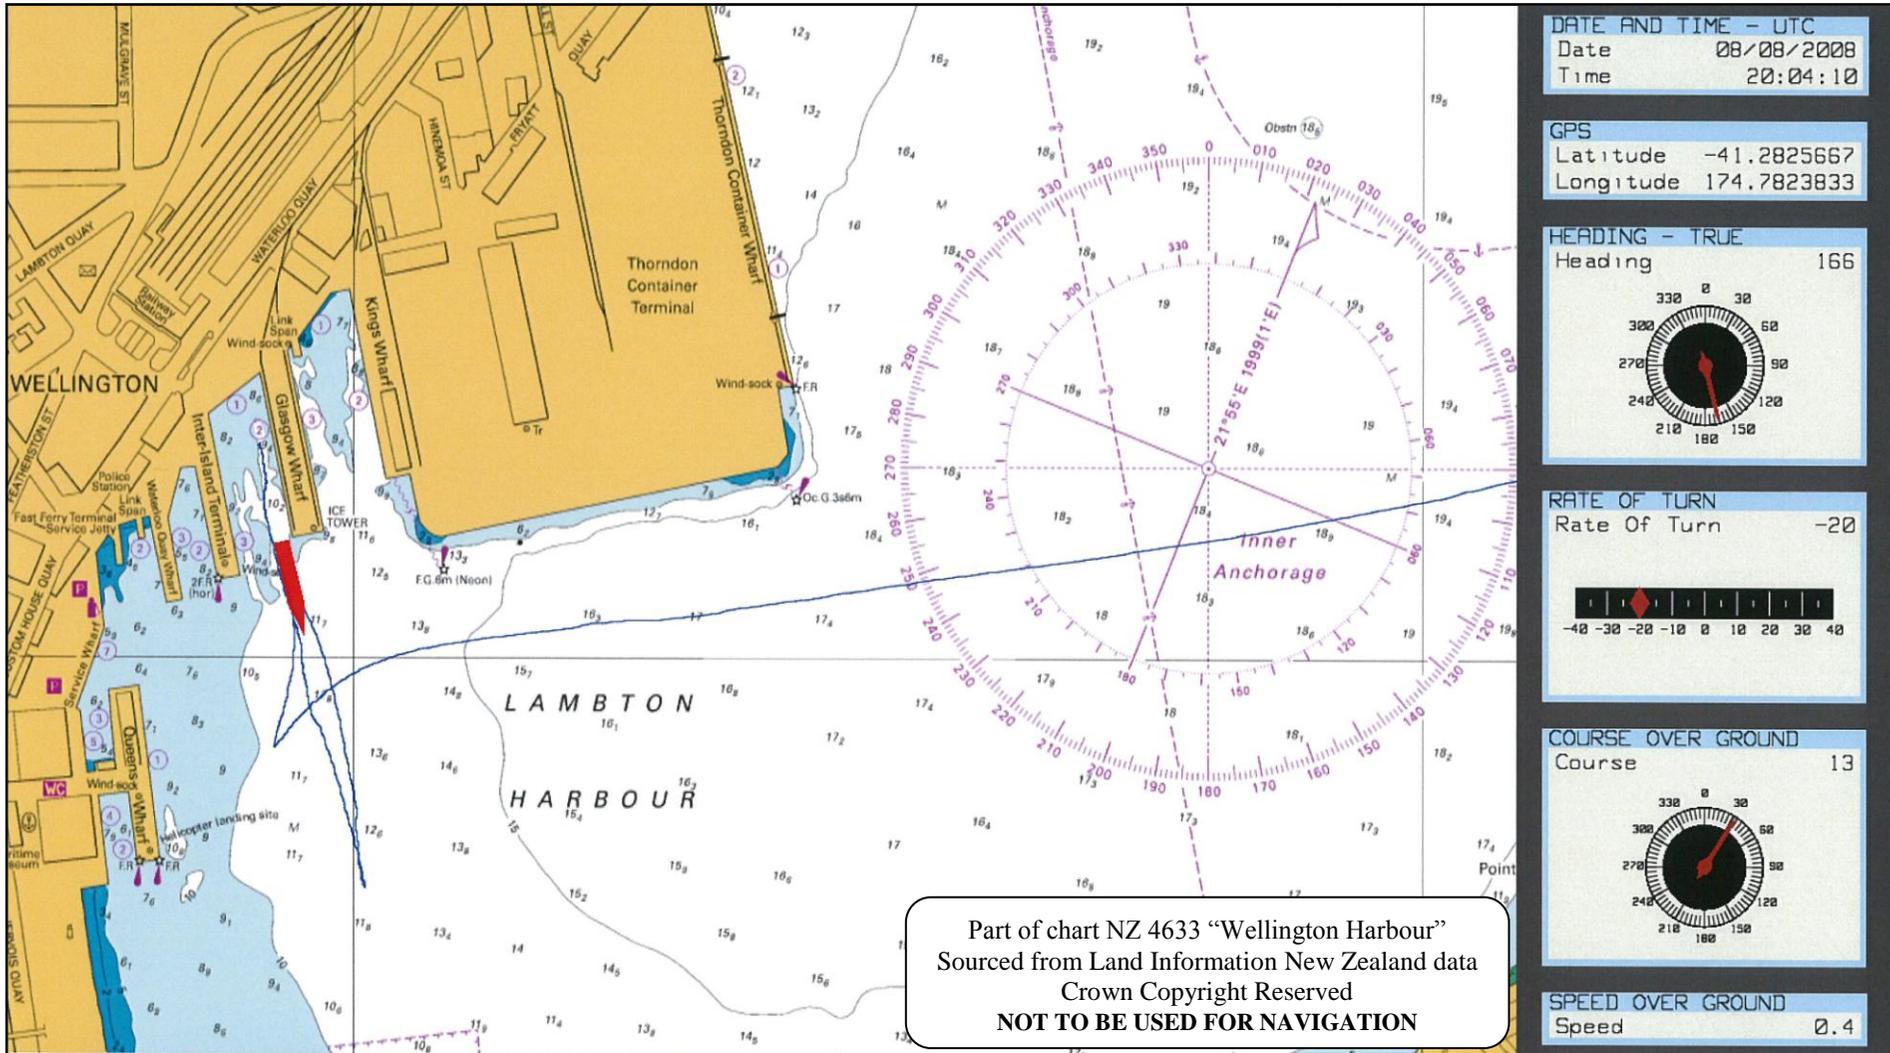
Monte Stello contacts knuckle of wharf
