Report 08-209: Loss of the rigid inflatable boat Mugwop,  
off the entrance to Lyttelton Harbour, 28 October 2008

Marine Inquiry 08-209

Loss of the rigid inflatable boat Mugwop,  
off the entrance to Lyttelton Harbour,  
28 October 2008

Approved for publication: February 2011

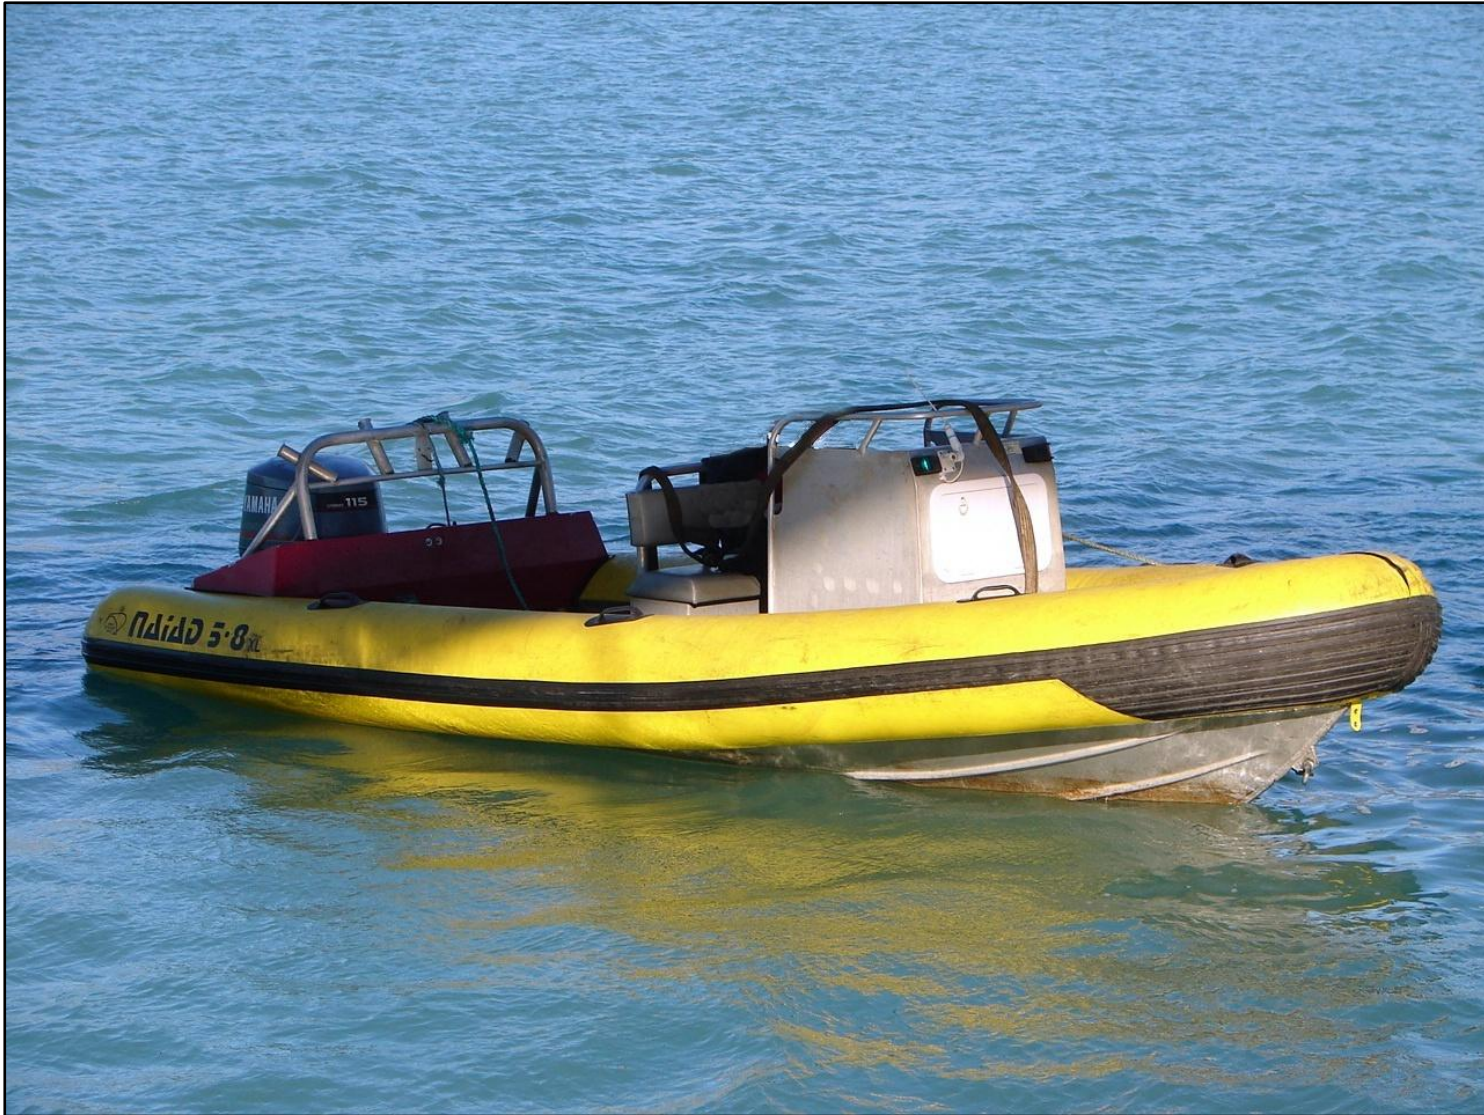
*The Mugwop*

- 4.2.6. RIBs have been referred to as the “four-wheel drive of the sea”, but of course any boat has its limitations. In all 3 previous occurrences the Commission has investigated involving RIBs, the boat was travelling at high speed in a following sea, and lost all or most of its inflatable pontoons. The reason for this was that when the bow buried into the back of a wave, the forces on the bow area were at their highest. Whether the pontoons could withstand the pressure would have depended on how hard the boat was being driven and the condition of the pontoons, including how well they had been fitted. The pontoon securing tag at the front of the boat was not attached to the aluminium hull. It can be seen hanging down unsecured in the photograph at the beginning of this report.

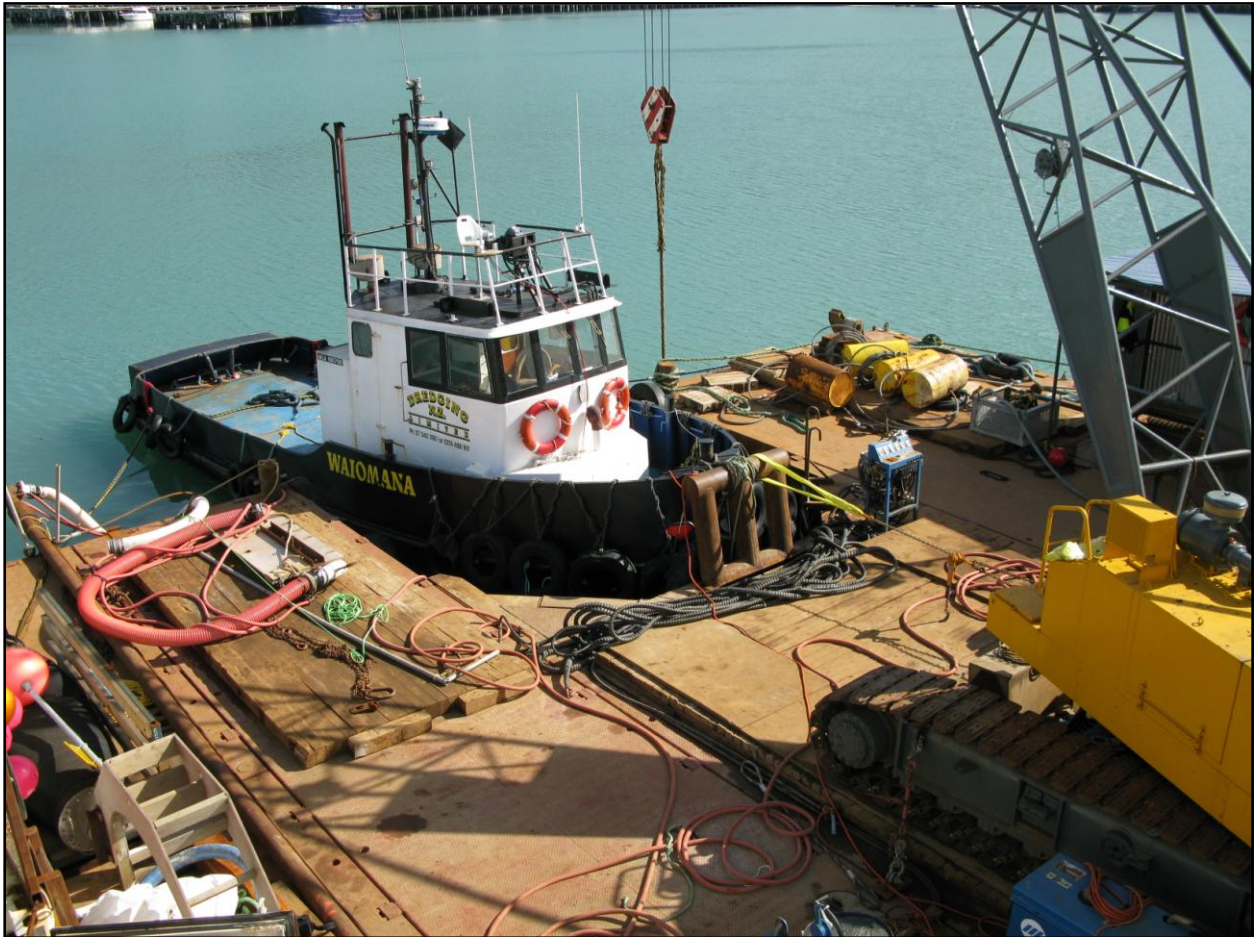
**Figure 5**  
**The *Waiomana* secured to the *Flexifloat***

Usually the ropes that secured the tug to the barge were sufficiently strong to maintain the rigidity of the 2 vessels, but when the state of the sea deteriorated, as it did in the *Flexifloat* incident, the movement between the tug and barge became sufficient to strain the securing lines until they broke.

3.3.24. During the morning of the day of the accident, the fixed-length wire strop had been lost overboard, so a black-and-yellow 100 mm plaited polypropylene rope had been used to secure the port quarter of the tug to the *Flexifloat*. During the voyage back into Lyttelton Harbour, that rope had chafed where it crossed the deck edge of the barge and had eventually parted. Another mooring rope had been quickly secured, but when the hand winch was tightened the securing hook on it straightened. It was after this that the tug master decided it was too rough to re-secure the tug into the barge, so arranged for the barge to anchor and called for assistance from the larger tug, the *Kurutai*.
