Marine Inquiry 09-202: Passenger vessel Oceanic Discoverer
Fatal injury, Port of Napier
19 February 2009

Final Report

Approved for Publication: November 2011

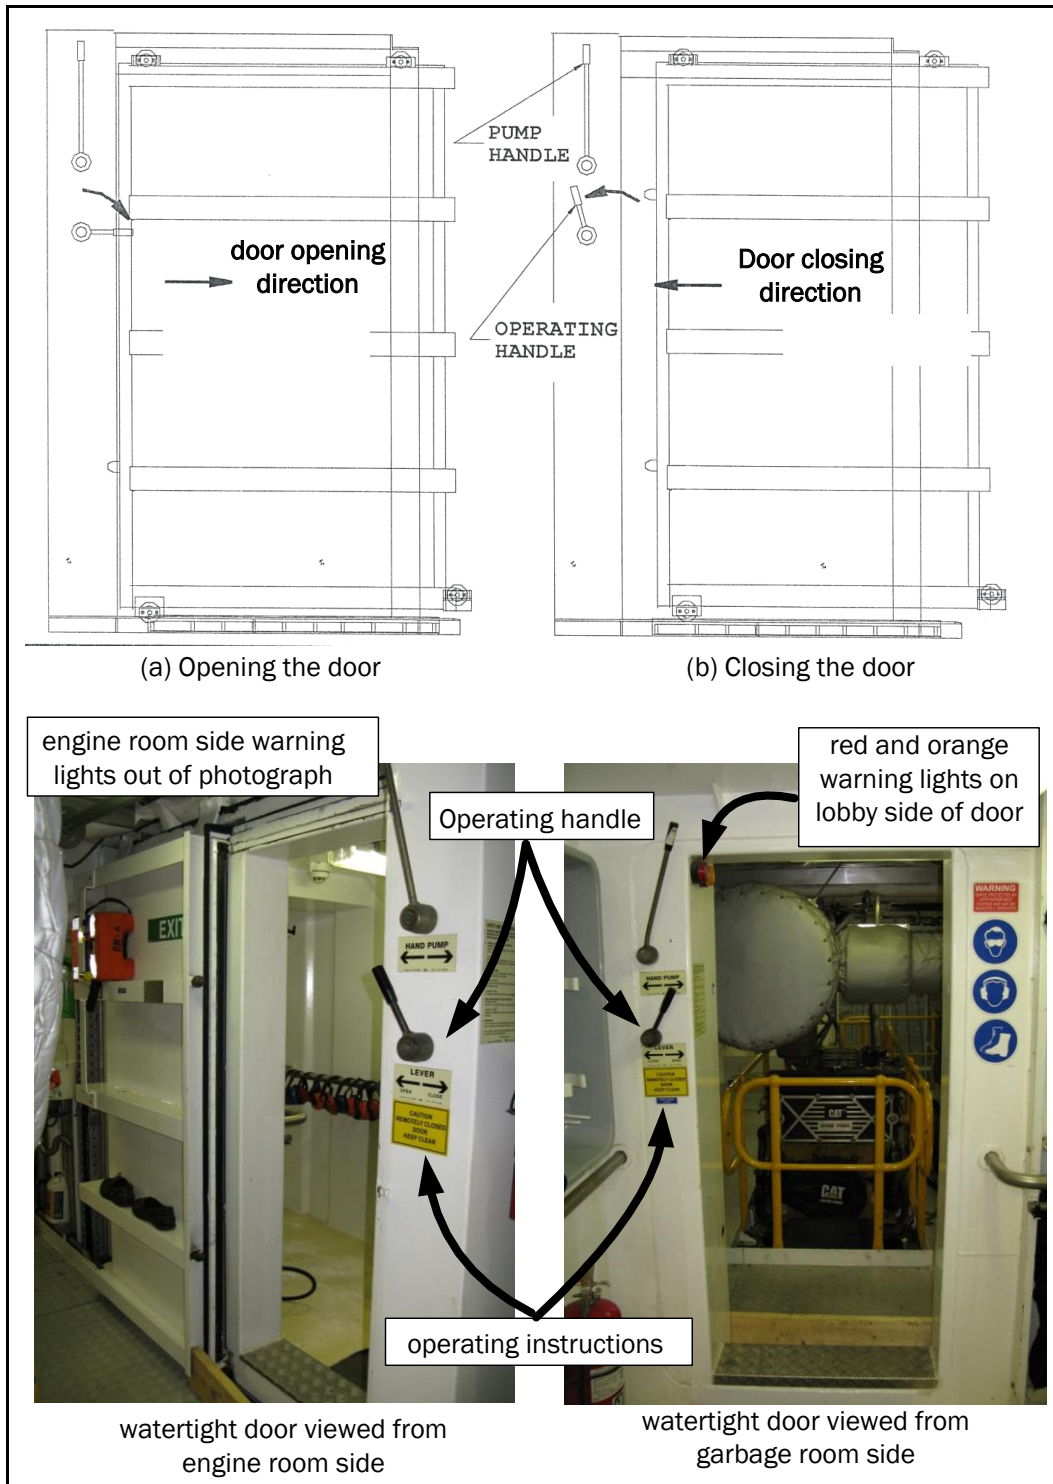
Figure 2
Operating controls and indicators for the watertight door

- 3.4.17. When the door was in the opening position, its operating handle protruded into the doorway as seen in Figure 2 (a). Thus when opening the door a person could see the handle on the other side of the doorway in order to reach through to hold the handle before transit.

3.4.18. In the event of electrical failure and empty accumulator, the door could be activated using a manual pump (its handle is shown in Figure 2).

- a non-standard repair was evident where the spring on the door operating lever had been replaced by a bungee cord
- the mechanical lock for keeping the door in the closed position was not latching correctly. It is possible that it had been this way since commissioning.

- 4.4.8. The spring that returned the operating handle to the neutral position had broken and been replaced with an elastic cord. A replacement spring was purchased following the accident to reinstate the system to its original state.

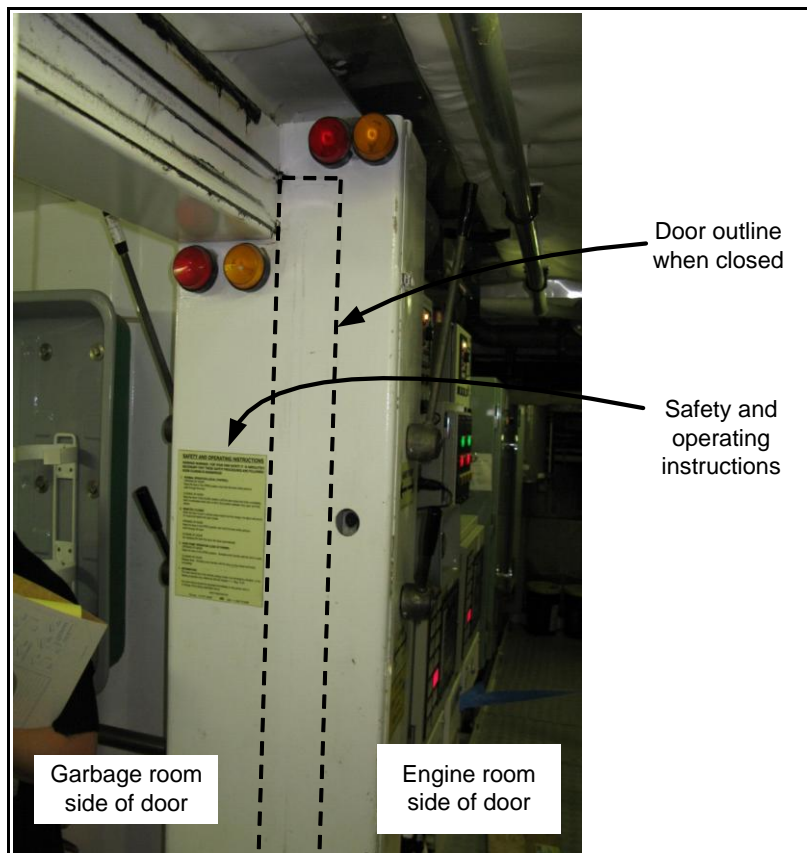
Figure 4
Warning lights on door

- 4.2.6. The vessel was carrying out a fire drill. About 2 minutes before the chief engineer became trapped, the master made an announcement on the PA that he was going to close the watertight doors remotely, then did so. From that time a red light on either side of the door would have been flashing to alert anyone approaching the door that it was in remote-close mode. Both these flashing red lights were tested and found to be working after the accident.

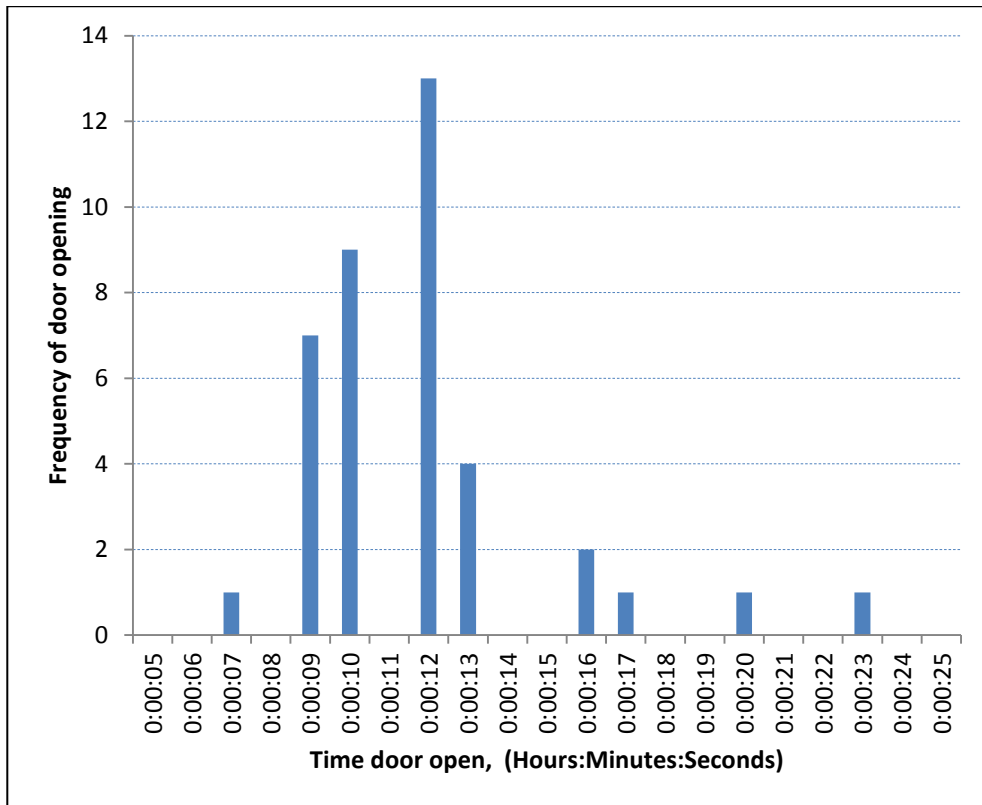
Figure 6
Histogram showing length of time door was opened during transits

- 3.7.4. The data in the histogram confirmed the procedure the crew said they routinely used to pass through the accident door. Based on the tested door speed, it would have taken a minimum of about 20 seconds for a person to open fully, pass through and close the door. The histogram showed that 34 of the recorded 39 transits of the door were completed in 13 seconds or less. The door was opened for about 9 seconds when the second engineer went through it; less than 20 seconds later the door was used again by the chief engineer and he became trapped. The door would have opened approximately 42 centimetres (about halfway) when the second engineer went through it.

- 3.7.5. It was not determined which of these recorded transits, if any, were made by the chief engineer. However, as mentioned, the crew routinely went through the door in the same manner; the chief engineer did not advise them any differently and it is assumed that he routinely exhibited the same behavioural traits as the rest of the crew.

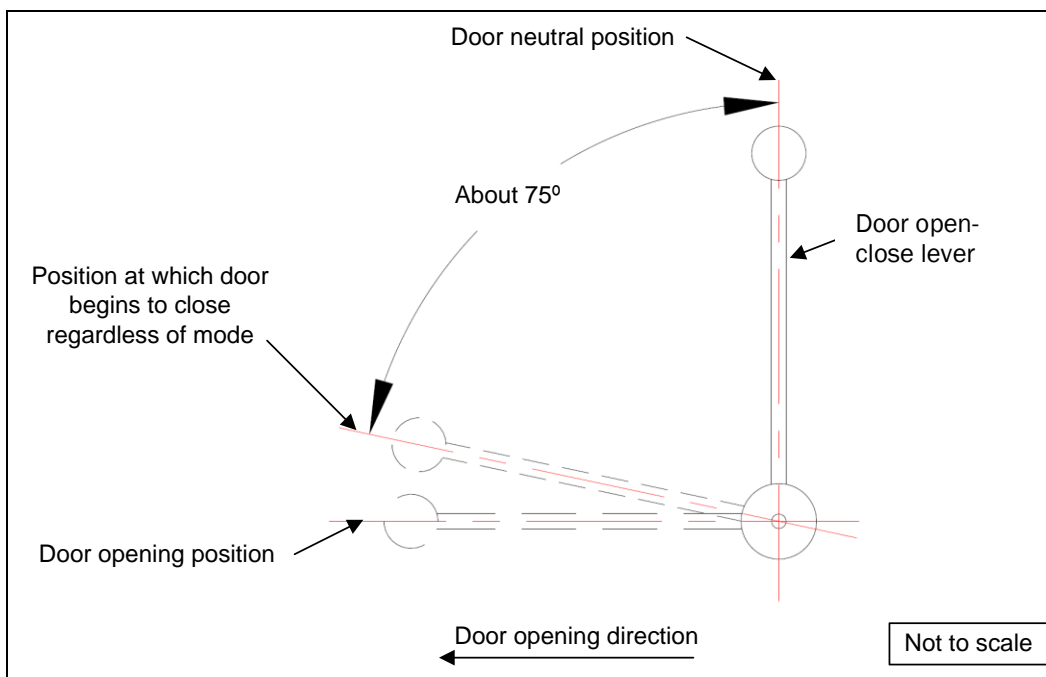
Figure 7
Diagram showing position of door handle where door begins to close regardless of mode

3.8.4. It was noted that when the open-close lever was slowly released from the opening position of 90 degrees from vertical (the lever had a full travel about 100 degrees from vertical), there was a position at about 75 degrees where the door would start to close, whether in local-control or remote-close mode, as shown in Figure 7.

- 4.2.18. There was another factor that would not have contributed to the accident, and that was the peculiarity that when the operating handle was placed at about 75 degrees from vertical in the "opening" arc, the door would begin to close, even with the door in local-control mode (as shown in Figure 7). When the door was in local-control mode it should have remained stationary unless the handle was in the opening or closing position. Releasing the door handle from its opening position when in the local-control mode should have caused the door to stop and stay where it was. This was a serious design or maintenance fault. Anyone passing through the door in the belief that they were opening the door in local-control mode could have been caught out if they eased the downward pressure on the handle enough for it to take up the position at about 75 degrees from vertical (Figure 7). Instead of the door stopping where it was, it would have begun closing on them. The reason for this peculiarity not contributing to this accident was that the door was in remote-close mode, so the user would have been expecting the door to close automatically when the handle reached this position.

- 7.5 The watertight doors on the *Oceanic Discoverer* had an unexplained design or maintenance peculiarity where the door would begin to self-close even when in the local-control mode. This peculiarity was observed on one other vessel that the Commission visited.

The Commission therefore recommends that the watertight door manufacturer investigate this safety issue, provides a solution, and promulgates that solution through the International Association of Classification Societies (IACS) and any other way it can. (027/11)

This recommendation has been sent to the IACS for its information so that Class surveyors can check for this peculiarity when surveying this make of watertight door. (027/11)
