**Report 09-203, jet boat, *DRJS-11* grounding and subsequent rollover Dart River,  
near Glenorchy, 20 February 2009**

**Report 09-203**

**jet boat  
*DRJS-11***

**grounding and subsequent rollover**

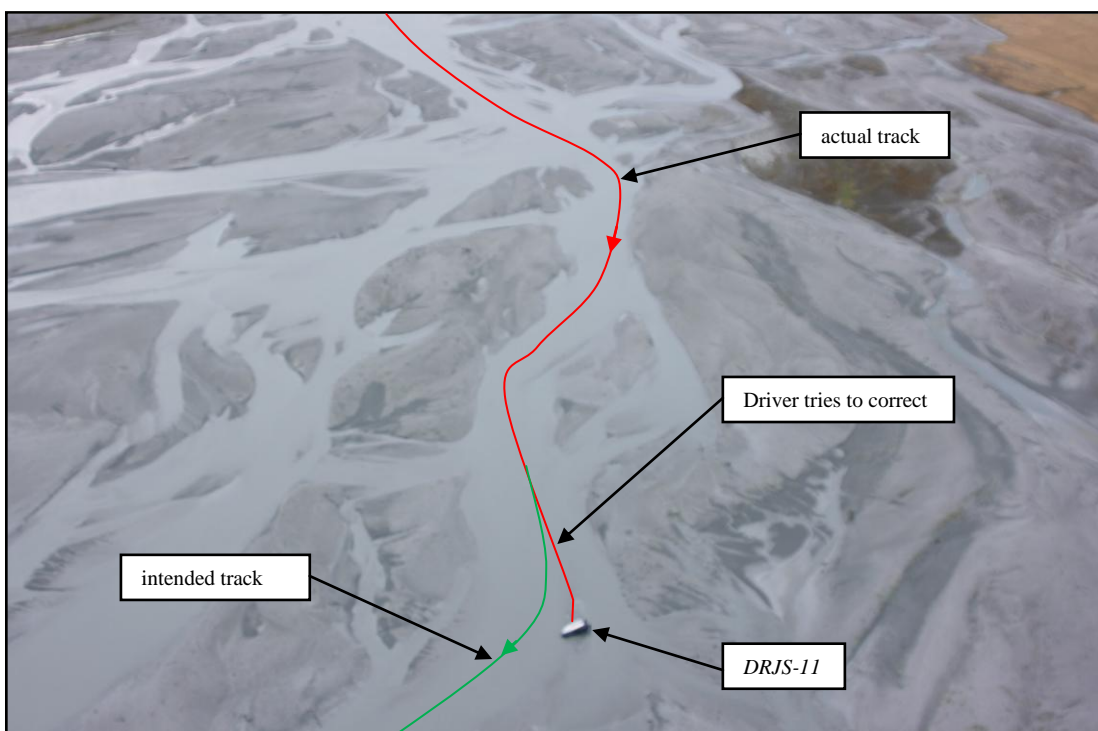
**Figure 3**  
**Track of DRJS-11**

1.1.8 The driver of *DRJS-11* got the boat up onto the plane and headed down river towards the lake. On the way down, a passenger sitting close to the driver began asking questions about the vegetation and bird life. The driver was responding to his questions. The boat had just made a left-hand turn to follow the main channel when he noticed a flock of geese taking flight to the right of the boat. He pointed these out to the interested passenger, and when he looked ahead again he noticed the boat had drifted left of his intended track. He turned the wheel to the right

to regain his line but he immediately realised that his correction had been too late to clear the gravel bank, so he centred the wheel and took his foot off the throttle pedal. He said he heard the keel rubbing on gravel and as the boat slowed it rolled slowly over to port, sliding for a period on its port side before rolling over and coming to rest upside down on the roll bar and canopy.

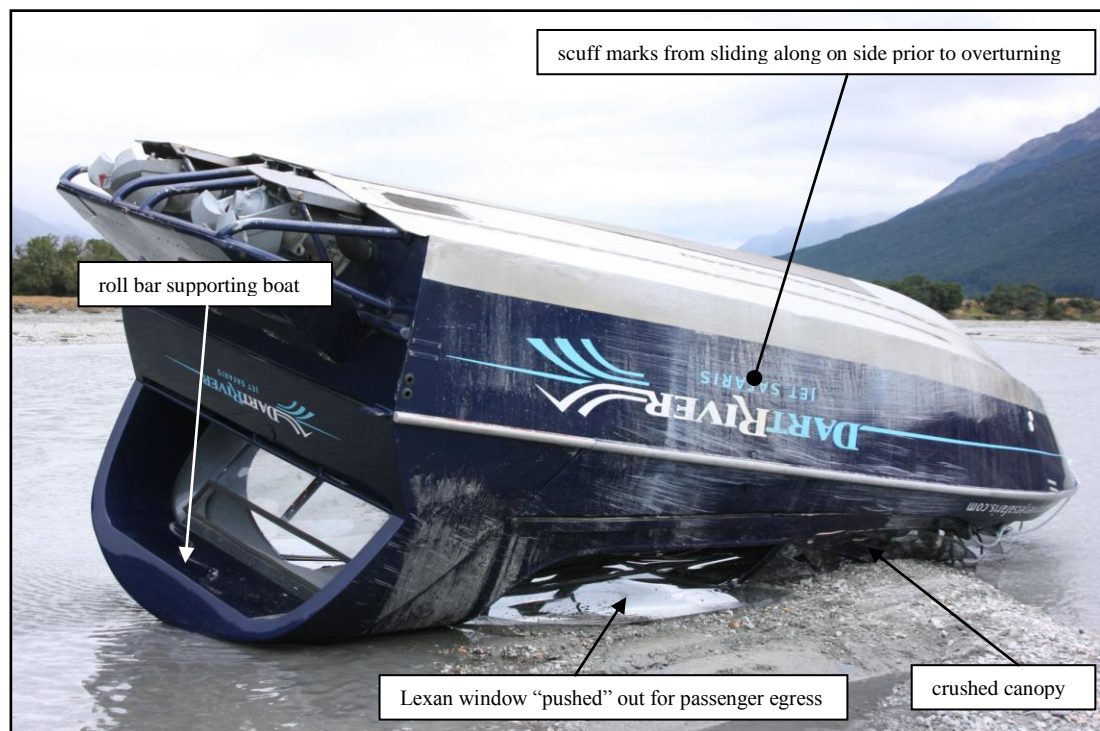
**Figure 4**  
***DRJS-11* at the accident site, still inverted**

- 1.1.9 When the boat came to rest upside down the driver made a “code one” emergency call on the boat’s VHF radio, shut off both propulsion motors and shouted out for the passengers to “kick the windows”, which was heard by some of the passengers; other passengers also shouted to others to kick the windows out. After the windows had been kicked out the passengers started to crawl out of the boat through the canopy windows. The majority of the passengers exited the boat on the starboard side, onto the gravel bank, but 2 of the passengers exited on the port side into the river. One of the passengers who exited on the port side of the boat was drenched with petrol over his back. The petrol was draining out of the boat’s fuel tank through a vent positioned on the boat’s side near to one of the escape windows.

- 1.2.8 Apart from extensive damage to the canopy, and superficial damage to the hull and roll structure, the boat was intact. All of the control cables and linkages to the jet unit nozzles and reverse buckets were intact and a full range of movement was possible for all components. The engines were not operated, but the driver stated that he had not noticed any mechanical malfunction with the boat leading up to and at the time of the accident.

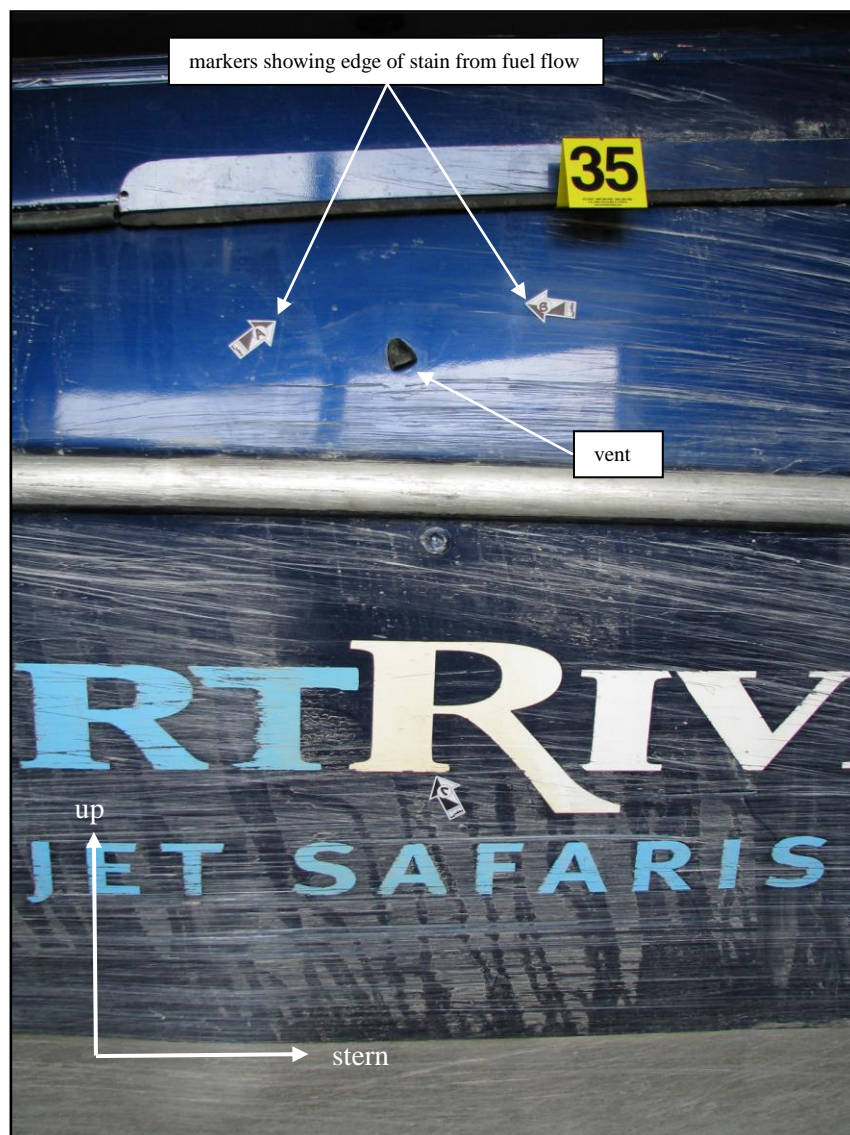
**Figure 6**

**Port side of DRJS-11 showing vent from which fuel flowed when the boat was inverted**

- 2.9 Fire within an upturned jet boat would be an identifiable risk. With 2 petrol engines operating at high speeds, the fuel and ignition sources would be present within the engine compartment in the event of some kind of disruption to components. In this case fuel leaking from the fuel tank vents was an added risk, albeit it was leaking outside the passenger compartment. Once the side windows had been kicked out however, petrol fumes could have entered the passenger space. The positioning of the fuel tank vents over the escape route was unfortunate in this respect, and also because passengers had to pass through the leaking fuel in order to exit.

- reduce the risk to the passengers of the possibility of a fire from the leaking fuel and an electrical ignition source
  - prevent fuel leaking from the tank vents,

*MNZ is following up with Dart River Safaris Ltd. and their authorised person to determine that changes to the fuel breather system, made since the accident, satisfactorily address this hazard. Only one other New Zealand operator has jet boats with enclosed canopies. In that instance the fuel valves are placed well away from the emergency exits. Any new commercial jet boats with canopies will be inspected prior to commencing operation to ensure this hazard has been addressed.*
