Report 09-204 : Coastguard rescue vessel *Dive! Tutukaka Rescue* collision with rocks,  
Taiharuru River entrance Northland, 4 March 2009; and  
Report 09-207:Coastguard rescue vessel *Trusts Rescue*, heavy weather encounter,  
Manukau Bar, 31 May 2009

## Final Report

Coastguard rescue vessel *Dive! Tutukaka Rescue* collision with  
rocks, Taiharuru River entrance Northland  
4 March 2009

Coastguard rescue vessel *Trusts Rescue*  
heavy weather encounter, Manukau Bar  
31 May 2009

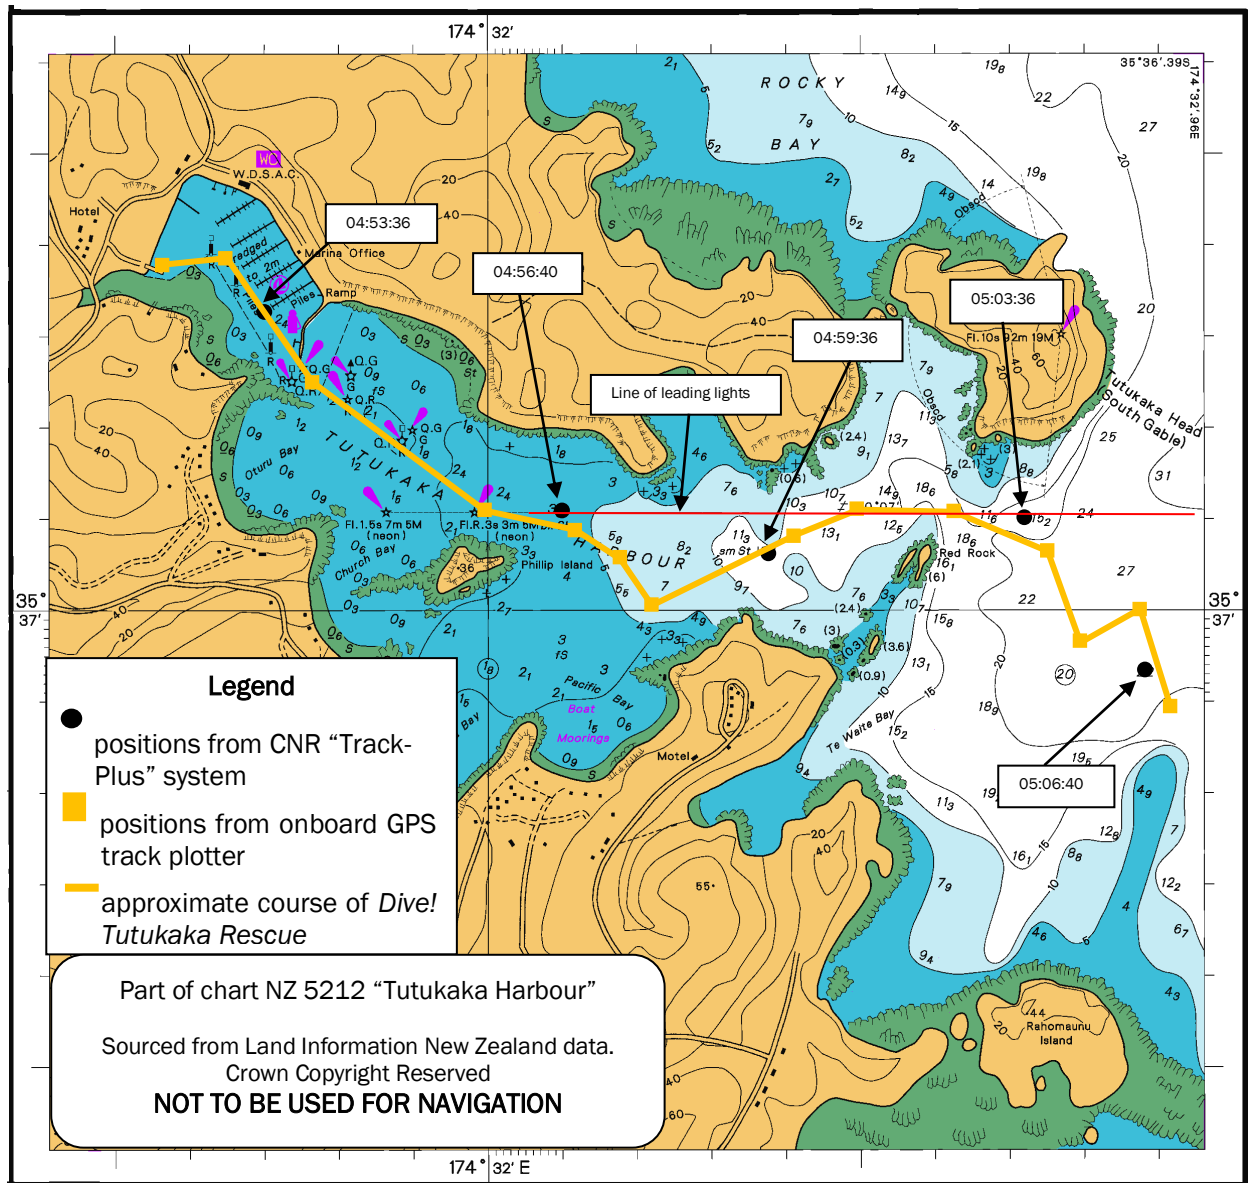
**Figure 3**  
 Approximate track of the Dive! Tutukaka Rescue leaving Tutukaka Harbour

3.1.10. The navigator was conning the vessel out of the harbour using his multifunction display, which was showing the chart with GPS overlay. The 2 crew members at the rear of the cockpit were also indicating in which direction to go to remain on the leading lights behind the vessel. The helmsman found it difficult to maintain the required track from the instructions received and the multifunction display in front of him.

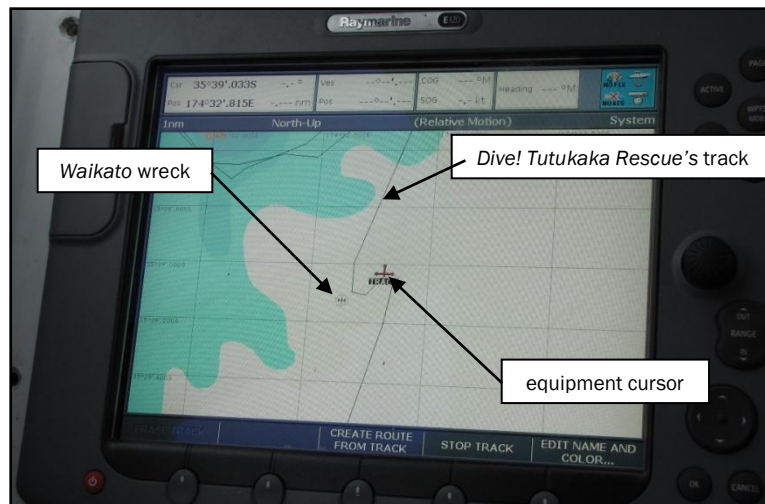
**Figure 5**  
 Screenshot of onboard display showing alterations of course at  
 the Waikato wreck

3.1.19. At about 0542, the *Dive! Tutukaka Rescue* made a radio call to the *Indian Summer* “I think we can see you now”, referring to having seen a light ahead of the *Dive! Tutukaka Rescue*. One of the crew members had just said to the skipper that he thought the light was a house on the shore, when seconds afterwards senior crew member 3 saw right ahead a rock illuminated in the beam of the vessel’s spotlight. He managed to shout “Rock” before the vessel hit the rock bow on. The speed of the vessel at the time was estimated to be about 15 kt.

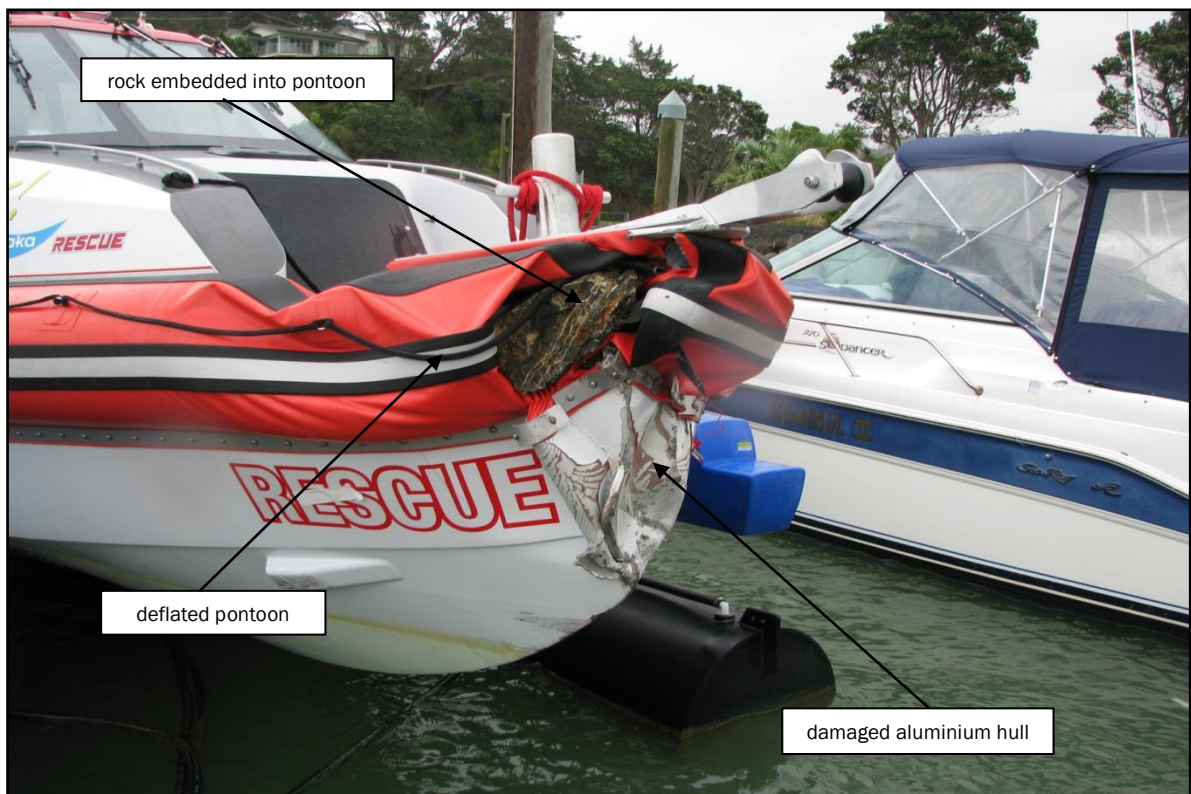
Figure 7  
Bow damage to the *Dive Tutukaka Rescue*

3.3.1. The bow of the *Dive! Tutukaka Rescue* was extensively damaged by the impact with the rock. The aluminium hull was pushed back with the bow inflatable pontoon ruptured. There was a small hole above the water line that allowed the ingress of a small amount of water. Part of the rock that the vessel hit was left embedded in the remains of the inflatable pontoon (see Figure 7)

3.3.2. In the cockpit damage was sustained by equipment and fittings from the crew being violently thrown against them during the impact. Other slight damage was sustained as the crew freed the anchor and fittings.

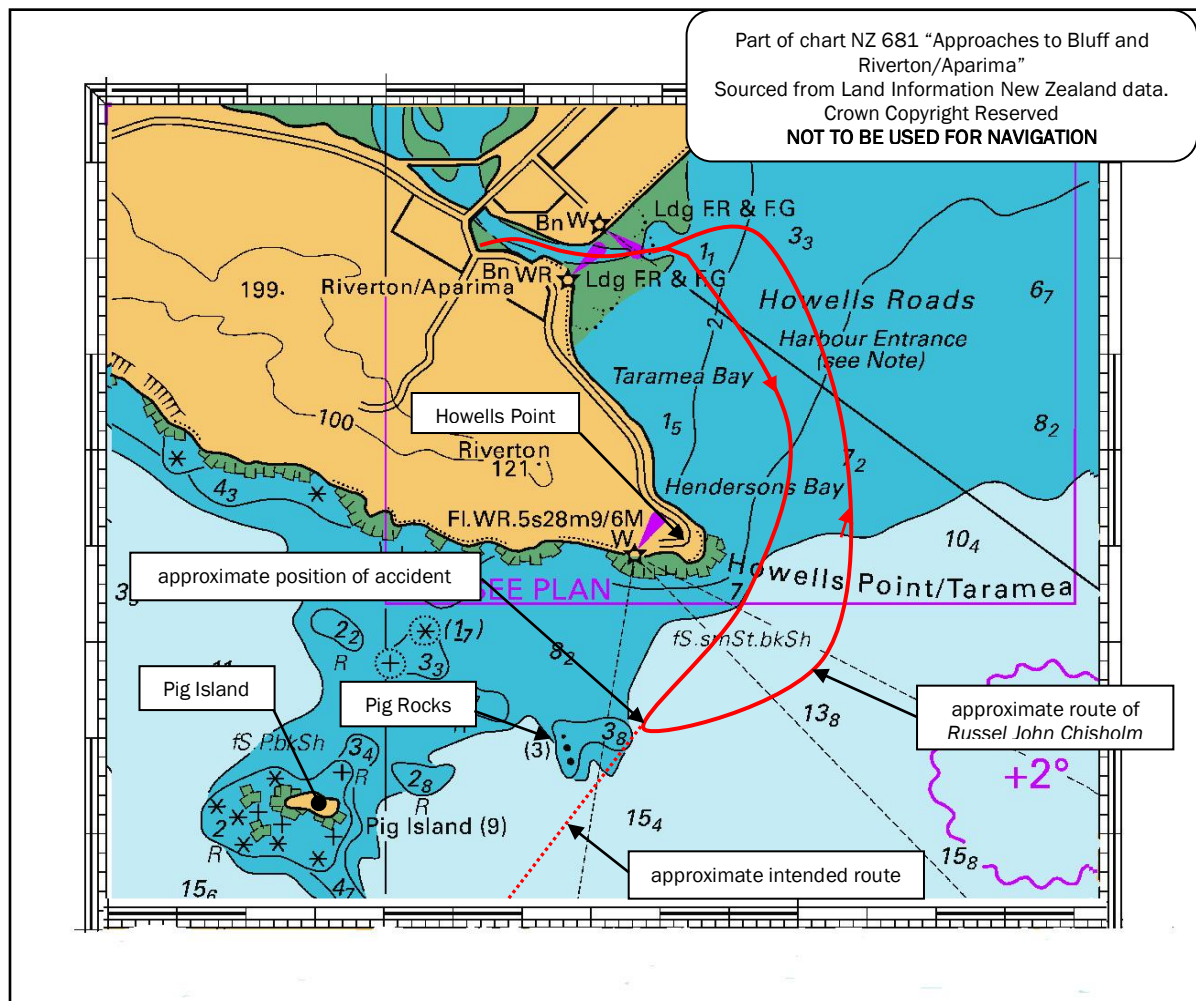
Figure 10  
Approximate route of the *Russell John Chisholm*

- 5.1.8. The climatic and sea conditions at the time were described as being about Beaufort 5 with a northerly wind of about 20 kt and 2 m waves. The sun had set at about 1815 and twilight had ended at about 1921. The waxing gibbous moon had risen at about 1338.

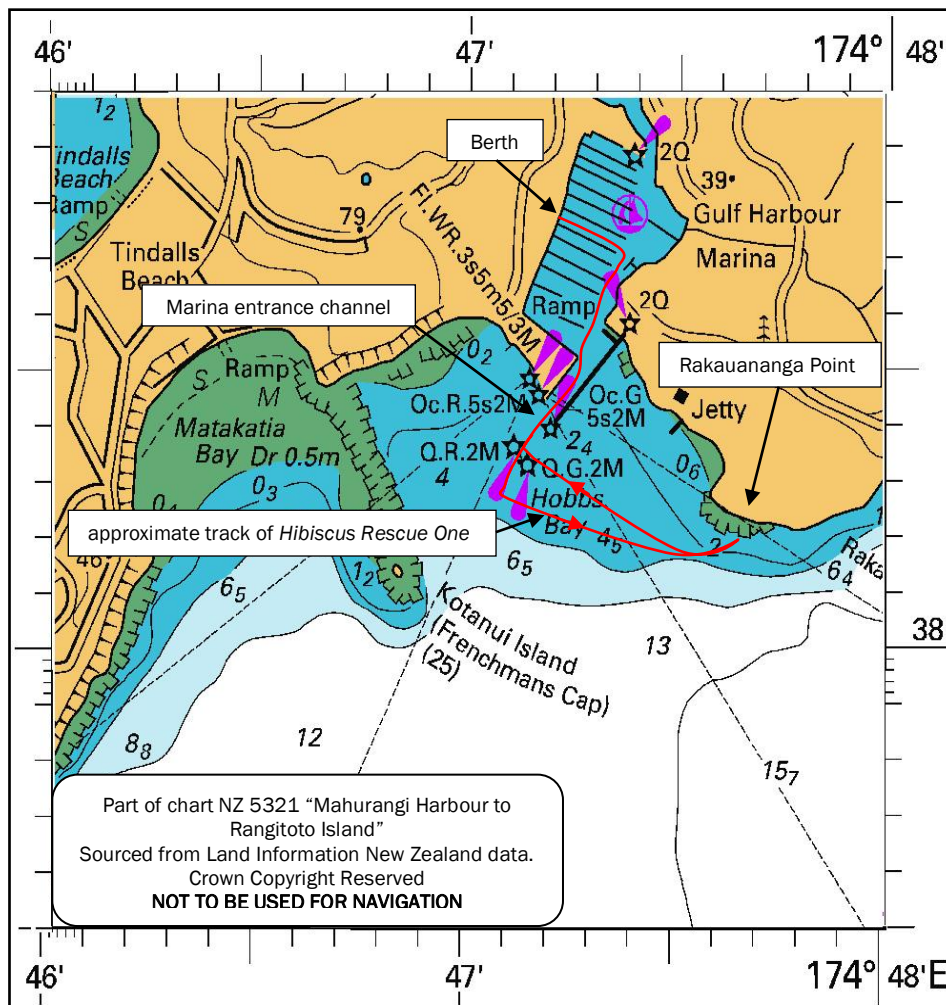
Figure 11  
Track of the Hibiscus Rescue One

5.2.9. At about 2202, a shuddering and skidding was experienced on board the vessel as it grounded on rocks at Rakauananga Point. The vessel spun approximately 180°, and the engines were thrown upwards on their pivots and cut out. The skipper was thrown from the helm station.

5.2.12. There were no injuries to the crew. The vessel sustained damage to the engine skegs, the engine cowlings and the engine hydraulics, and scraping to the underside of the vessel's hull.
