Final Report
Into the capsizing and foundering of the
Single outrigger passenger ferry

Uean Te Raoi II

Off Maiana Island in the Republic of Kiribati

Prepared by the Transport Accident Investigation Commission

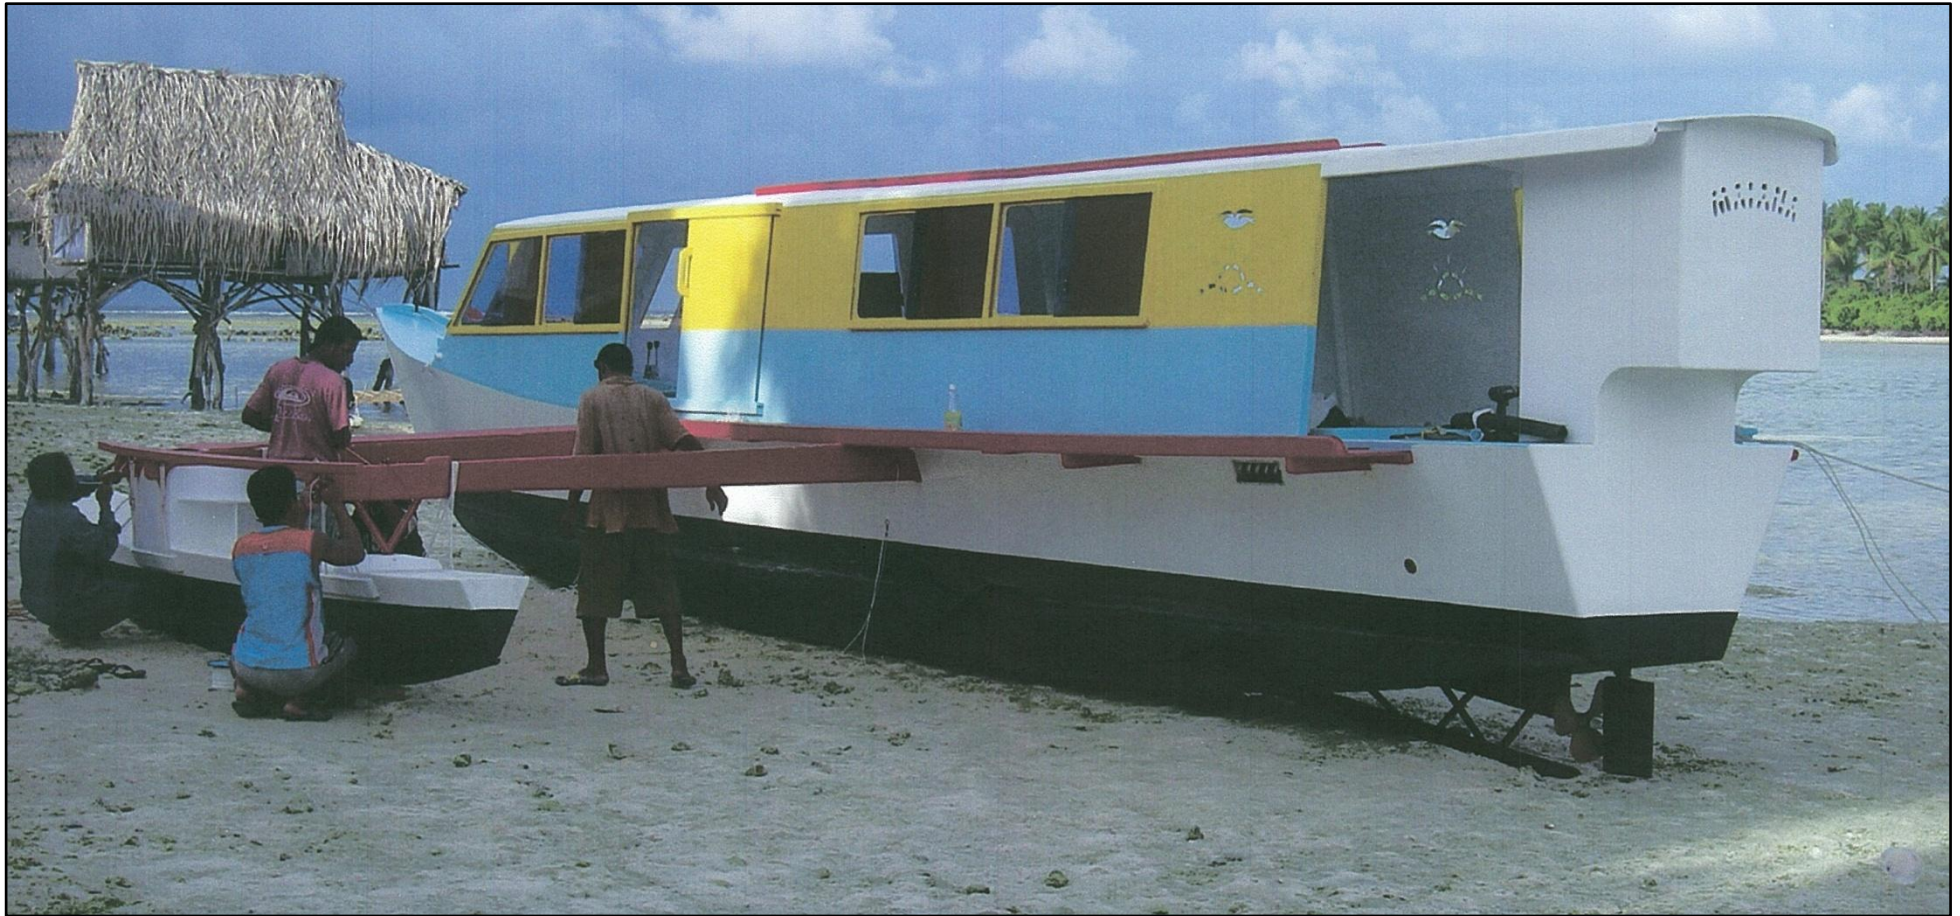
Uean Te Ranoi II prior to launching

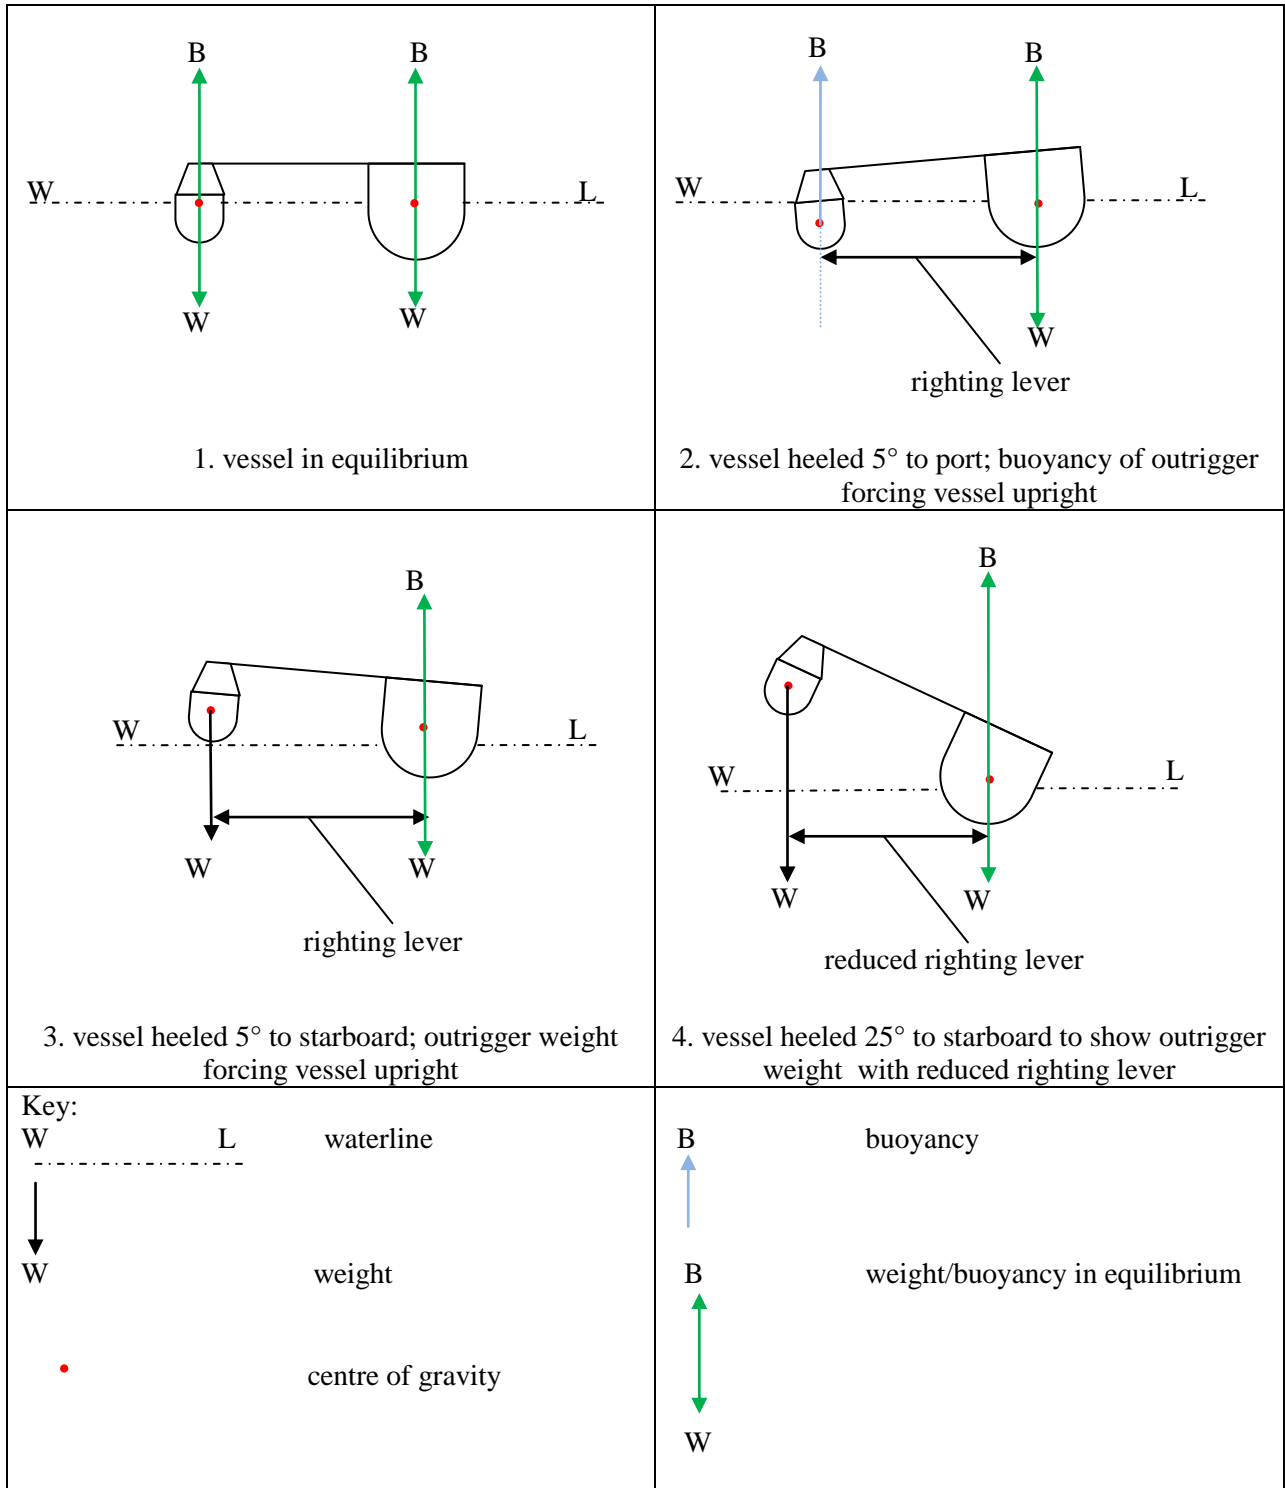
Figure 3
Diagram showing effect of outrigger on stability of the vessel

1.4.19 He also noted that the layout of the vessel was changed, with the addition of a cabin structure that caused more wind resistance, and with the passengers being carried on top of the hull instead of lower inside the hull with the original design. These factors contributed to a decrease in the vessel's safety, with regard to its resistance to capsize.

1.4.20 He said that an earlier decision not to allow weight to be carried on the cross beams addressed a structural issue, but prevented the traditional method of stability improvement used on this type of vessel (Stronach & Associates, 2009).

- 2.12 Capsizing in the other direction however, relied on the sum of the weight of the outrigger and the distance that weight was displaced from the centre of gravity of the main hull. As the outrigger rises out of the sea when the vessel rolls, the downward weight increases (and thus the righting lever) as the outrigger rises clear of the water. If the capsizing moment caused by waves and wind was to exceed the righting lever provided by the outrigger, the vessel would continue to roll over towards the non-outrigger side. As the angle of heel increased, the righting lever provided by the outrigger would decrease to a point where the vessel was lying on its beam with the outrigger vertically up in the air, at which point the outrigger would provide no righting lever to prevent capsizing.

- 2.13 The *Uean Te Raoi II* was travelling south with the outrigger positioned to seaward, toward what had become a significant wind and sea. Witnesses reported the outrigger rising out of the sea on several occasions before the actual capsizing. Some were concerned enough to comment to the skipper, who from his reported response, was unconcerned and had what was possibly misplaced confidence in the vessel's ability to handle the sea conditions in the direction of travel at the time. The independent naval architect noted in his report that: "It is reported that the outrigger was becoming airborne at times, which indicates that the stability was marginal." He also noted earlier in his report that "for a vessel with the reported dimensions, a difference in height of 1 m between the outrigger and the main hull will cause a roll angle of about 14°".

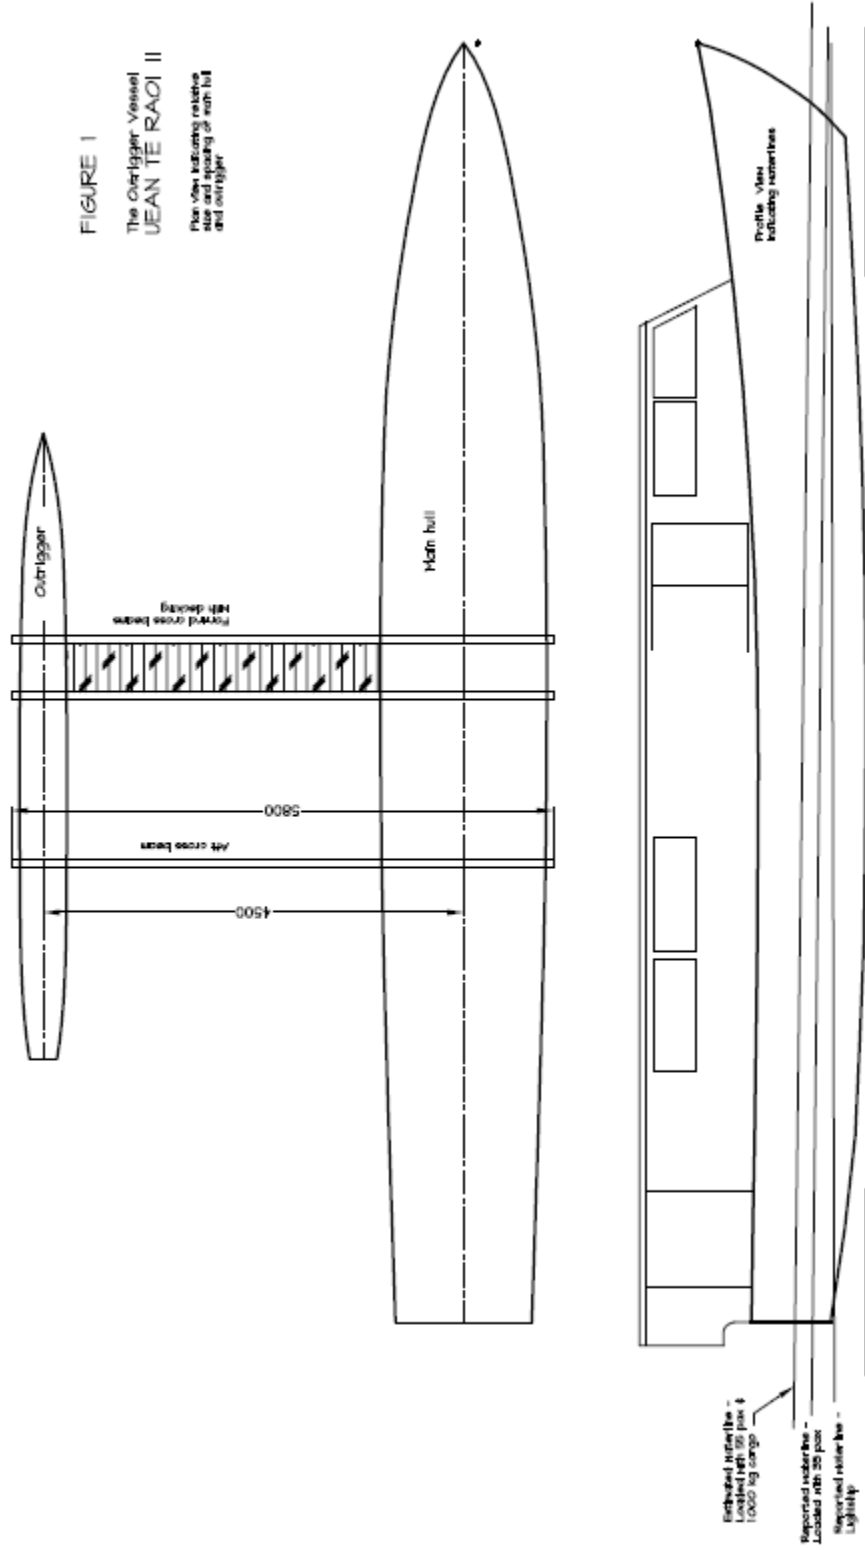
FIGURE 1
 The Outrigger Vessel
 JEAN TE RAOI II
 Plan view indicating relative
 positioning of main hull
 and outrigger

An earlier decision not to allow weight to be carried on the cross beams addressed a structural issue, but prevented the traditional method of stability improvement used on this type of vessel.

The resulting vessel did not provide an acceptable level of safety in anything beyond sheltered waters operation. It was at significant risk of capsize with loads of over 30 persons, combined with wind conditions of over 30 kts, or in beam sea conditions of over about 1.5 m.

Estimated waterline -
 Loaded with 50 pass &
 1000 kg cargo

Reported waterline -
 Loaded with 20 pass

Reported waterline -
 Lightly
