Report 10-003: Cessna C208 Caravan, ZK-TZR, engine fuel leak and forced landing,  
Nelson, 10 February 2010

Aviation inquiry: 10-003  
Cessna C208 Caravan, ZK-TZR  
engine fuel leak and forced landing  
Nelson, 10 February 2010

Approved for publication: 23 February 2011

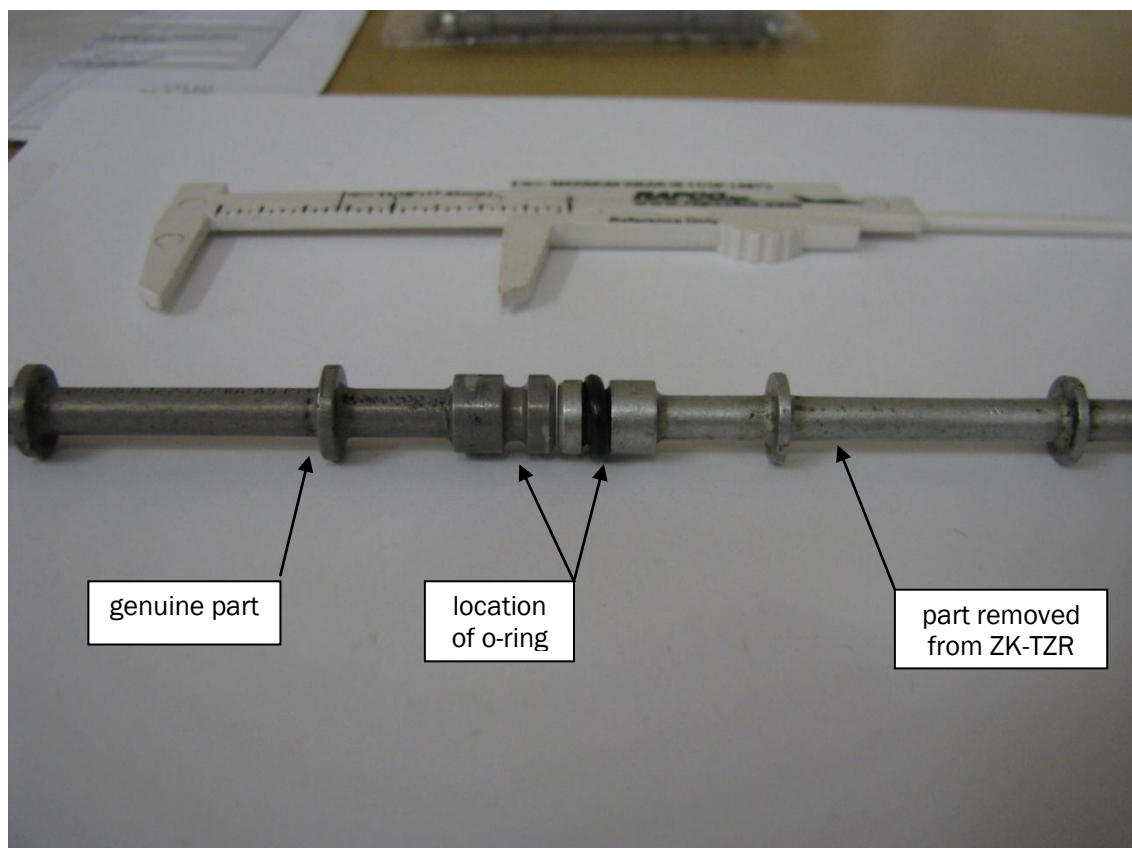
Figure 1  
Fuel-transfer tubes

- 3.2.3. An examination of the suspect fuel-transfer tubes confirmed that the part number engraved on the side of the tubes was the correct Pratt & Whitney Canada part number. However, the normal anodic coating was no longer present and the tubes appeared smaller alongside known genuine parts. Measurements of the suspect tubes showed they were between 0.008 and 0.019 inches (0.2 and 0.48 mm) below limits in all areas except one. The internal tube diameters were also larger than new and other used tubes. The material used in the construction of the suspect tubes was determined to be a 2024 aluminium alloy of the type normally used in their construction.

- 3.2.4. The examination determined that the suspect tubes were genuine in origin but had probably been immersed in a chemical milling solution, although no trace of the solution could be found. The manufacturer noted that chemical milling was not an approved method for cleaning and repairing the tubes.

- 3.2.5. An examination of the supplied o-rings confirmed they were of the correct composition, microstructure and hardness when compared with original specifications. The o-rings displayed mechanical damage and chipping consistent with having been pinched and rolled.

- 4.2. The fuel leak was confirmed as being from the fuel-transfer tubes. The tubes were determined to be genuine aircraft parts, but had at some time been cleaned in a milling solution. This had had the effect of removing the anodised coating and shrinking the overall dimensions of the tubes. As a result, the o-rings did not provide a snug fit when installed and therefore could move with changes in fuel pressure. Eventually the o-rings deteriorated through chipping and rolling to allow fuel under pressure to leak from the tubes. Despite a review of maintenance records, enquiries with relevant New Zealand maintenance organisations and the assistance of the FAA, the facility where the tubes had been removed and cleaned in a non-approved manner could not be identified.

- 5.1. The reduction in engine performance was caused by fuel leaking past o-rings that had been damaged by fuel-transfer tubes that were able to move because the tubes were out of size tolerance.

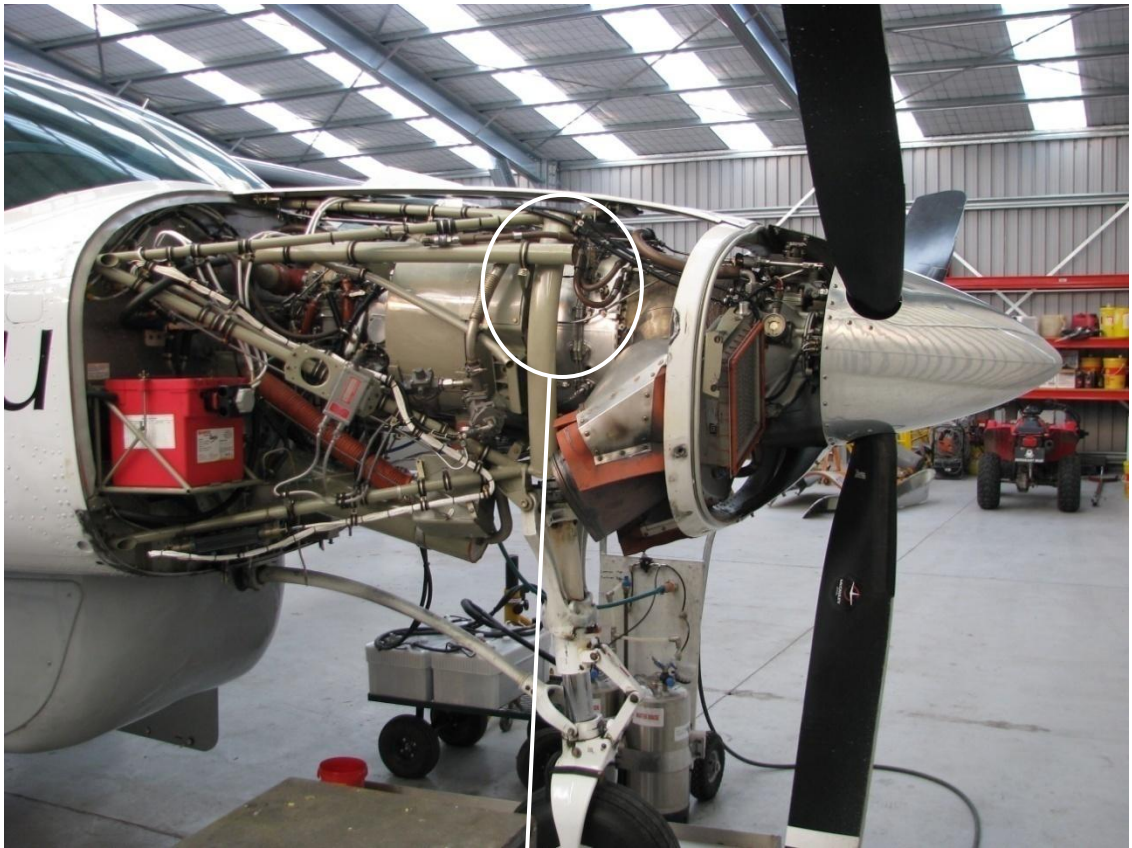
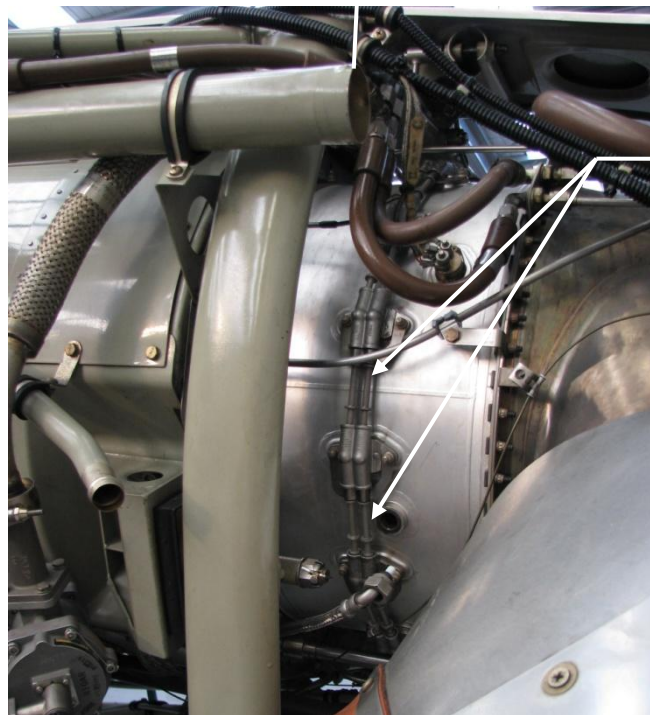
Figure 2  
Location of fuel-transfer tubes

Fuel transfer tubes
