Inquiry 10-008: Cessna 152 ZK-TOD and Cessna 152 ZK-JGB
mid-air collision near Feilding, Manawatu, 26 July 2010

Final Report

Aviation inquiry: 10-008
Cessna 152 ZK-TOD and Cessna 152 ZK-JGB
mid-air collision near Feilding, Manawatu
26 July 2010

Approved for publication: 13 February 2013

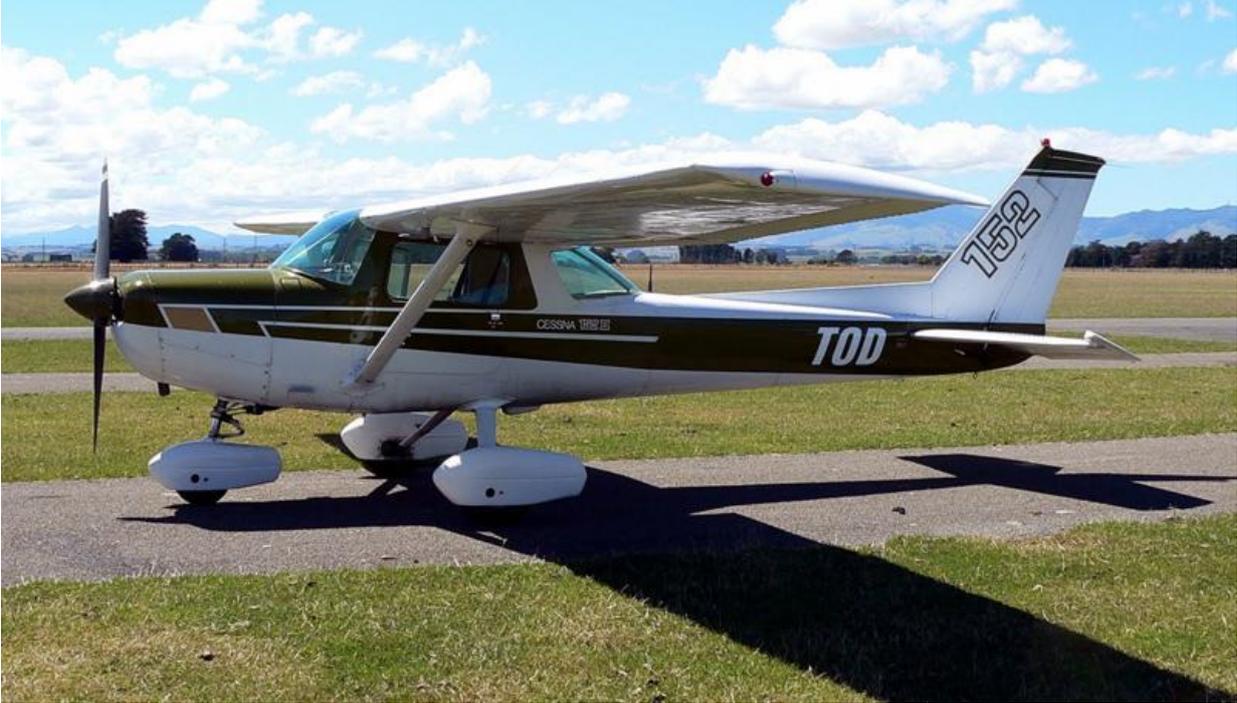
Cessna 152 ZK-TOD (Cessna A)
(Courtesy of Flight Training Manawatu)

- 3.2.5. A rounded indentation and rubber transfer marks about the leading edge of the right wing, about 2 m inboard of the wing tip, approximated the dimensions and matched the tread of the nosewheel of Cessna B. Outboard sections of the right wing and the right aileron had detached from the aircraft as it descended and were found about 280 m to the north of the main wreckage. Other pieces of light material, for example Perspex and pieces of aluminium, were found scattered about the adjacent paddocks.

- 4.2.11. The nosewheel of Cessna B struck the outboard right wing of Cessna A. The impact caused the outboard 2 m of the wing of Cessna A, including the aileron, to separate, which rendered the aeroplane uncontrollable. One of the pilots on board Cessna A transmitted a distress call, which might have included reference to an engine failure. Dealing with an engine failure would be a distraction that could cause pilots to lose awareness of their surroundings, so the possibility that Cessna A suffered an engine failure prior to the collision must be considered. However, if an engine failure had occurred Cessna A would have begun to lose height earlier. The radar records show that Cessna A maintained a steady altitude until the collision, so it was therefore unlikely that the engine failed before the collision. The scenario of a simulated engine failure is commonly used during a pilot's training to initiate an emergency response. If the words "engine failure" were used, that could possibly have been an automatic reaction if the pilots were unaware of what had caused the sudden departure from controlled flight.

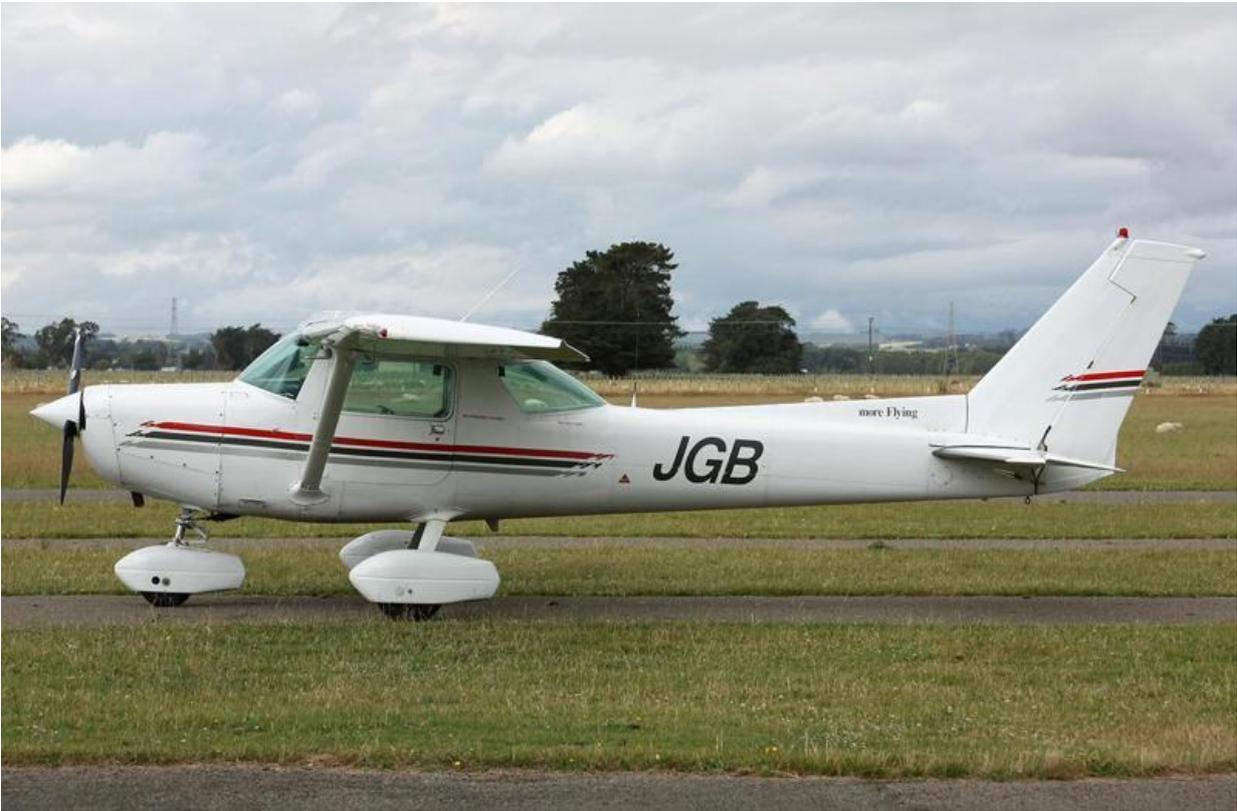
Cessna 152 ZK-JGB (Cessna B)
(Courtesy of Flight Training Manawatu)

- 3.2.7. Cessna B had sustained major damage to the front of the aircraft. The nosewheel leg was still attached by a support bracket, but had been forced backwards. The engine carburettor was fractured, which was probably what had caused the engine to stop. The engine firewall displayed crease marks typical of those seen after a heavy nose-gear landing. The fairing at the base of the left wing strut had damage consistent with it having been struck by the nosewheel as it was pushed backwards. The aeroplane's flight controls were intact and operated as designed.

- 4.2.12. Despite the engine of Cessna B stopping, student B was able to glide back and land on the grass beside the runway. The damage to the engine carburettor would have caused the engine to stop. This damage was probably caused by the nosewheel and engine being forced back when they struck the wing of Cessna A.

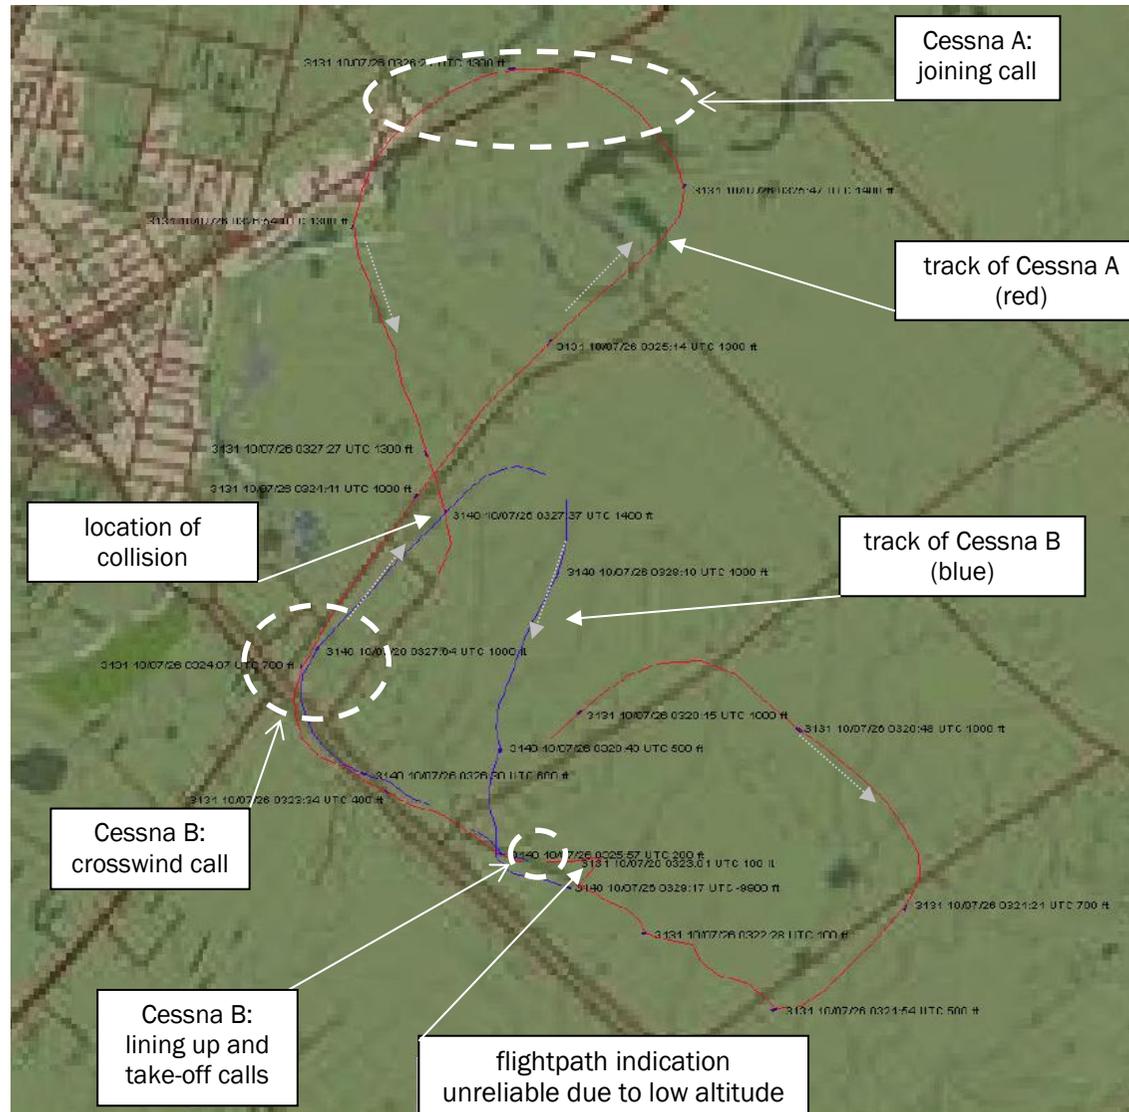
Figure 5
 Radar recording of Cessna A and Cessna B
 (Courtesy of Airways New Zealand)

3.2.28. The 2 aeroplanes then maintained steady tracks as they approached each other – Cessna B climbing with a groundspeed of between 65 knots and 70 knots on a track of about 020° magnetic, and Cessna A on a track of about 140° magnetic with a groundspeed of between 90 knots and 95 knots. At about 1527:30 Cessna B levelled at 1300 feet. The data showed that the 2 aeroplanes collided at 1527:36, at a recorded altitude of 1300 feet (see Figure 5).

- 4.2.2. The radar recordings and the nature of the damage to both aeroplanes indicated that both aeroplanes maintained constant tracks for the 30 seconds prior to the collision. Student B said that he had not seen Cessna A until after the collision. The steady course maintained by Cessna A leading up to the collision suggests that its pilots were not expecting a conflict with the other aeroplane, and did not see it in time to take avoiding action. Whether they saw it immediately before the collision will never be known, but it remains a possibility.

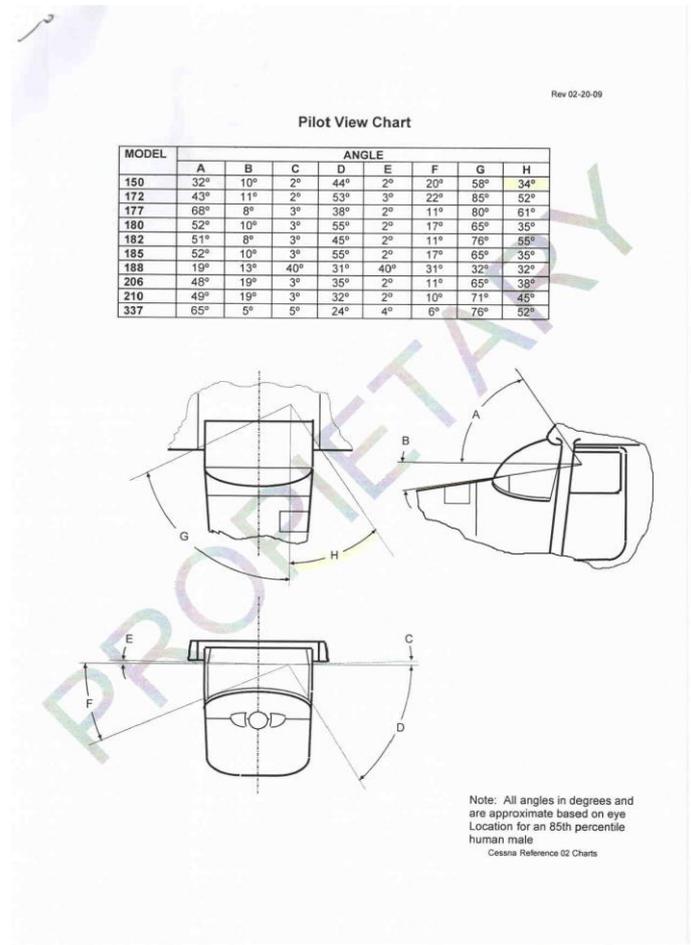
Figure 8
Cessna pilot view chart
(Courtesy of Cessna Aircraft Company)

4.3.10. Figure 8 shows a pilot's field-of-view chart for the Cessna range of single-engine, high-wing aeroplanes. The figures are based on the eye location for an "85th percentile human male". In other words the data should be accurate for 85% of males, but would vary for persons away from this average. The figures for the model 150 are representative of the available visibility for the Cessna 152.

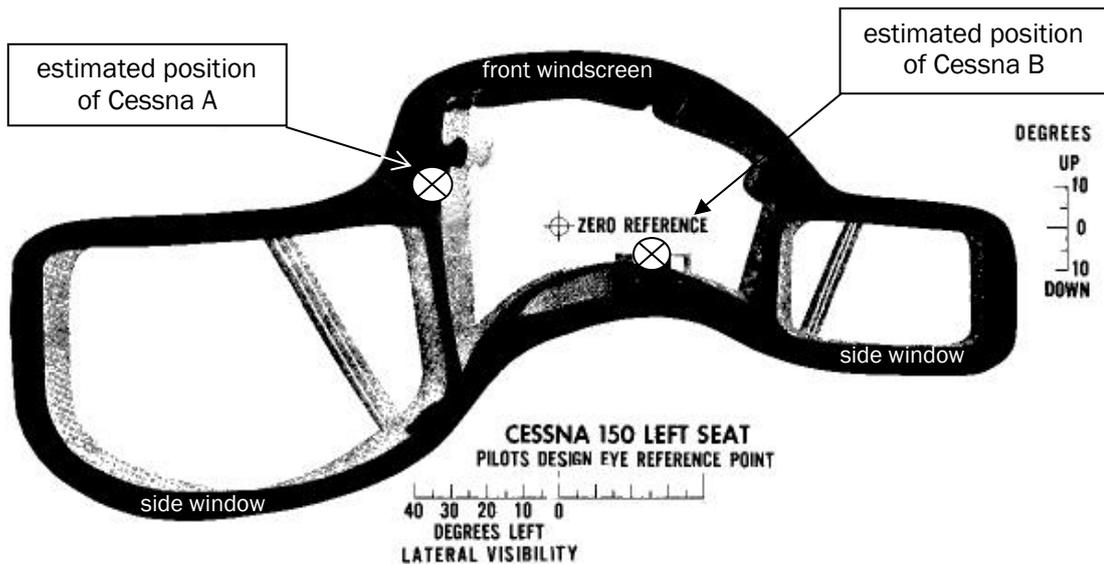
Figure 9
Visibility diagram – left seat
(Courtesy of the ATSB)

4.3.11. Figure 9 and Figure 10 show the visibility available for the average pilot when positioned in the left and right seats. Using the radar data to determine the relative bearings and height differences between the 2 aeroplanes at given times, the approximate locations of the opposing aeroplanes as they approached each other for the final 30 seconds have been plotted and shown in Figure 9 for both students seated in the left seat, and Figure 10 for the instructor seated in the right seat.

- 4.3.12. According to the pilot field-of-view charts, the opposing aeroplane should have been visible to the 3 pilots to some extent. Student A, seated in the left seat of Cessna A, would have had the most difficulty of the 3 pilots in seeing the other aeroplane. Cessna B should have been visible in the main windscreen but, as it was climbing towards Cessna A, it would have been low down in the front windscreen and about in line with the top of the instrument panel. Student A would have needed to stretch up to get a clear view of Cessna B as it approached.
- 4.3.13. For student B seated in the left seat of Cessna B, the other aeroplane should have appeared about midway up the main windscreen, but may have been blocked or partially blocked by the framing between the left door and front windscreen.

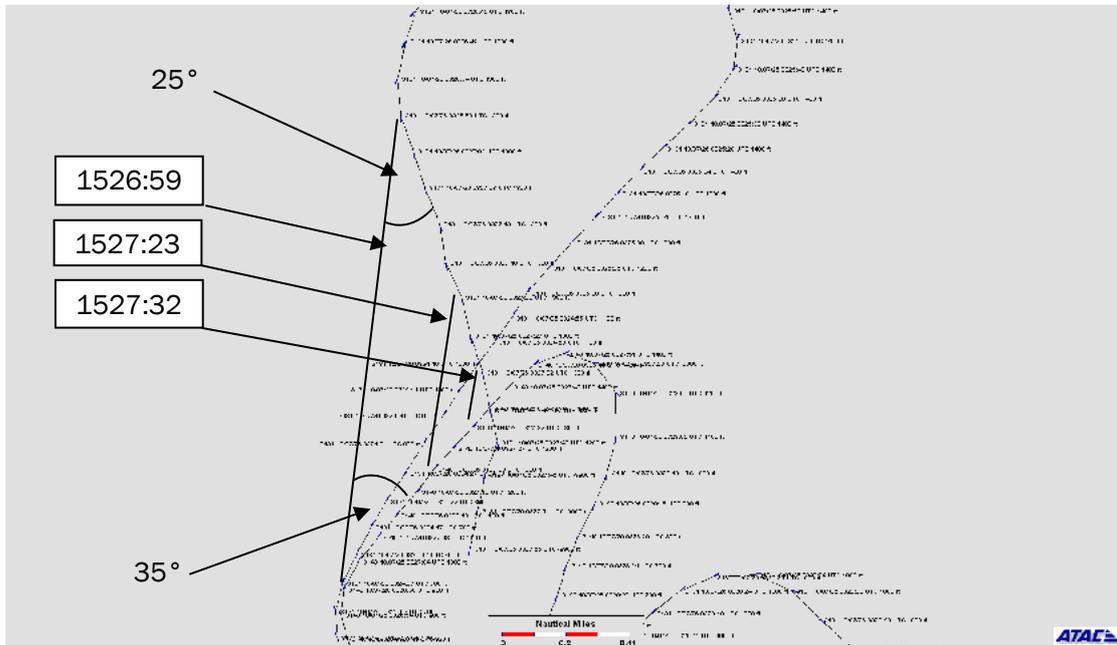
Figure 11
Relative bearing plot
(Courtesy of Airways New Zealand)

- 4.3.21. The pilots of both aeroplanes should therefore have been able to see the other. However, with a closing speed calculated to be between 130 and 145 knots (about 240-270 km per hour),

the opposing aeroplane would have initially appeared small and its apparent size would not have changed appreciably. The constant bearing and lack of relative movement as they closed on each other during the last 30 seconds meant that there was little to attract the pilots' attention towards the other aeroplane.
