Report 10-009: Walter Fletcher FU24, ZK-EUF,
loss of control on take-off and impact with terrain,
Fox Glacier aerodrome, South Westland, 4 September 2010

Final Report

Aviation inquiry 10-009
Walter Fletcher FU24, ZK-EUF
loss of control on take-off and impact with terrain
Fox Glacier aerodrome,
South Westland
4 September 2010

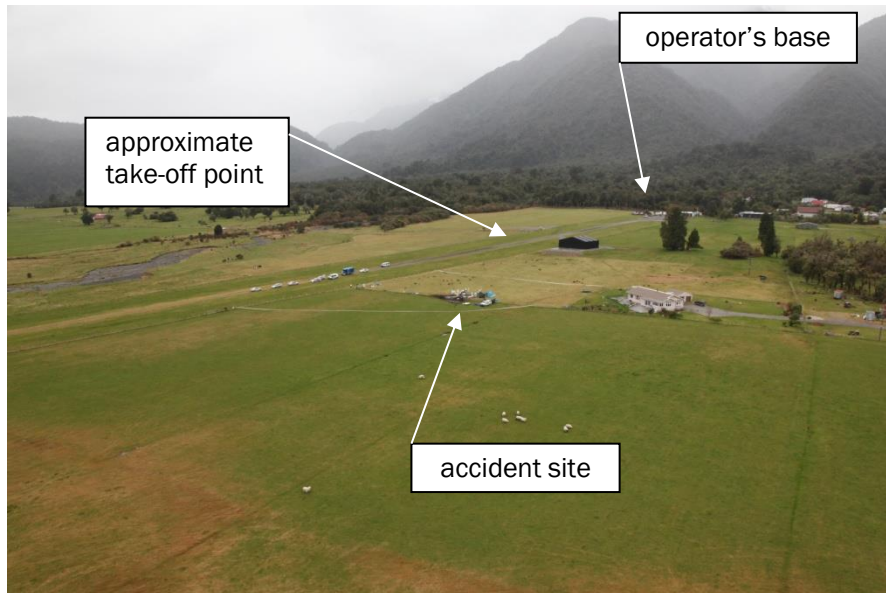
Figure 2
Fox Glacier aerodrome - general
(Courtesy of New Zealand Police)

- 3.2.1. The accident site was in a grassed paddock adjacent to the Fox Glacier aerodrome (see Figure 2). The aerodrome consisted of a single runway aligned about 265° magnetic. The runway sloped up to the east, which restricted take-offs to a westerly direction and landings to an easterly direction. The first approximately 400m of the runway, starting from the operator's buildings at the eastern end, were of bitumen construction. A further approximately 360m of grass were available if required. The wreckage of ZK-EUF was found 100m south of the runway and about 200m past the end of the bitumen section of runway (see Figure 3).

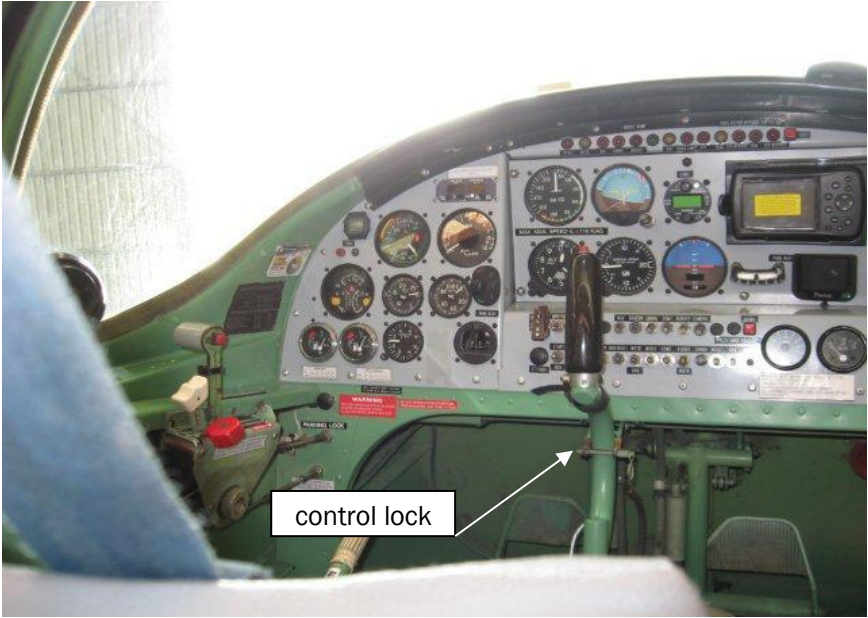
Figure 5
Control lock (Courtesy of M Feeney)

3.5.3. To prevent the controls moving about when the aeroplane was unattended, a control lock was fitted below the instrument panel in front of the pilot's seat (see Figure 5). To lock the controls, the control column would be moved fully forward to sit in a protruding "H" shaped bracket that would be pulled out from below the instrument panel. A pin would be inserted through 2 holes in the bracket to hold the control column in place. Soon after the accident the aeroplane owner commented that he never used the control lock between flights and the pilot used a bungee cord to hold the control column forward when getting in and out of the cockpit.

- 4.2.9. The control lock was not located during the site examination and so the possibility of the pilot becoming airborne or attempting to become airborne with the controls locked cannot be fully excluded. The engineering company and aeroplane owner submitted that this may have been the cause of the accident. However, this was considered unlikely for the following reasons:

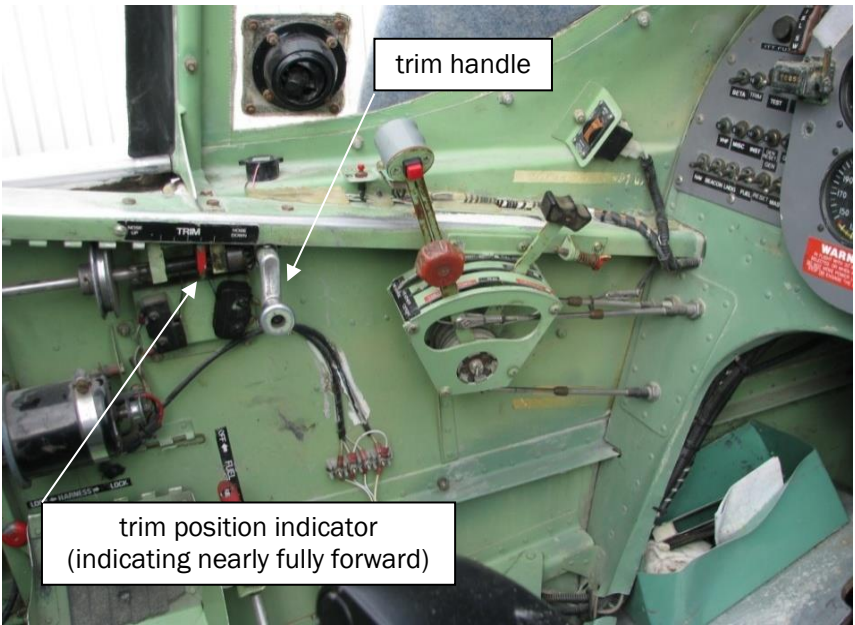
Figure 6
Trim handle

3.5.4. An elevator trim system was fitted to assist the pilot and ease elevator control forces when operating in a range of speeds and loading conditions. Fletcher aeroplanes had either electrically or manually operated trim controls. The trim control for ZK-EUF was manual, with a rotating handle located on the left side of the cockpit, aft of the power-control lever (see Figure 6). The trim could therefore be moved with the pilot's left hand while at the same time the right hand held the control column. The trim took about 25 turns of the handle for full travel.

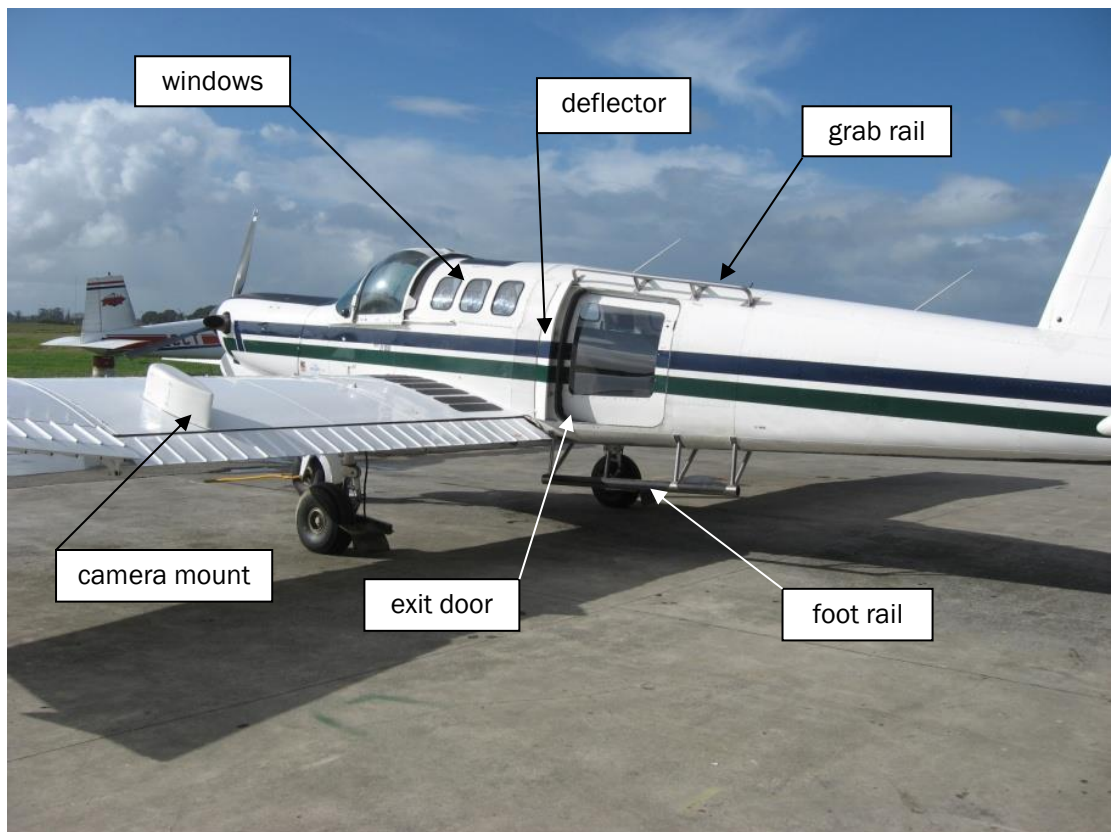
Figure 8
ZK-EUF modifications

3.6.23. The engineering company modified ZK-EUF for parachuting operations by firstly removing all the equipment associated with topdressing, such as the hopper and spray equipment. Then, installing a range of major modifications that had been used on other aeroplanes, including some Walter Fletchers, the engineering company configured ZK-EUF for parachuting. These modifications included the installation of a strengthened floor and a parachutist access door in the rear of the aeroplane, internal and external grab rails, and a step (see Figure 8). Two STCs for the fitment of 2 oxygen systems to permit flights up to 16 000 feet were also embodied at this time.
